# Arlington Place HOA

## CAPITAL RESERVE STUDY

Report Number: 22-14  
Site Inspection Date: April 1<sup>st</sup>, 2016  
Report Submittal Date: June 7<sup>th</sup>, 2016  
Report Revision Date: October 17<sup>th</sup>, 2022

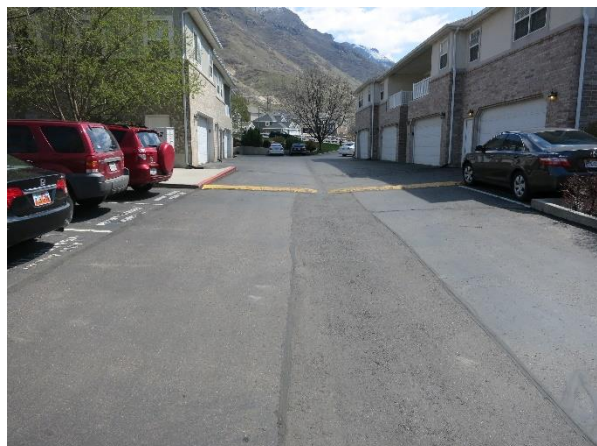
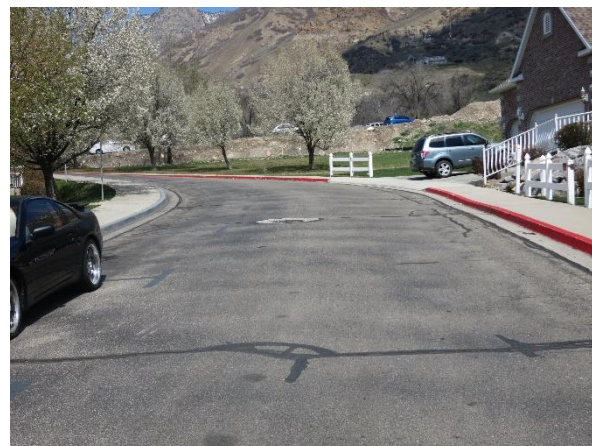
Component Name: 2" Asphalt Overlay  
 Component Number: Drive Materials 1001

Component Life Expectancy: 20 years  
 Average Age of Component: 18 years  
 Remaining Component Life: 2 years

The AASHTO Pavement Design Guide recommends asphalt paving receive immediate rehabilitation when signs of alligator cracking or longitudinal cracks wider than 1/4 inch are present. An asphalt overlay is recommended every 15 to 20 years. The overlay will add new structure to the road and fix any pot holes or structural defects that may develop over time. Without an overlay, the road base beneath the paving could deteriorate leading to a complete asphalt replacement.

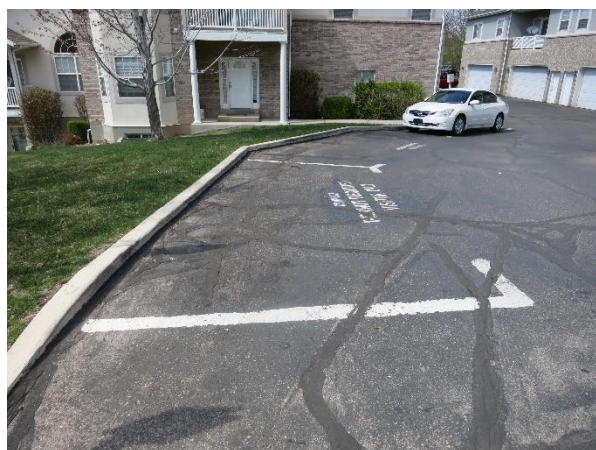
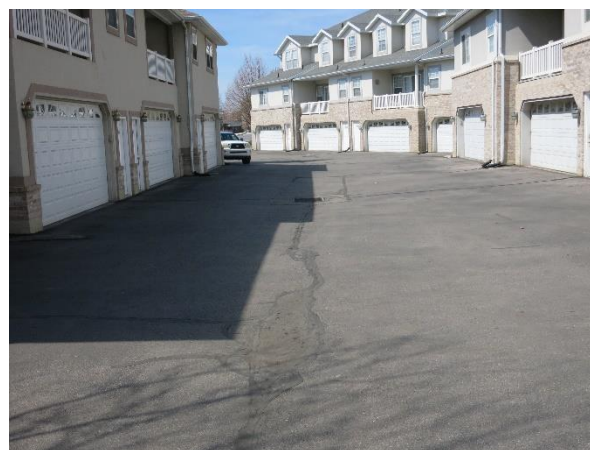
Component Name: Asphalt Slurry & Crack Seal  
 Component Number: Drive Materials 1002

Component Life Expectancy: 5 years  
 Average Age of Component: 2 years  
 Remaining Component Life: 3 years

A crack and slurry seal is recommended every 5 years. Slurry seal will help protect the asphalt from degradation by sealing cracks, preventing water seepage and damage. It also rejuvenates the surface and renews the oils, keeping the asphalt from becoming overly brittle.

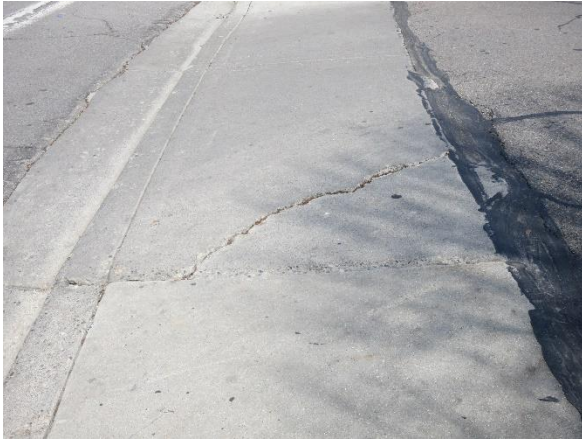
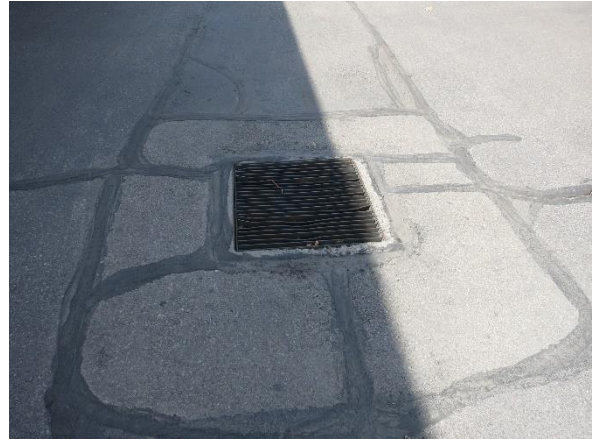
Component Name: Concrete Repair/Replace  
 Component Number: Drive Materials 1003

Reoccurring Allowance: 5 years  
 \_\_\_\_\_  
 \_\_\_\_\_

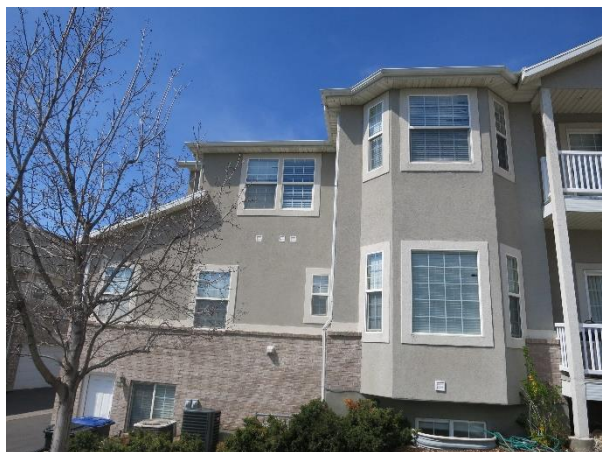
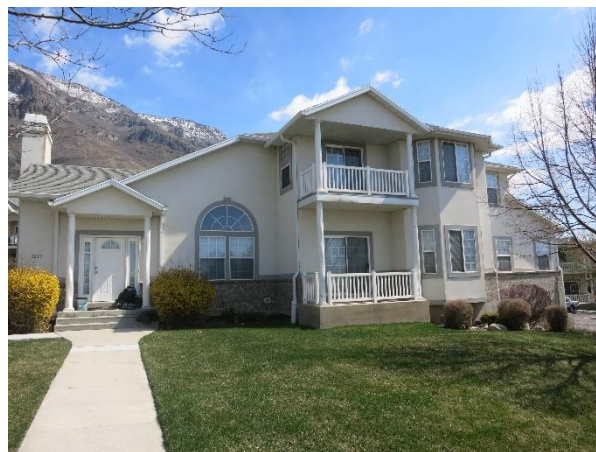
Component Name: Stucco Repair  
 Component Number: Building Exterior 2001

Reoccurring Allowance: 5 years

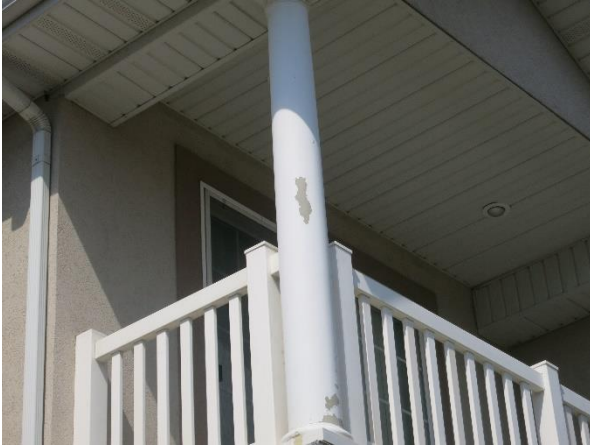
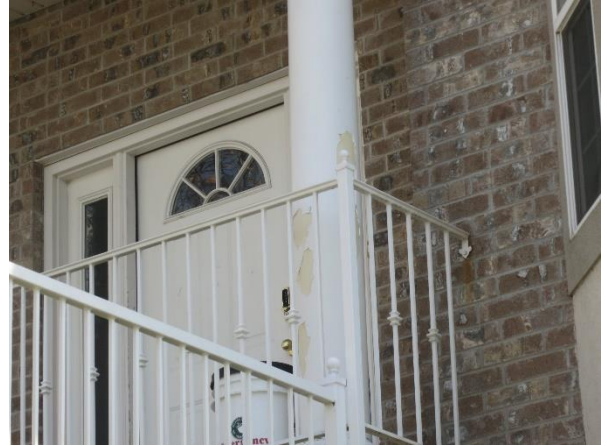
Component Name: Trim, Door & Column Painting  
 Component Number: Building Exterior 2003

Component Life Expectancy: 8 years  
 Average Age of Component: 7 years  
 Remaining Component Life: 1 years

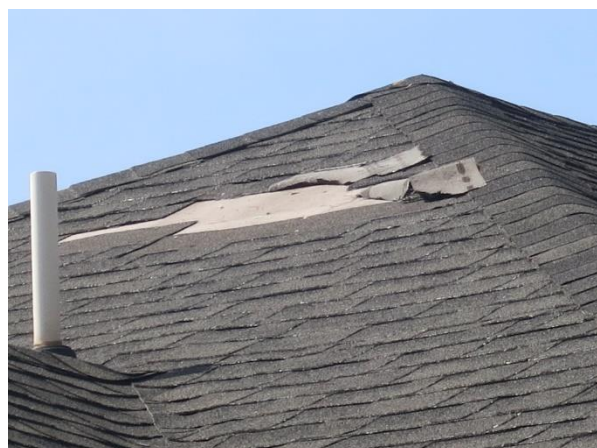
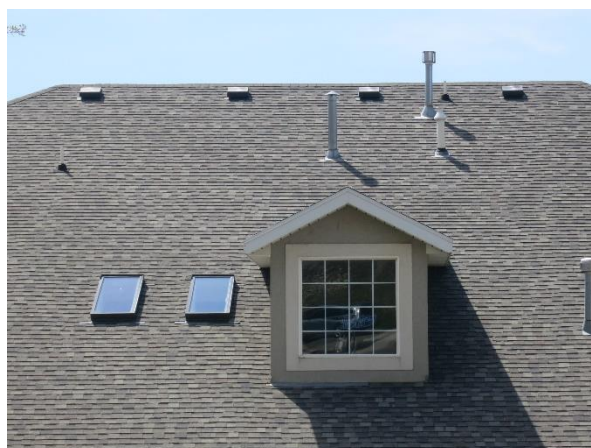
Component Name: Shingle Replacement  
 Component Number: Building Exterior 2004

Component Life Expectancy: 30 years  
 Age of Component: 4/1 years  
 Remaining Component Life: 26/29 years

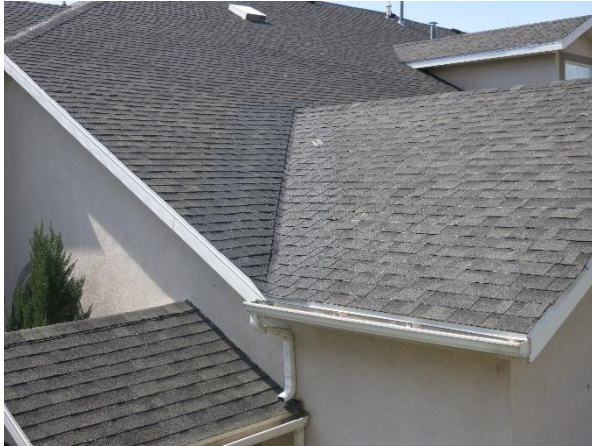
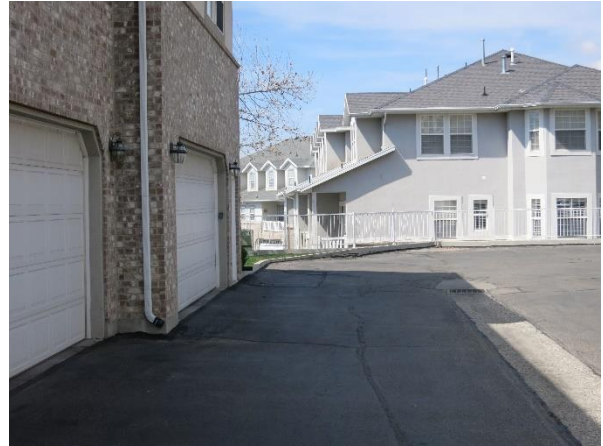
Component Name: Aluminum Gutter Replacement  
 Component Number: Building Exterior 2005

Component Life Expectancy: 25 years  
 Age of Component: 1 years  
 Remaining Component Life: 24 years

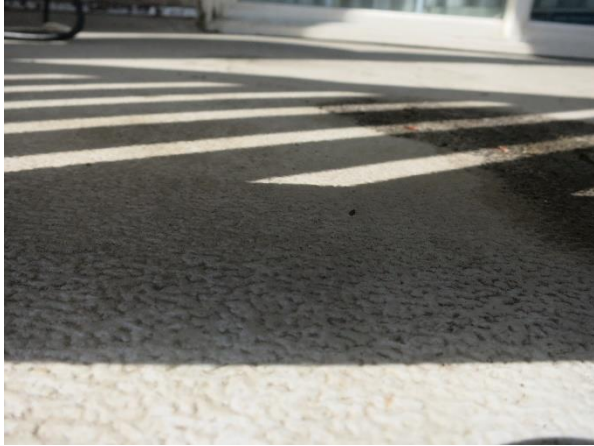
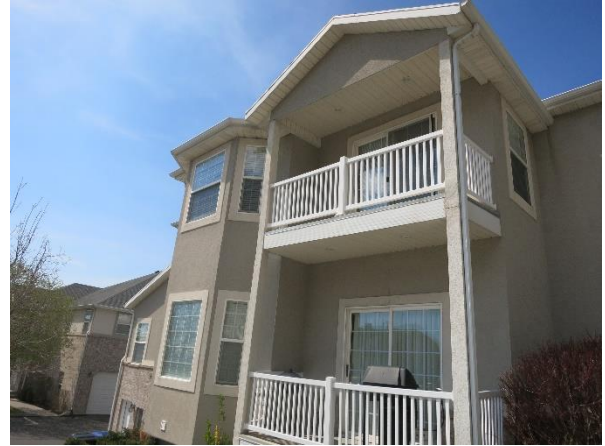
Component Name: Decking Surface Replacement  
 Component Number: Building Exterior 2009

Component Life Expectancy: 10 years  
 Age of Component: 4 years  
 Remaining Component Life: 6 years

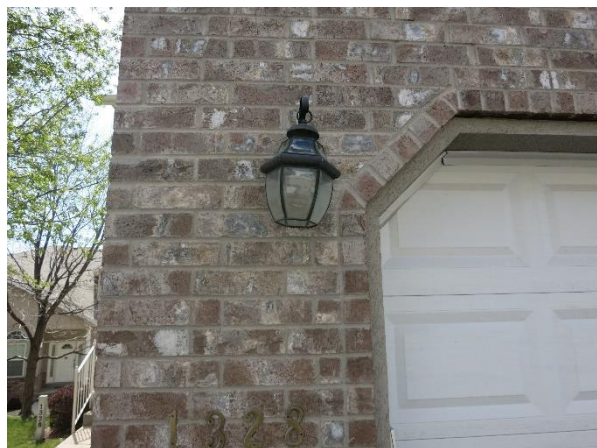
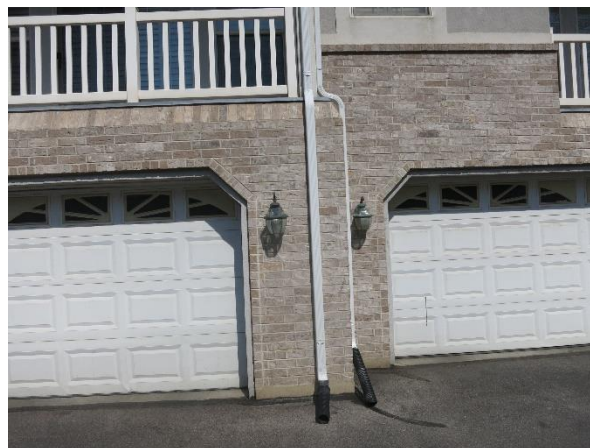
Component Name: Exterior Lighting  
 Component Number: Residential Building 2010

Component Life Expectancy: 20 years  
 Age of Component: 18 years  
 Remaining Component Life: 2 years

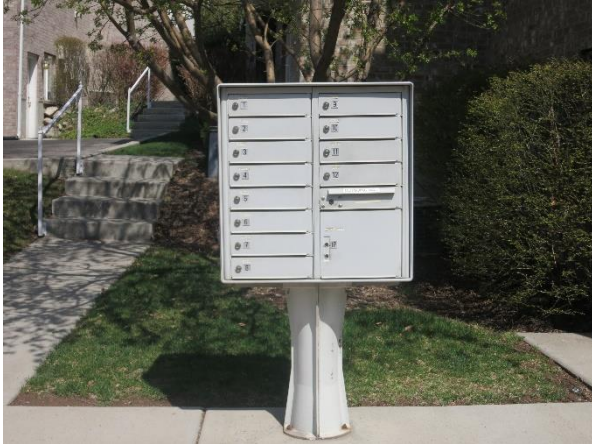
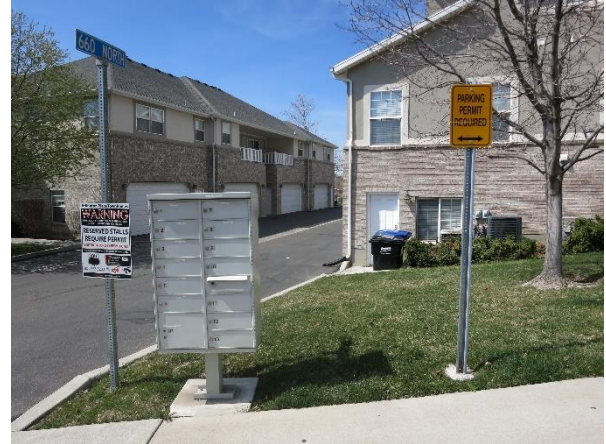
Component Name: Mailboxes  
 Component Number: Common Development 3001

Component Life Expectancy: 20 years  
 Age of Component: 18 years  
 Remaining Component Life: 2 years

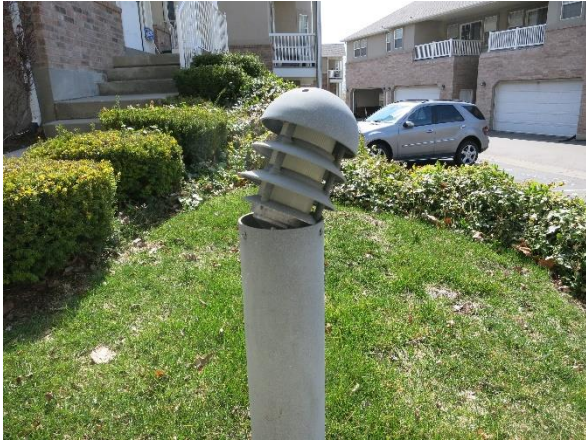
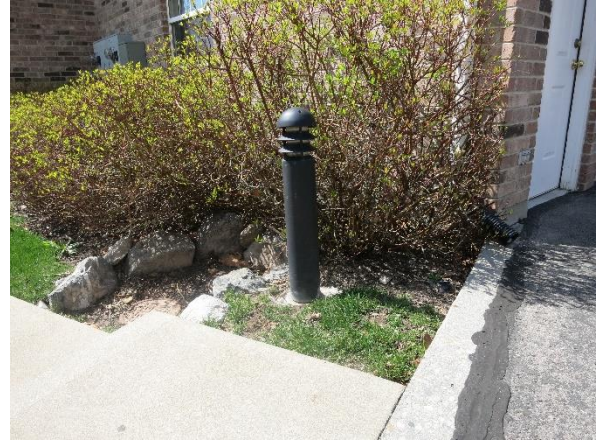
Component Name: Bollard Lighting  
 Component Number: Common Development 3002

Component Life Expectancy: 20 years  
 Age of Component: 18 years  
 Remaining Component Life: 2 years

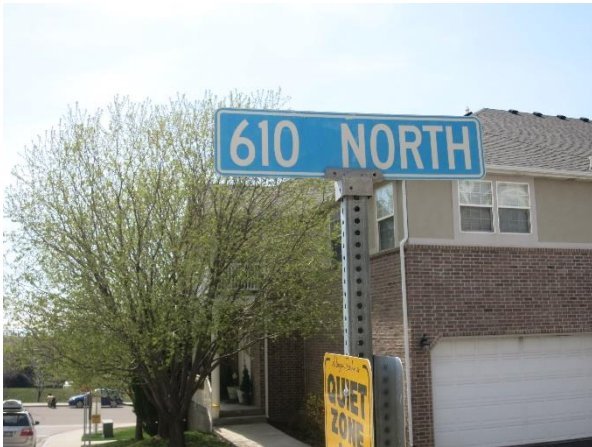
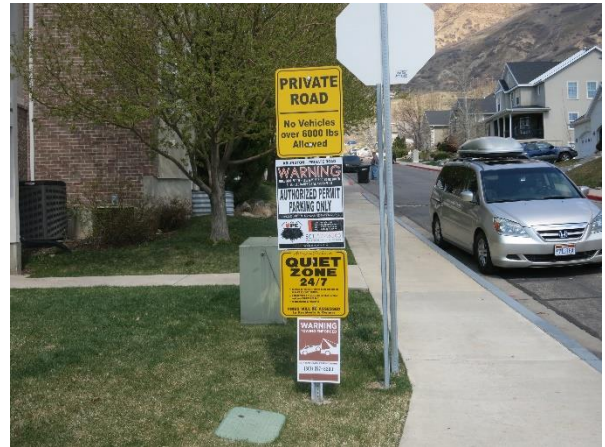
Component Name: Street Signs  
 Component Number: Common Development 3003

Component Life Expectancy: 8 years  
 Age of Component: 1 years  
 Remaining Component Life: 7 years

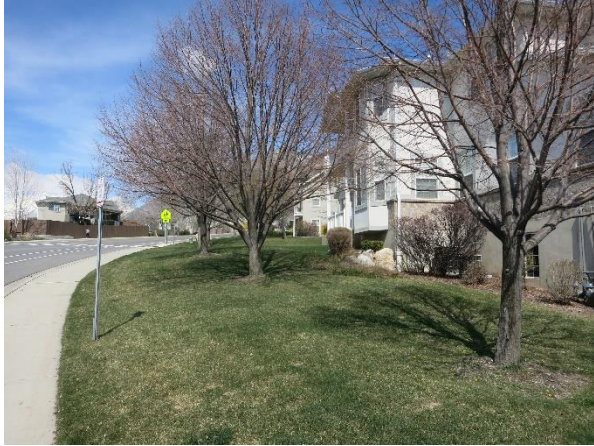
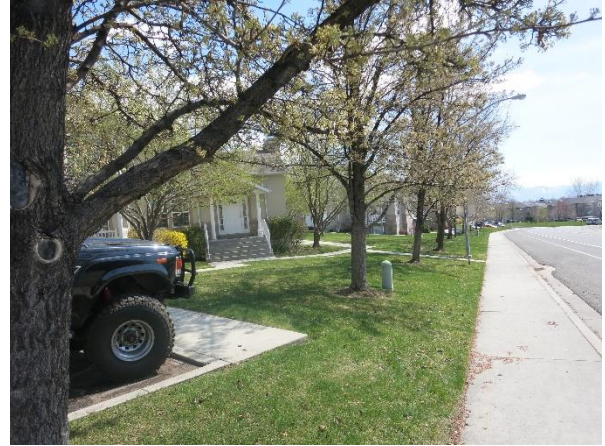
Component Name: Tree Trimming  
 Component Number: Common Development 3008

Component Life Expectancy: 3 years  
 Age of Component: 0 years  
 Remaining Component Life: 3 years
