# TEMPLE SHADOWS AT CEDAR HILLS CAPITAL RESERVE STUDY

Report Number: 11-03-02  
Site Inspection Date: October 29<sup>th</sup>, 2011  
Report Submittal Date: November 3<sup>rd</sup>, 2011  
Revision Date March 8<sup>th</sup>, 2016

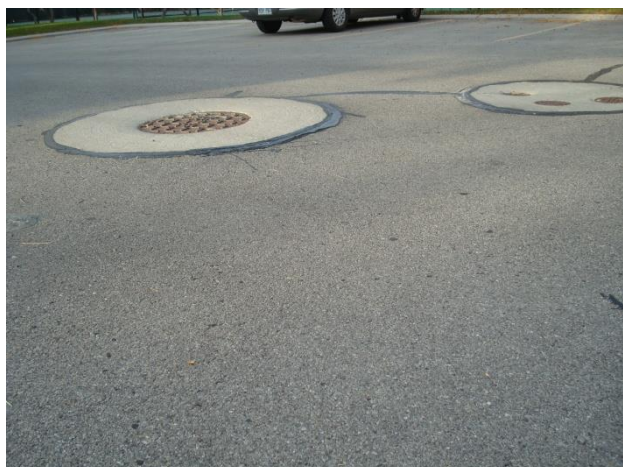
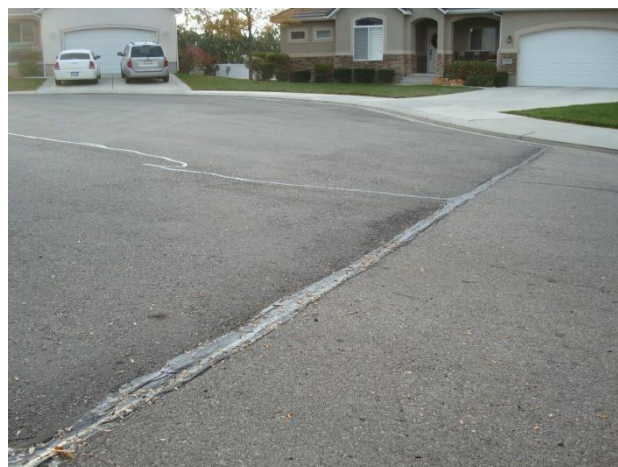
Component Name: 2" Asphalt Overlay  
 Component Number: Drive Materials 1001

Component Life Expectancy: 20 years  
 Age of Component: 15 years  
 Remaining Component Life: 5 years

The asphalt appeared to be in adequate condition with areas containing minor cracking. No alligator cracking or longitudinal cracks wider than ¼ inch were observed during the walk through. An asphalt overlay is recommended every 15 to 20 years. Without an overlay, the road will eventually break apart, requiring a total reconstruction. Settling was observed throughout the community. This is typically caused by improper compaction of the base course or inadequate pavement sections. An overlay is recommended in these areas to prolong the life of the asphalt.

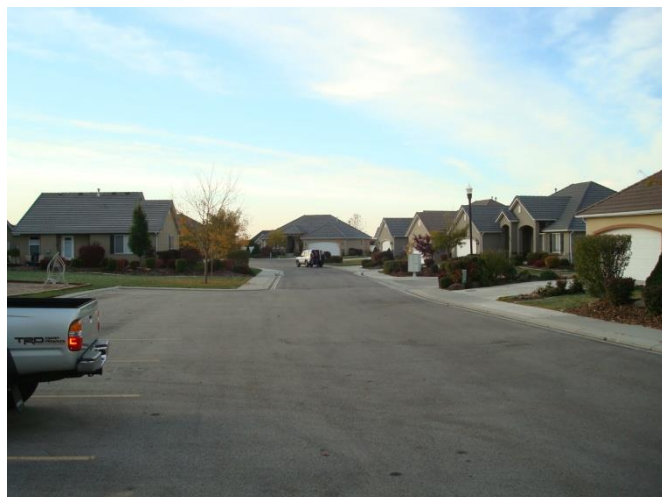
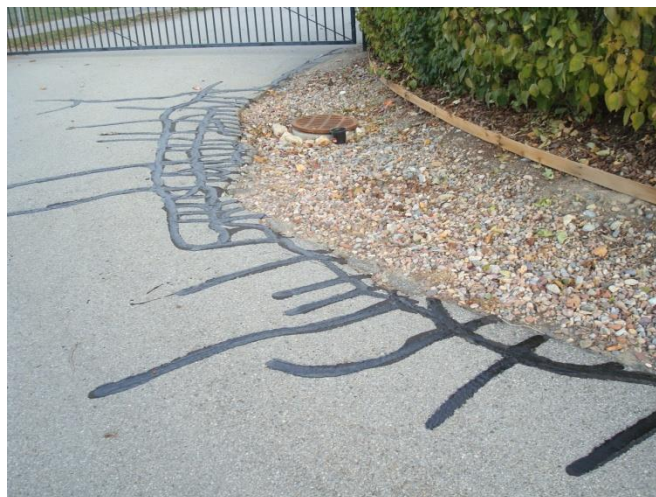
Component Name: Asphalt Slurry Seal  
 Component Number: Drive Materials 1002

Component Life Expectancy: 5 years  
 Age of Component: 5 years  
 Remaining Component Life: 0 years

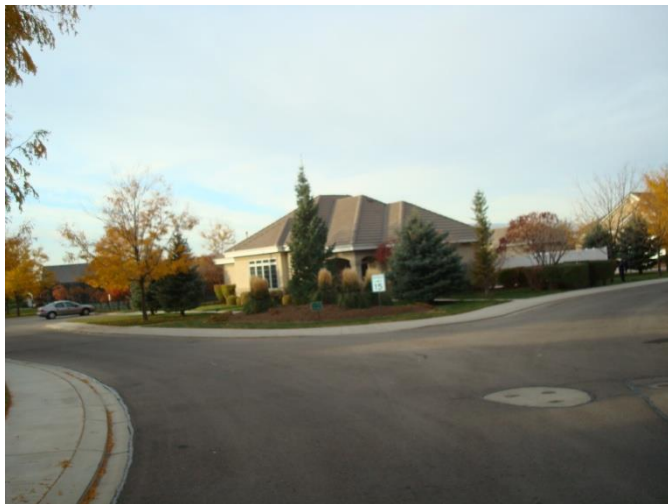
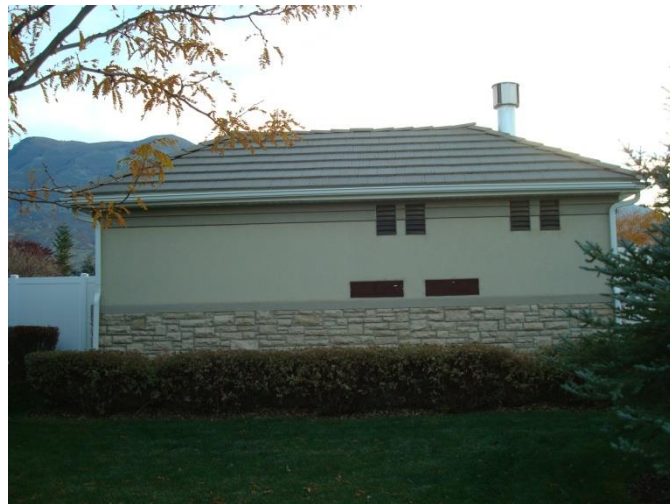
Component Name: Exterior Painting  
 Component Number: Residential Building 2001

Component Life Expectancy: 12 years  
 Age of Component: 12 years  
 Remaining Component Life: 0 years

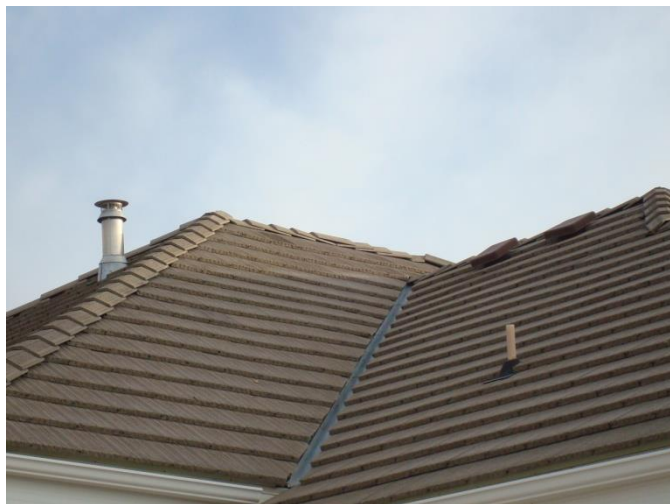
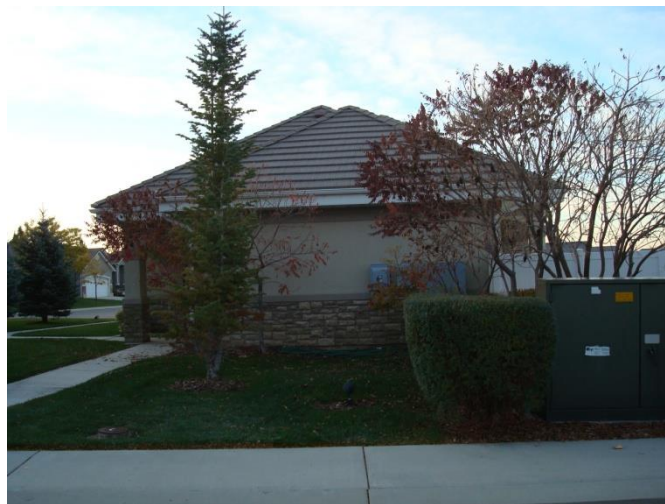
Component Name: Roof – Ceramic Tiles  
 Component Number: Residential Building 2002

Component Life Expectancy: 35 years  
 Age of Component: 15 years  
 Remaining Component Life: 20 years

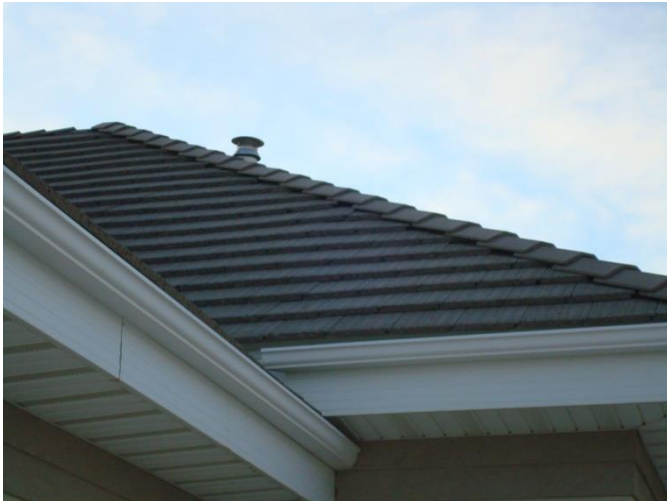
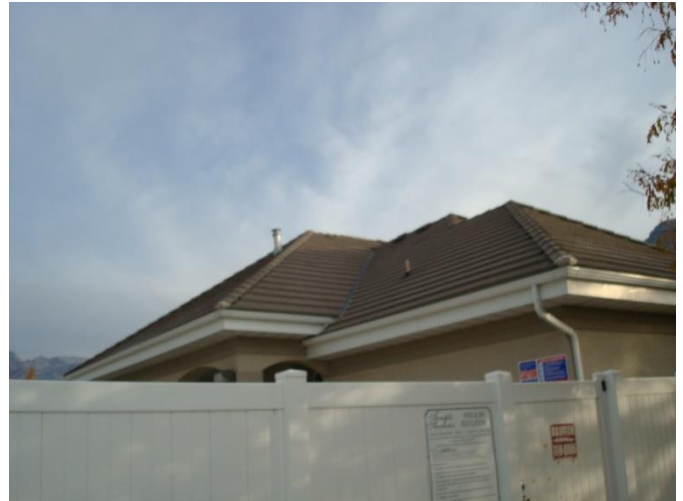
Component Name: Roof Drains/Gutters  
 Component Number: Residential Building 2003

Component Life Expectancy: 30 years  
 Age of Component: 15 years  
 Remaining Component Life: 15 years

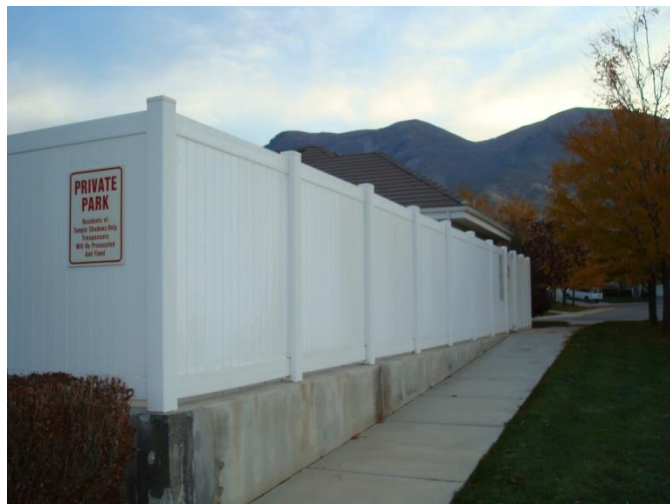
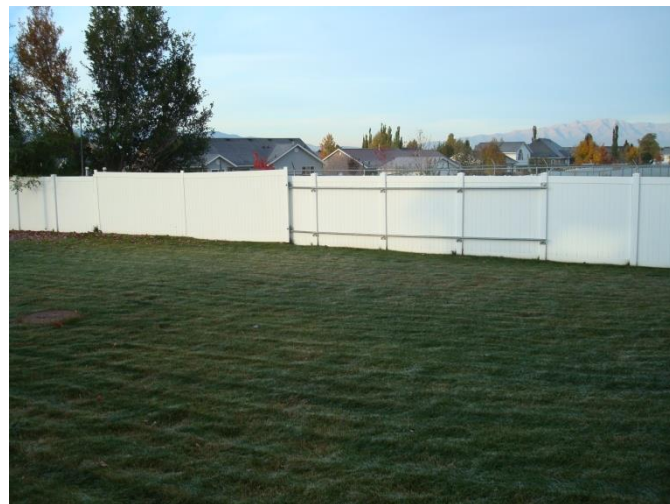
Component Name: 6' High PVC Vinyl Fencing  
 Component Number: Common Development 3002

Component Life Expectancy: 25 years  
 Age of Component: 15 years  
 Remaining Component Life: 10 years

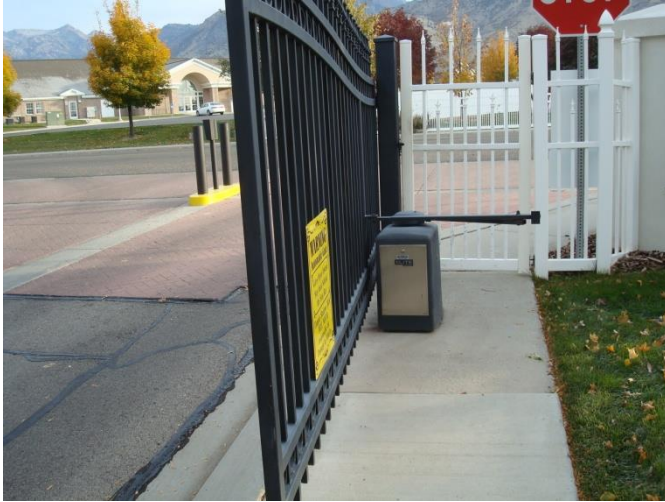
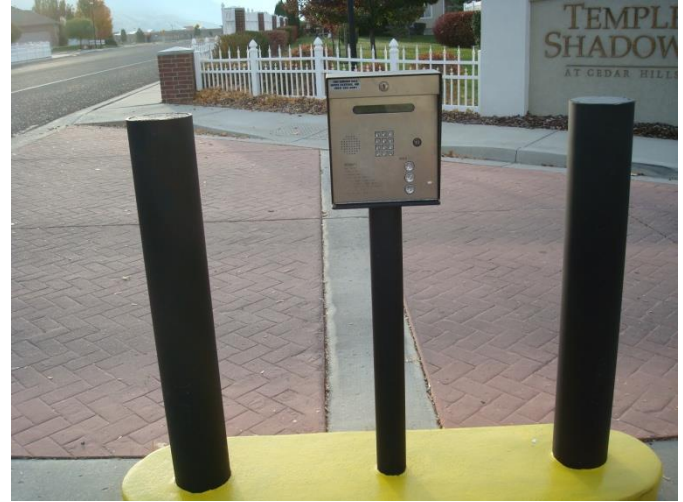
Component Name: Automatic Gate  
 Component Number: Common Development 3004

Component Life Expectancy: 20 years  
 Age of Component: 15 years  
 Remaining Component Life: 15 years

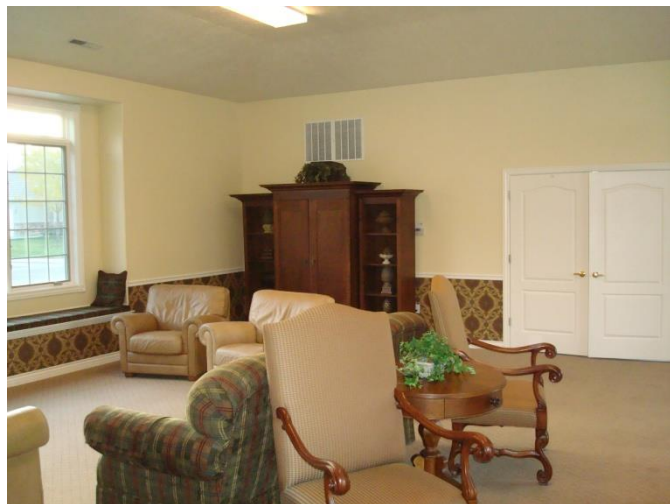
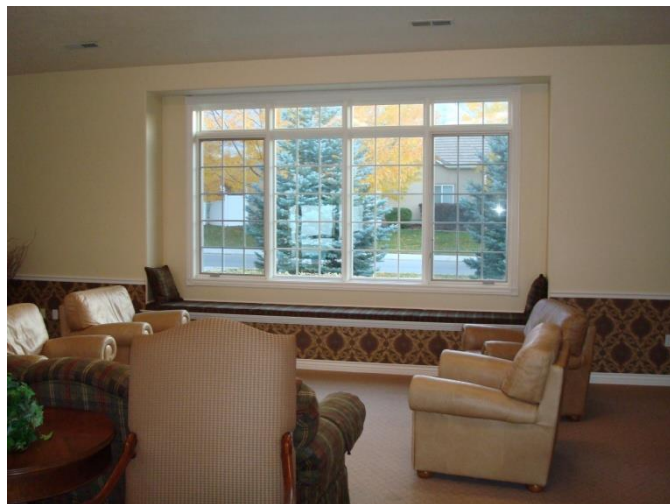
Component Name: Interior Paint  
 Component Number: Clubhouse 4001

Component Life Expectancy: 12 years  
 Age of Component: 12 years  
 Remaining Component Life: 0 years

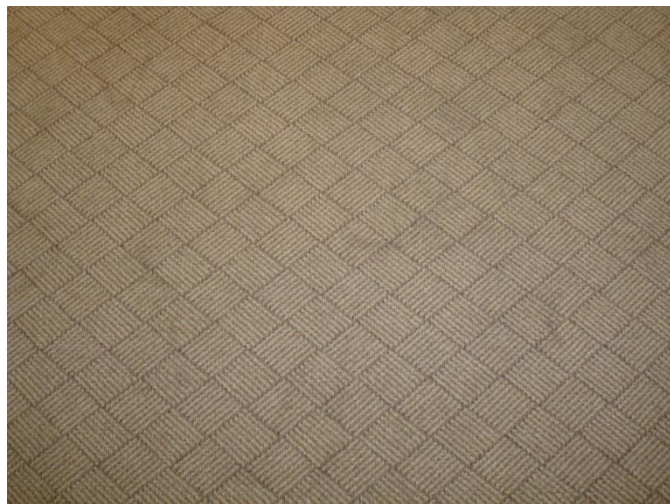
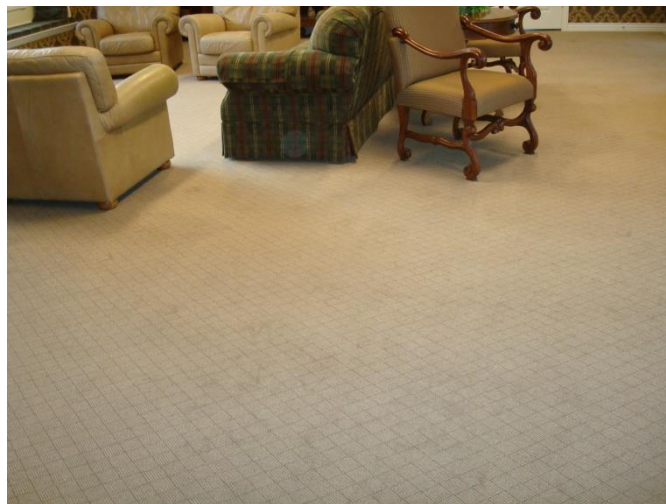
Component Name: Carpet Replacement  
 Component Number: Clubhouse 4002

Component Life Expectancy: 12 years  
 Age of Component: 12 years  
 Remaining Component Life: 0 years

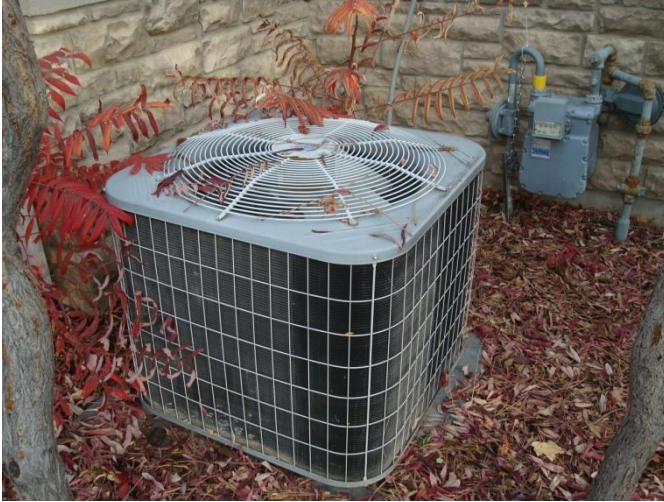
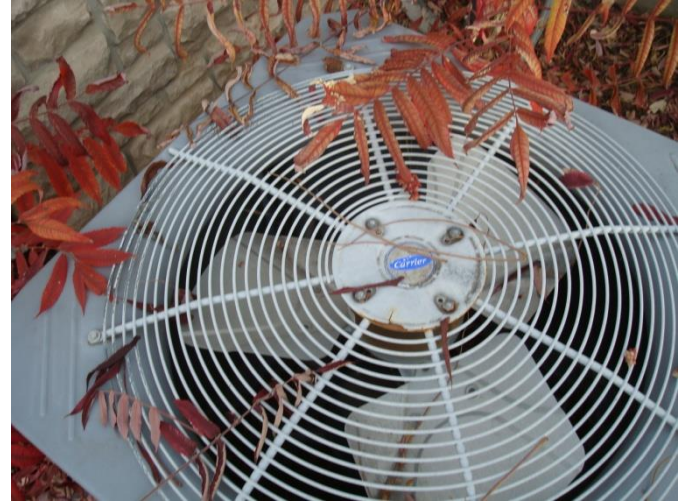
Component Name: Clubhouse AC Units  
 Component Number: Clubhouse 4003

Component Life Expectancy: 18 years  
 Age of Component: 15 years  
 Remaining Component Life: 3 years

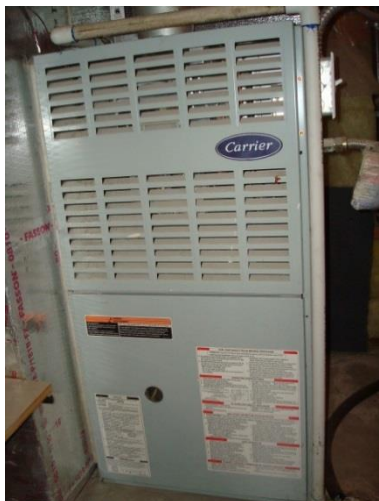
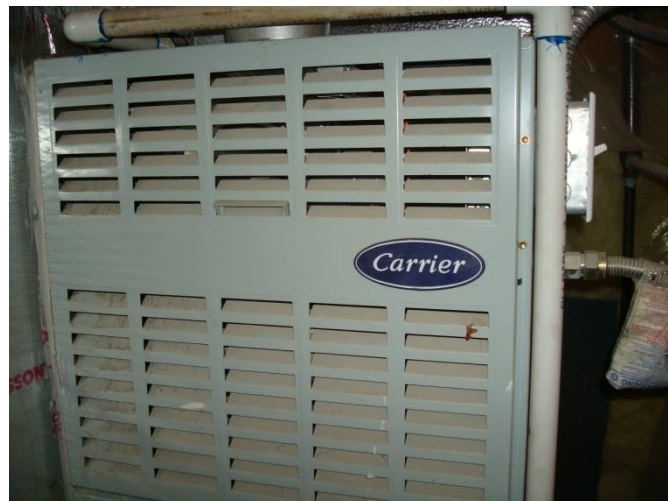
Component Name: Clubhouse Furnace  
 Component Number: Clubhouse 4004

Component Life Expectancy: 20 years  
 Age of Component: 15 years  
 Remaining Component Life: 5 years

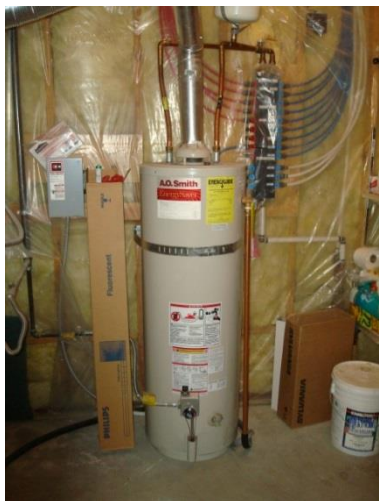
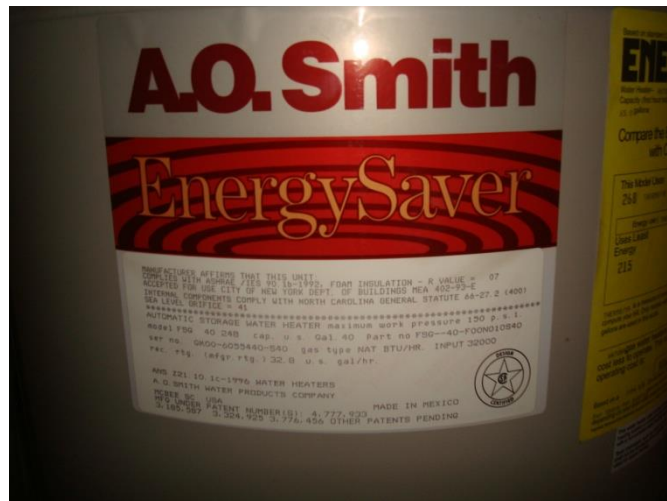
Component Name: Hot Water Heater  
 Component Number: Clubhouse 4005

Component Life Expectancy: 12 years  
 Age of Component: 11 years  
 Remaining Component Life: 1 years

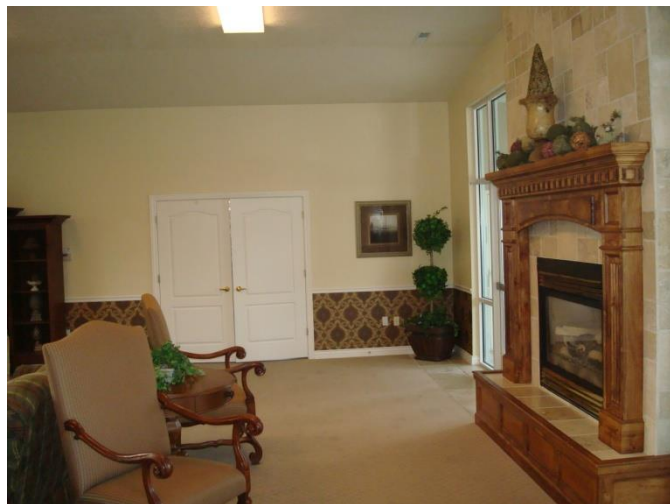
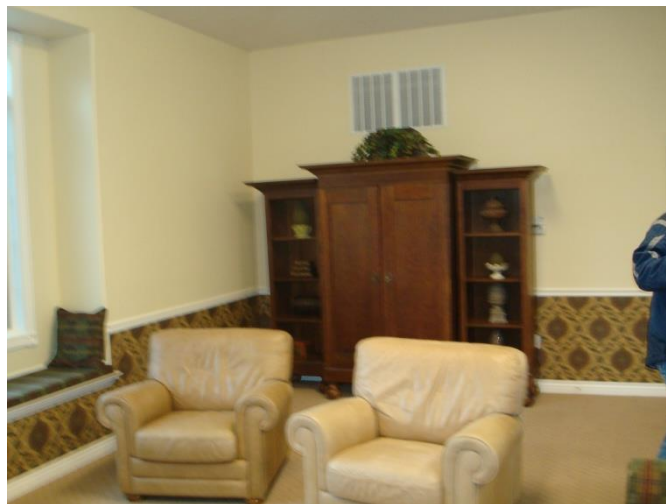
Component Name: Clubhouse Furniture  
 Component Number: Clubhouse 4006

Component Life Expectancy: 12 years  
 Age of Component: 7 years  
 Remaining Component Life: 5 years

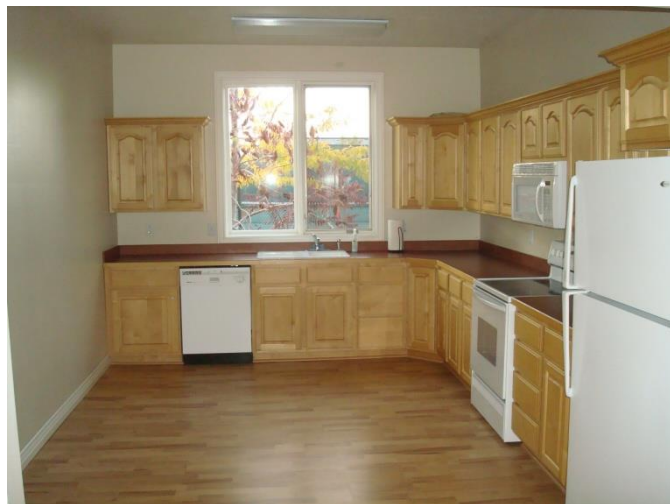
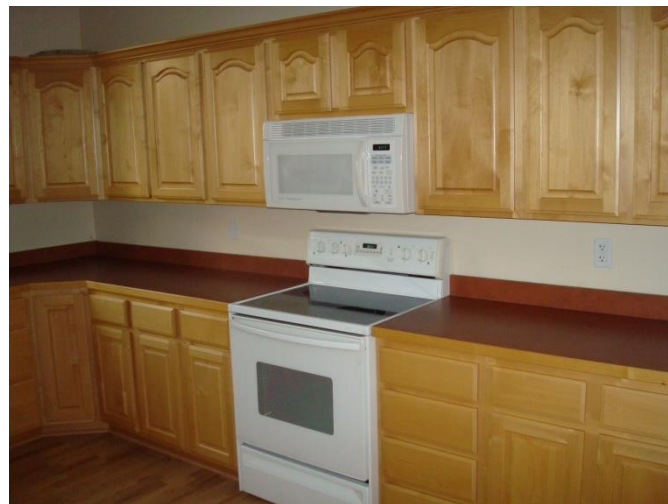
Component Name: Kitchen Renovation  
 Component Number: Clubhouse 4007

Component Life Expectancy: 20 years  
 Age of Component: 15 years  
 Remaining Component Life: 5 years

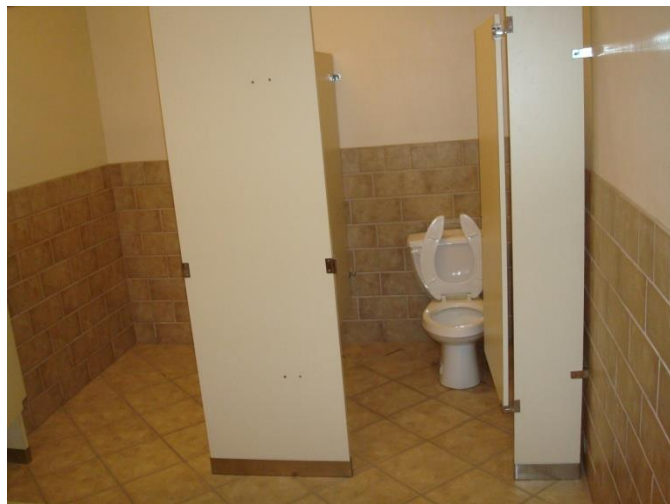
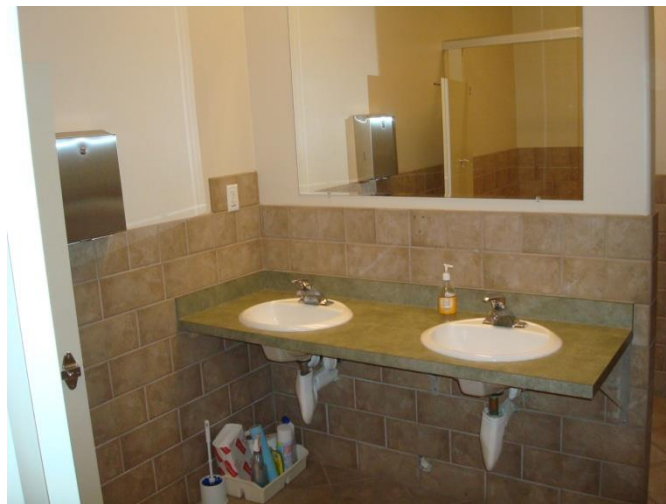
Component Name: Restroom Restoration  
 Component Number: Clubhouse 4010

Component Life Expectancy: 20 years  
 Age of Component: 15 years  
 Remaining Component Life: 5 years

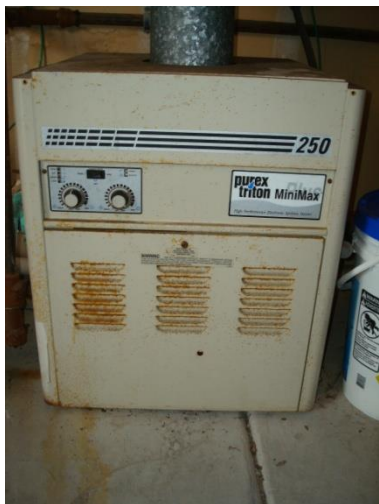
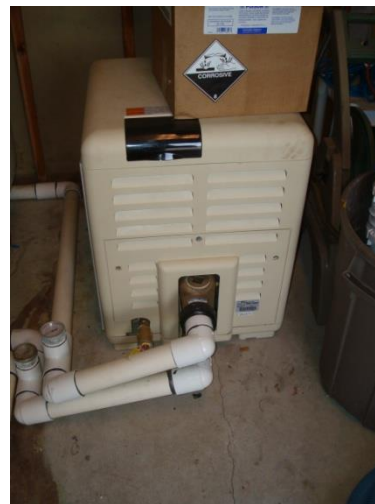
Component Name: Pool Heater  
 Component Number: Pool 5001

Component Life Expectancy: 12 years  
 Age of Component: 1 years  
 Remaining Component Life: 11 years

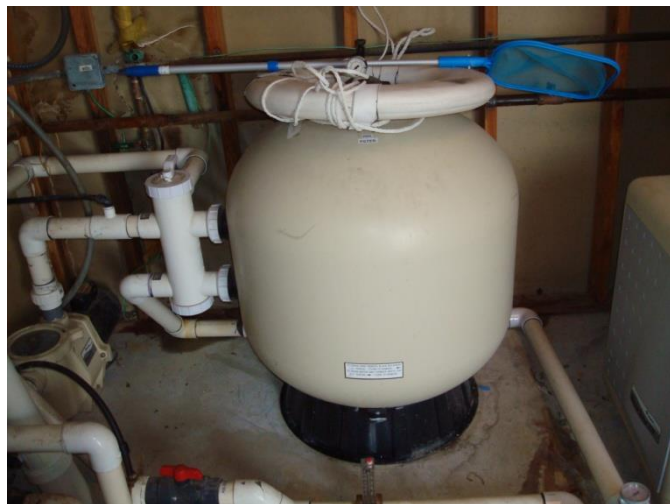
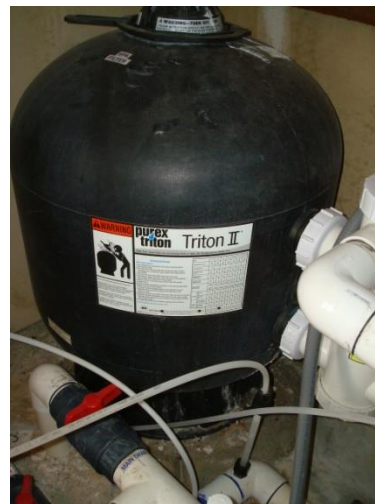
Component Name: Pool Sand Filter  
 Component Number: Pool 5002

Component Life Expectancy: 12 years  
 Age of Component: 1 years  
 Remaining Component Life: 11 years

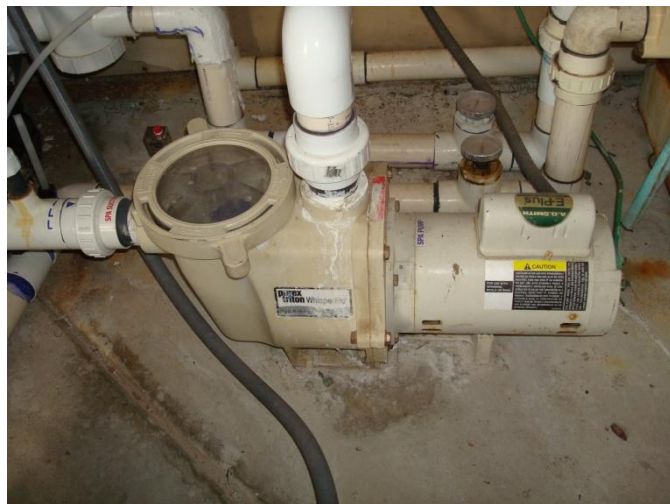
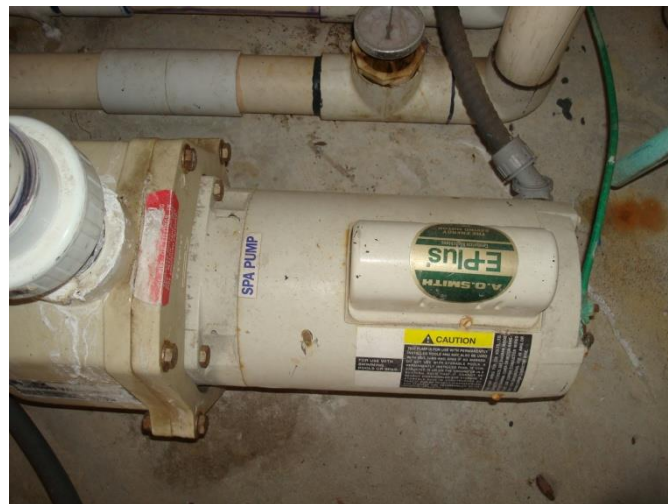
Component Name: Pool Pump  
 Component Number: Pool 5003

Component Life Expectancy: 8 years  
 Age of Component: 15 years  
 Remaining Component Life: 0 years

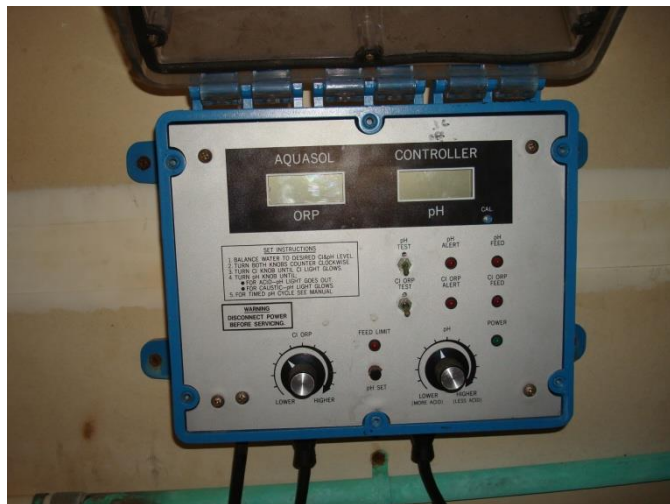
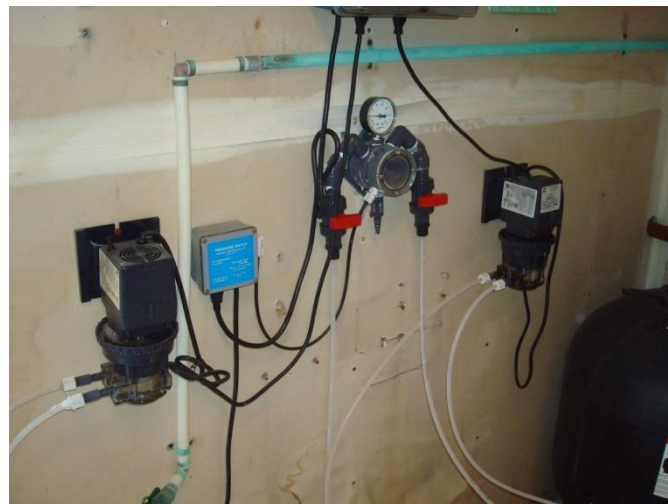
Component Name: Pool Chemical Dispenser  
 Component Number: Pool 5004

Component Life Expectancy: 10 years  
 Age of Component: 10 years  
 Remaining Component Life: 0 years

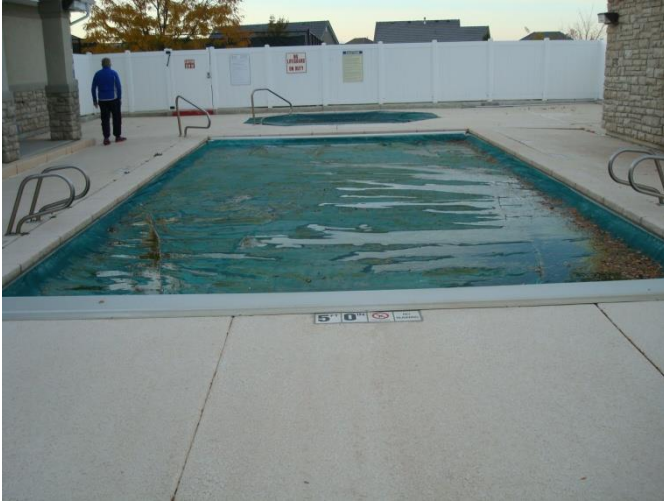
Component Name: Pool Resurfacing  
 Component Number: Pool 5005

Component Life Expectancy: 12 years  
 Age of Component: 12 years  
 Remaining Component Life: 0 years

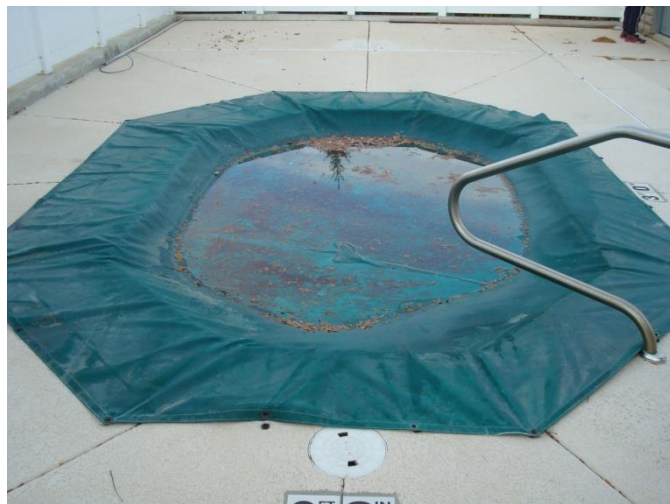
Component Name: Hot Tub Resurfacing  
 Component Number: Pool 5006

Component Life Expectancy: 8 years  
 Age of Component: 15 years  
 Remaining Component Life: 0 years

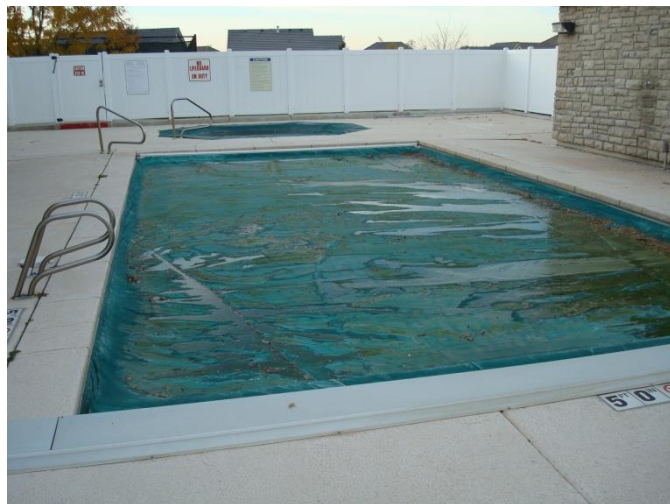
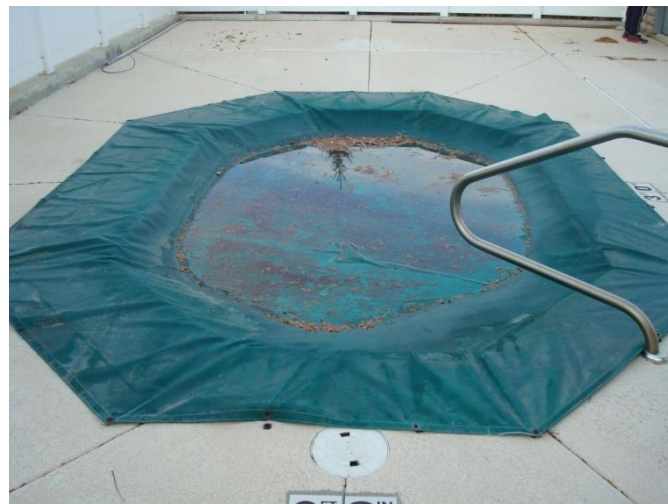
Component Name: Pool Cover  
 Component Number: Pool 5007

Component Life Expectancy: 12 years  
 Age of Component: 12 years  
 Remaining Component Life: 0 years

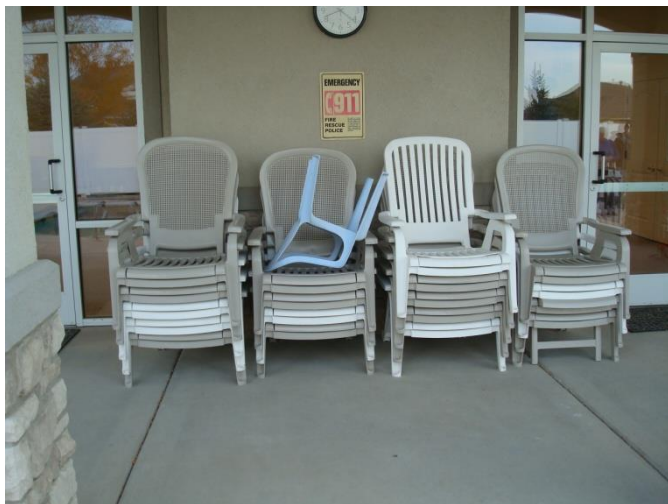
Component Name: Pool Furniture  
 Component Number: Pool 5009

Component Life Expectancy: 8 years  
 Age of Component: 10 years  
 Remaining Component Life: 0 years

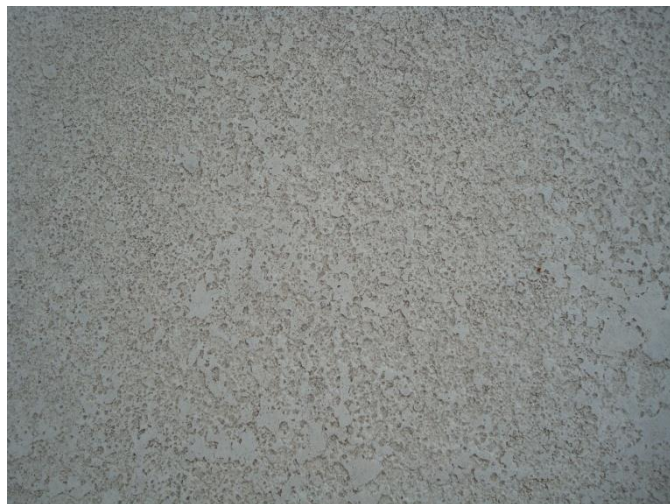
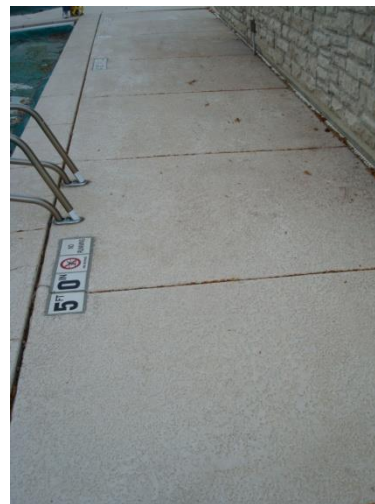
Component Name: Non-Slip Ground Surfacing  
 Component Number: Pool 5010

Component Life Expectancy: 12 years  
 Age of Component: 12 years  
 Remaining Component Life: 0 years

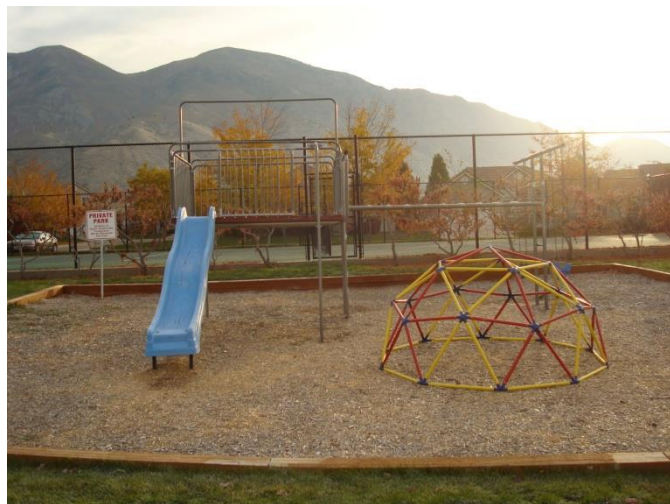
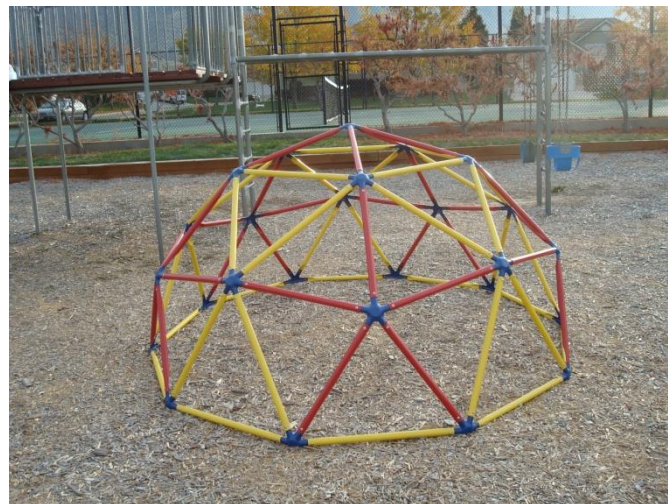
Component Name: Playground Equipment  
 Component Number: Recreation Equipment 6001

Component Life Expectancy: 16 years  
 Age of Component: 15 years  
 Remaining Component Life: 1 years

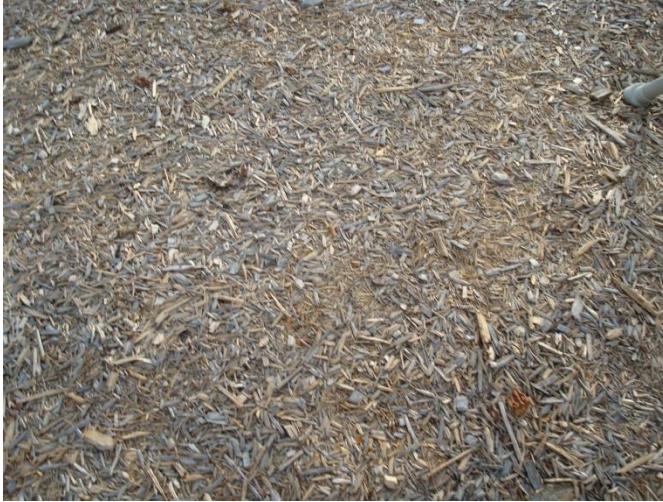
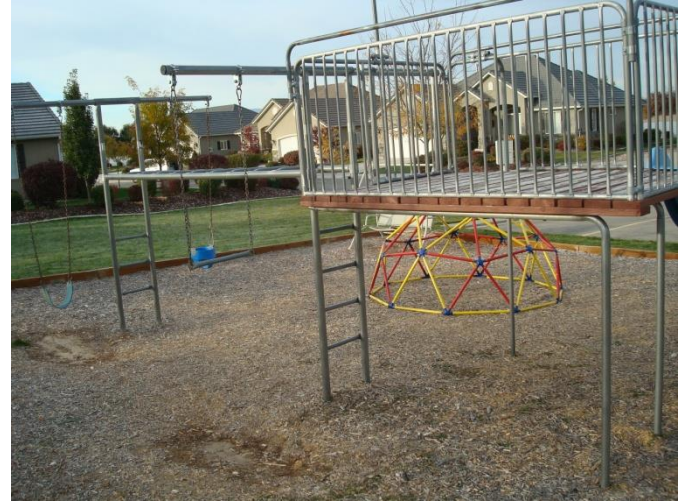
Component Name: Playground Groundcover  
 Component Number: Recreation Equipment 6002

Component Life Expectancy: 2 years  
 Age of Component: 2 years  
 Remaining Component Life: 0 years

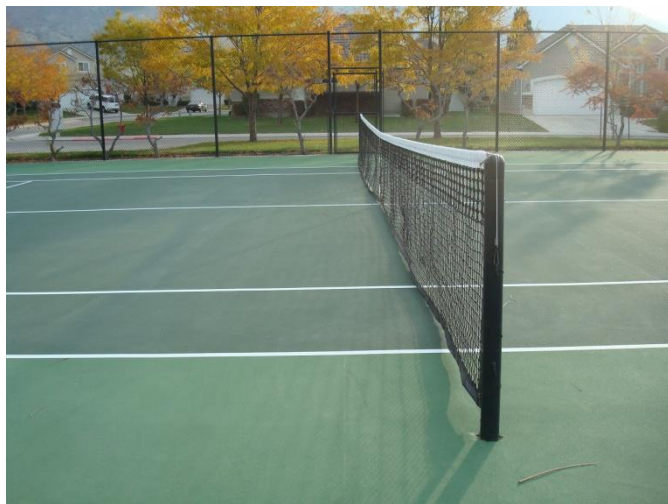
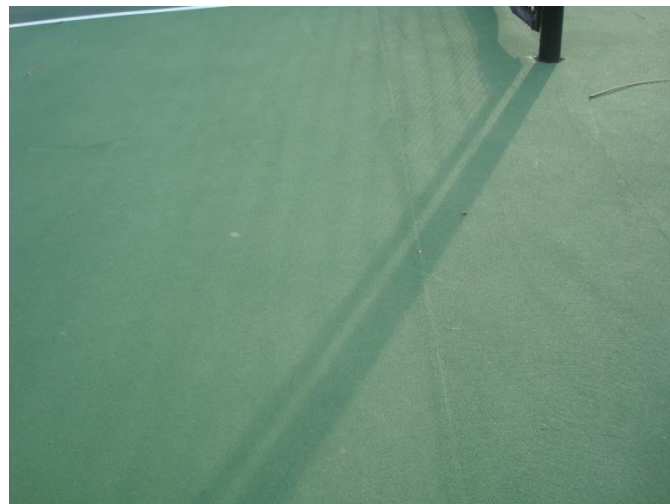
Component Name: Tennis Court  
 Component Number: Recreation Equipment 6003

Component Life Expectancy: 5 years  
 Age of Component: 5 years  
 Remaining Component Life: 0 years
