# Whispering Willows

## Tier 2 Reserve Study

Reference Number: 1496

Date of Property Inspection: 12/19/22

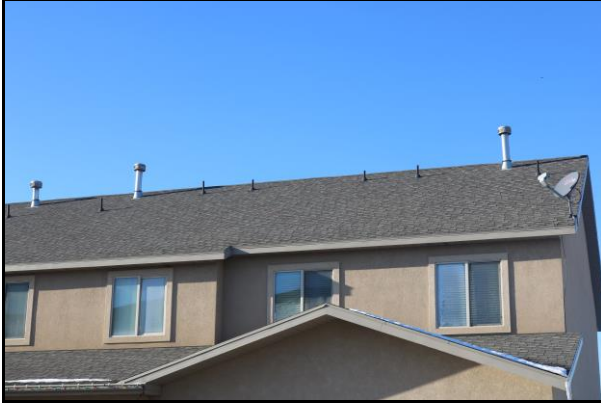
ID: **105**  
 Component: **Pitched Roods – Comp Shingle**  
 Locations: **Building Roofs**  
 Quantity: **Approx 181,175 Sq.Ft.**  
 Est. Total Life: **25**  
 Remaining Life: **11**  
 Est. Cost at end of life Low: **\$865,121**  
 Est. Cost at end of life High: **\$1,469,493**

Roofs show little wear and tear from the road, and looks to be in good condition. No major problems noted at this time.

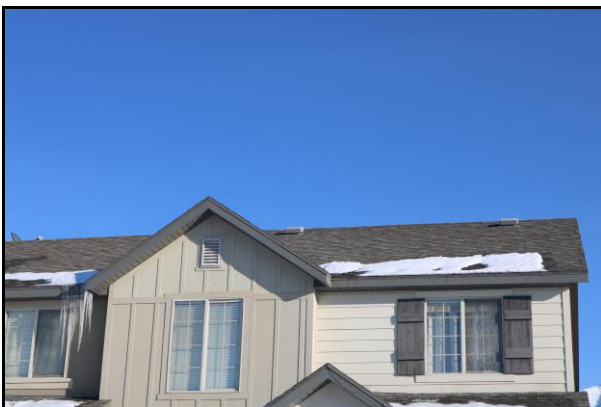
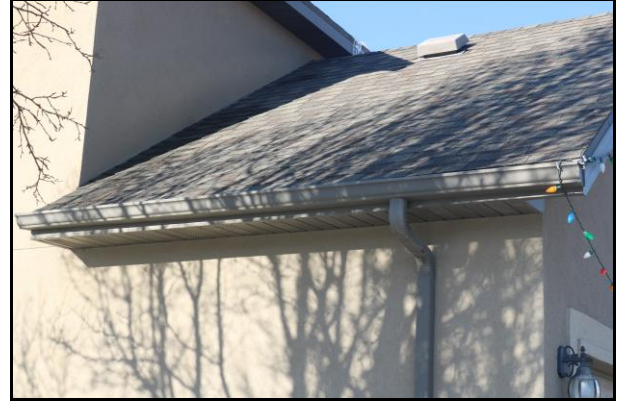
ID: **120**  
 Component: **Rain Gutter/Downspouts - Replace**  
 Location: **Building Roofs**  
 Quantity: **Approx 10,000 Linear Ft.**  
 Est. Total Life: **25**  
 Remaining Life: **11**  
 Est. Cost at end of Life Low: **\$44,626**  
 Est. Cost at end of life High: **\$89,253**

Gutters and Downspouts look to be in good condition and may live longer than estimation. No major problems noted at this time.

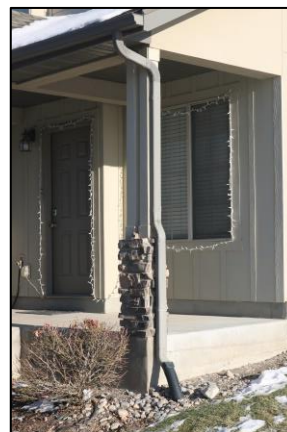
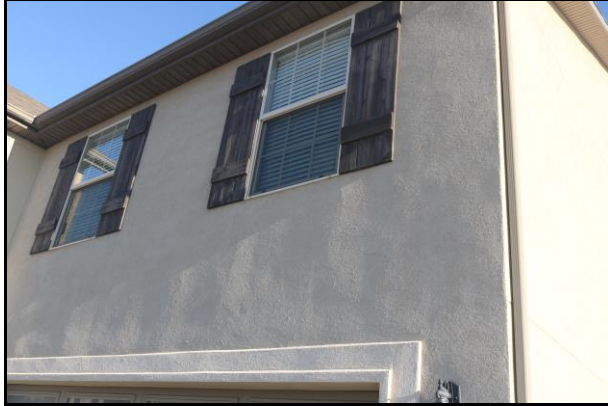
ID: **201**  
 Component: **Stucco Surfaces**  
 Location: **Building Exteriors**  
 Quantity: **Approx. 150,050 SqFt**  
 Est. Total Life: **12**  
 Remaining Life: **11**  
 Est. Cost at end of life Low: **\$502,218**  
 Est. Cost at end of life High: **\$1,506,654**

Most surfaces have been recently repainted. Some minor cracking on one building. No Major problems noted at this time.

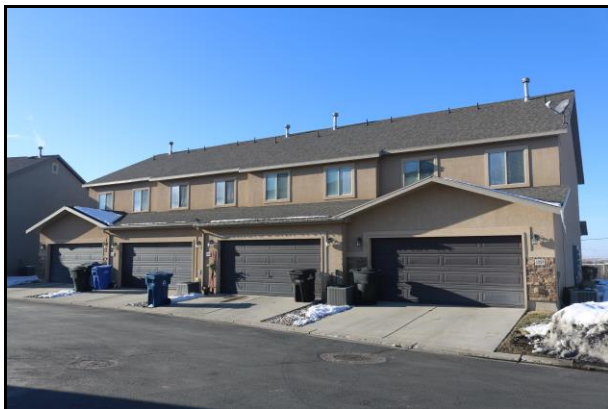
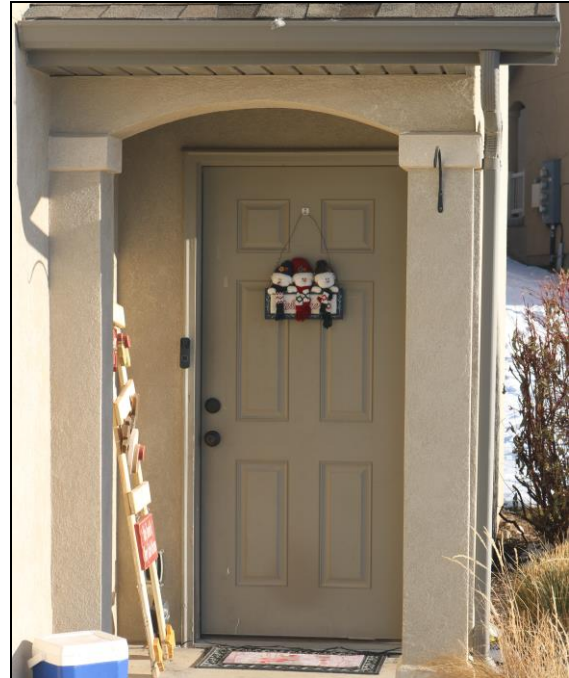
ID: **204**  
 Component: **Front Door**  
 Location: **Unit Front Doors**  
 Quantity: **152 Doors**  
 Est. Total Life: **6**  
 Remaining Life: **2**  
 Est. Cost at end of life Low: **\$465**  
 Est. Cost at end of life High: **\$1395**

Most doors look to be in good condition. Some need to be touched up with a small amount of paint. No Major problems at this time.

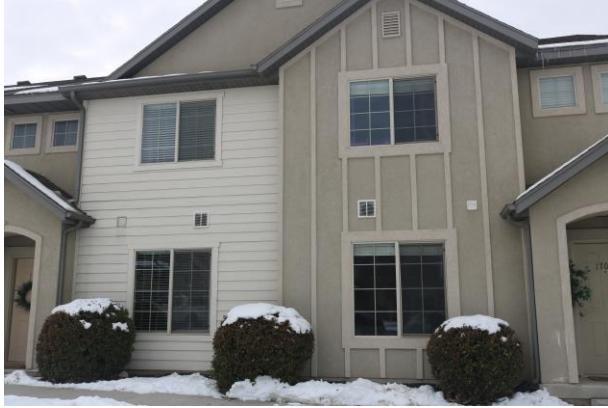
ID: **215**

A few of the buildings siding and fiberboard panels are showing wear and warping.

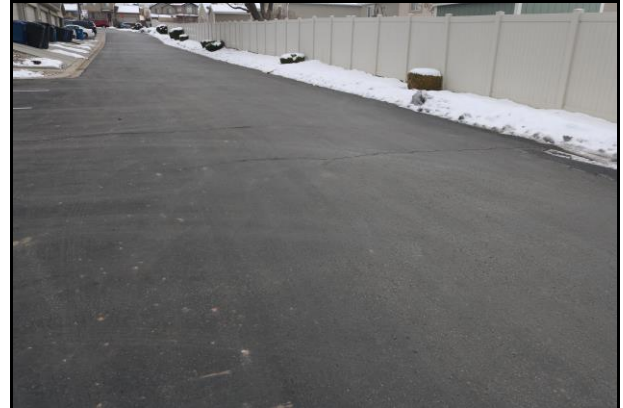
ID: **401**

Roads look to be in mostly good condition. Regular seal coats seem to have helped retain its life.

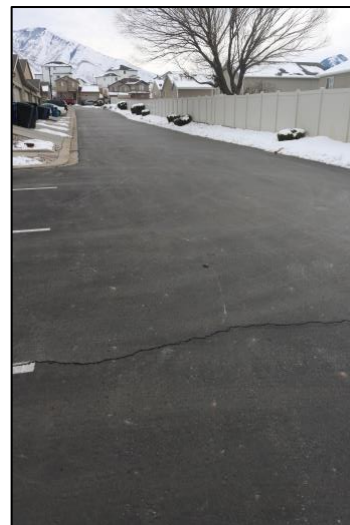
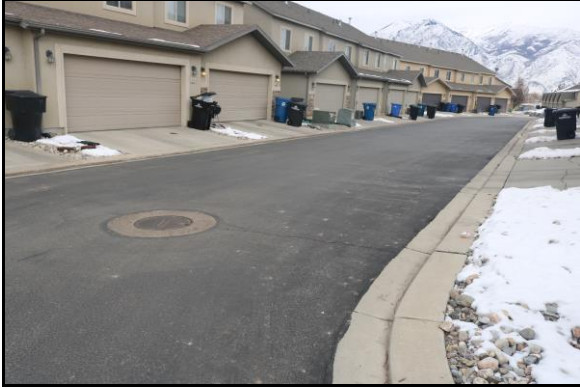
ID: **402**

Seal coat is wearing accurately to timeline. This should be redone in 2-3 years. Crack seals might need to be redone sooner.

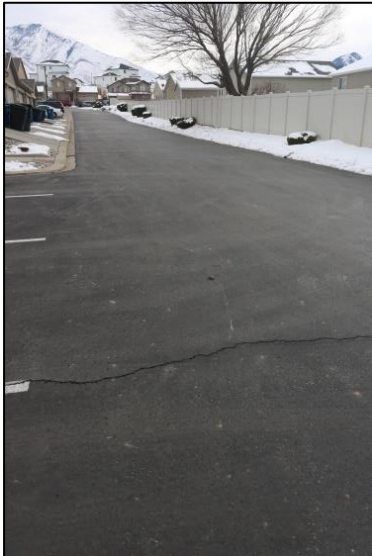
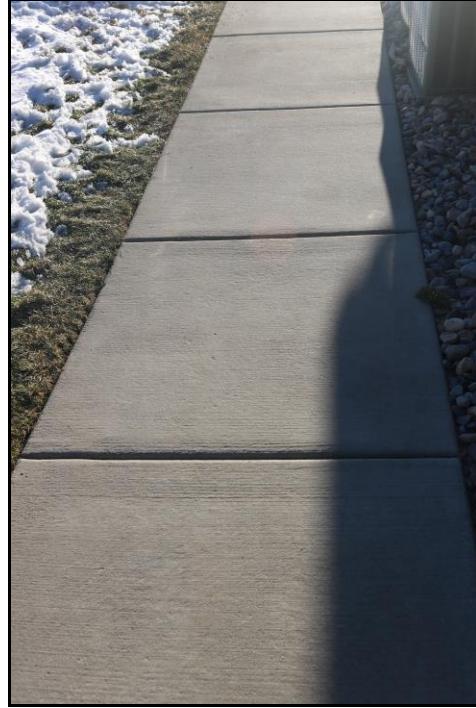
ID: **403**

Sidewalk concrete around the property looked to be in good condition with some cracks here and there.

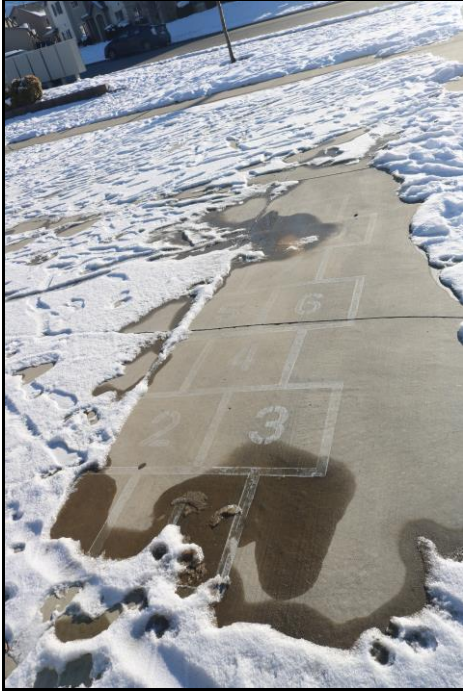
ID: **403**

Basketball court is fairly new and the concrete looks to be in good condition. HOA may want to consider repainting every 2-3 years to keep looking good under operating costs.

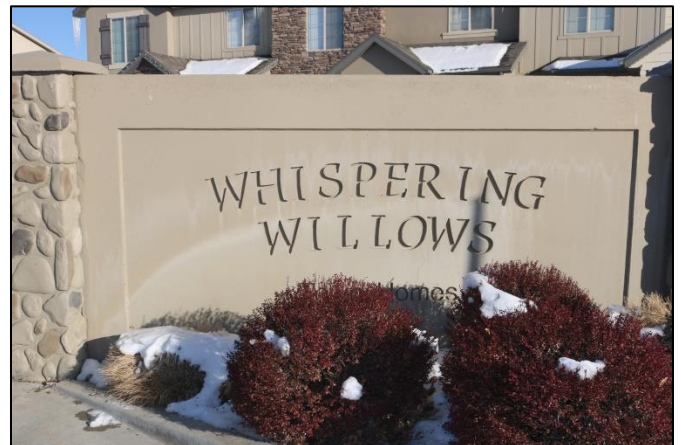
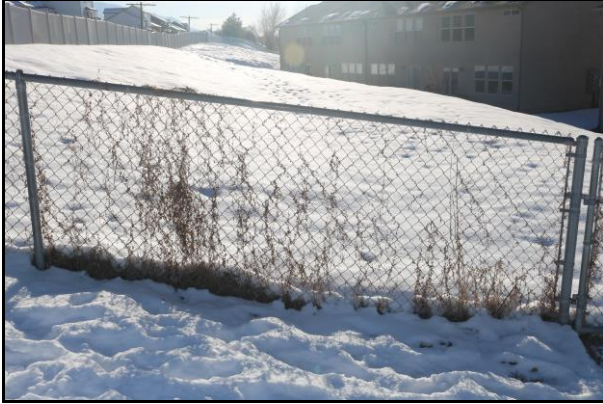
ID: **1003**

The small enclosure looks to be in good condition. If kept maintained it can last a long time. Operating expense upon replacement due to current costs.

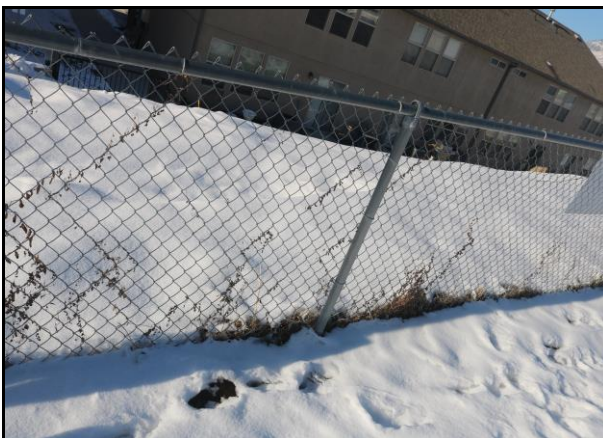
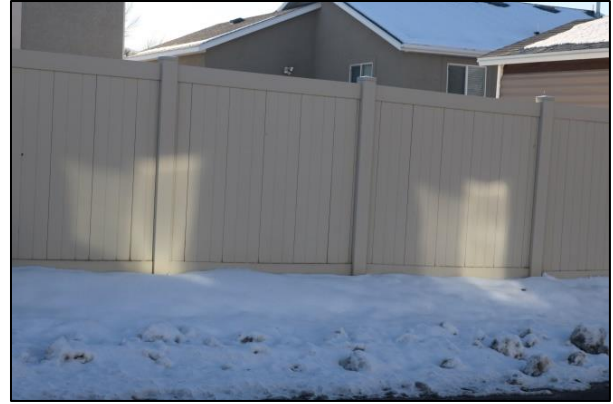
ID: **1008**

Most of the vinyl fencing seems to be kept in very good condition. There are some minor holes from vehicles kicking up rocks near North east side of the community. South West end is in near new looking condition.

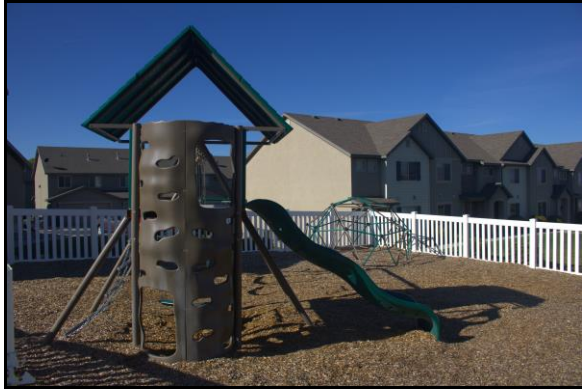
ID: **1301**

Play areas look to be in good condition. I noted standard wear and tear on most items. HOA might consider replacing the ripping swing seats at South Ridgefield non-fenced park as part of operating expenses.

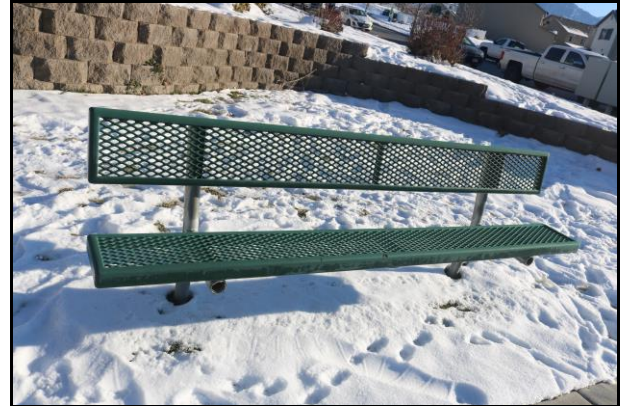
ID: **1306**

The benches around the property have small bits of tearing where metal is showing through. Board may consider replacing or repairing near the end of life.
