# SOMERSET VILLAGE

## HOA RESERVE STUDY

Beginning Period: January 1, 2023  
Ending: December 31, 2052

Report Number: 22-07  
Site Inspection Date: September 8, 2022  
Report Submittal Date: October 21, 2022

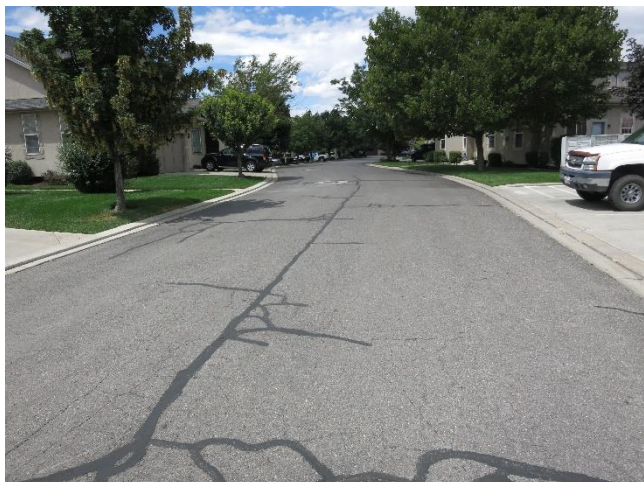
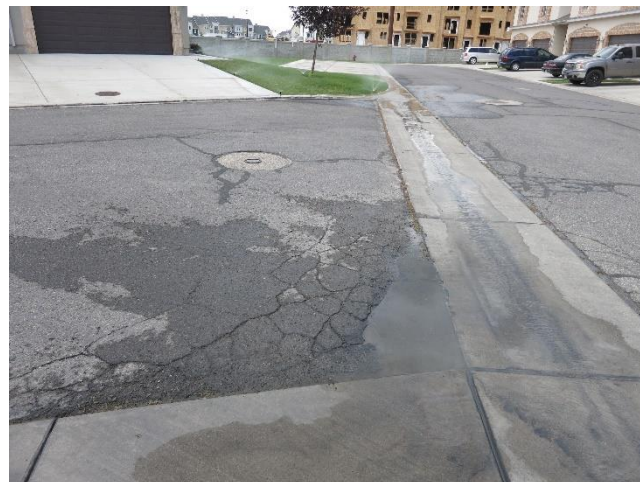
Component Name: 2" Asphalt Mill & Overlay  
 Component Number: Drive Materials 1001

Component Life Expectancy: 20 years  
 Average Age of Component: 15 years  
 Remaining Component Life: 5 years

The AASHTO Pavement Design Guide recommends asphalt paving receive immediate rehabilitation when signs of alligator cracking or longitudinal cracks wider than ¼ inch are present. An asphalt overlay is recommended every 15 to 20 years. The overlay will add new structure to the road and fix any pot holes or structural defects that may develop over time. Without an overlay, the road base beneath the paving could deteriorate leading to a complete asphalt replacement.

Areas that show signs of sinking can often be attributed to base course failure. These areas should be repaired prior to a new overlay.

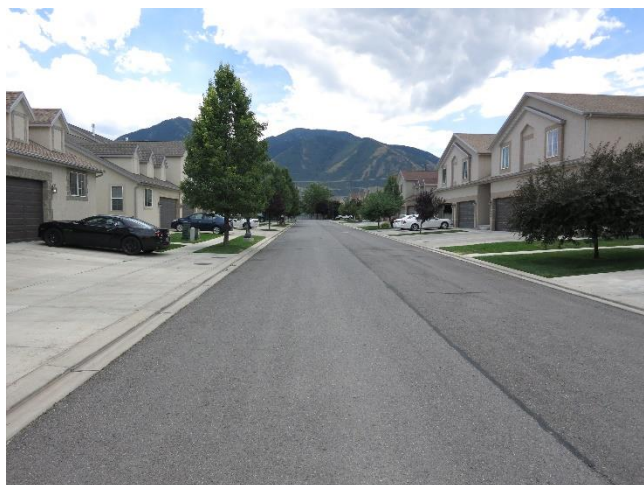
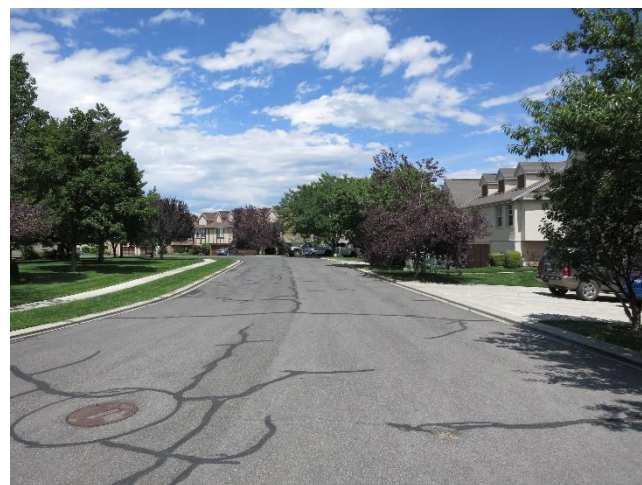
Component Name: Asphalt Slurry Seal  
 Component Number: Drive Materials 1002

Component Life Expectancy: 5 years  
 Average Age of Component: 4 years  
 Remaining Component Life: 1 years

A crack and slurry seal is recommended every 5 years. Slurry seal will help protect the asphalt from degradation by sealing cracks, preventing water seepage and damage. It also rejuvenates the surface and renews the oils, keeping the asphalt from becoming overly brittle.

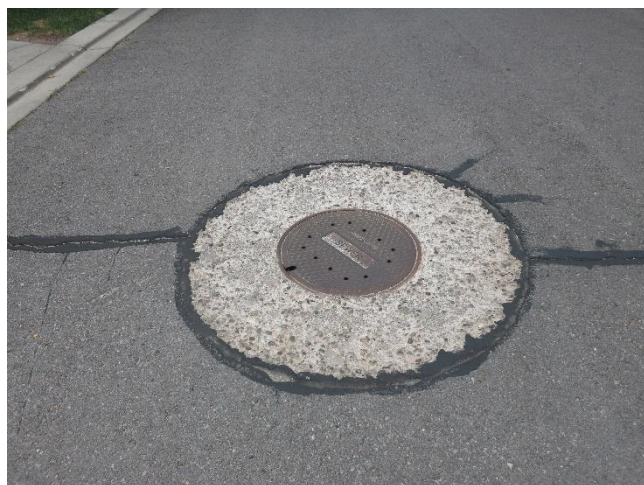
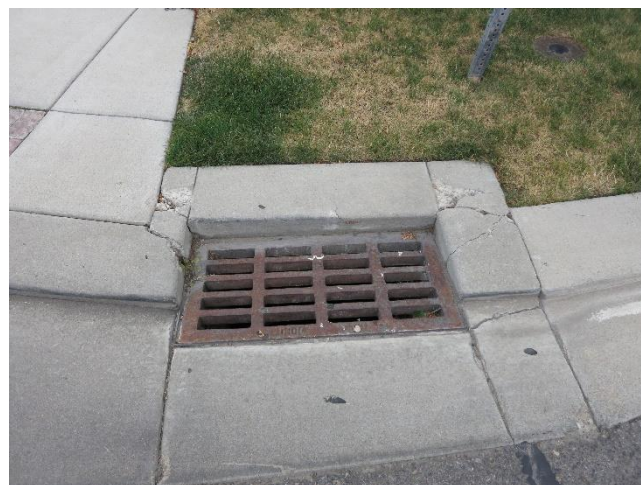
Component Name: Concrete Repair/Replace  
 Component Number: Drive Materials 1003

The American Public Works Association (Utah Chapter) recommends concrete panels to be repaired and or replaced when there are 3 or more cracks that extend the full depth of the slab or if there is spalling that covers more than 25% of the panel. Protruding edges should be ground down to prevent further damage and to prevent any safety hazards.

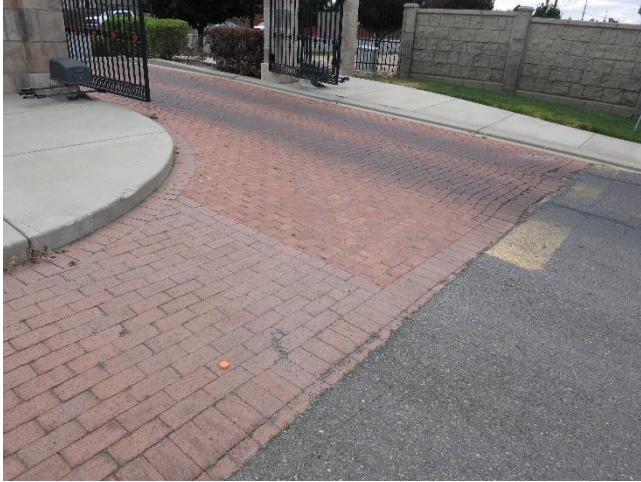
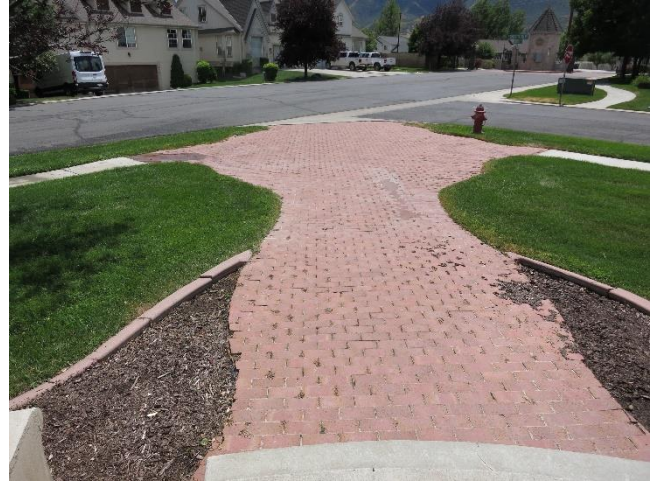
Component Name: Decorative Pavers  
 Component Number: Drive Materials 1004

Decorative brick pavers were observed at each entrance and for sidewalks near the decorative community feature. Although the pavers are considered durable materials the underlying base course can settle resulting in shifting and rutting. When this occurs, the pavers should be removed, and the underlying base course be replaced and properly compacted. Undamaged pavers may be reused. This is less likely to occur in the sidewalk and areas that receive light traffic. An allowance has been provided for paver repair.

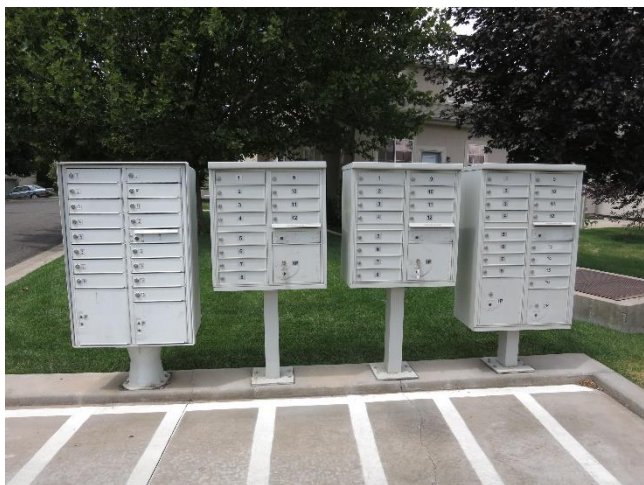
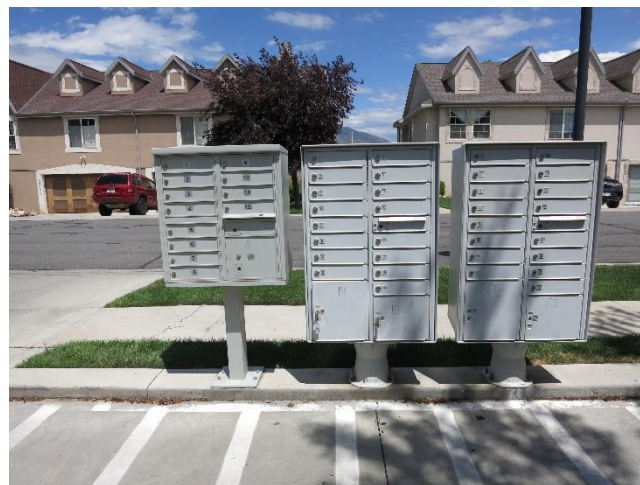
Component Name: Mailboxes  
 Component Number: Common Development 2001

Component Life Expectancy: 25 years  
 Age of Component: 15 years  
 Remaining Component Life: 10 years

The community uses pedestal cluster mailboxes. The post office should be notified when replacement is needed to verify if there are any shared costs. This report assumes that the post office will not maintain the mailbox clusters. The mailboxes were observed to be in working condition with minimal damage; excepting the HOA drop off box.

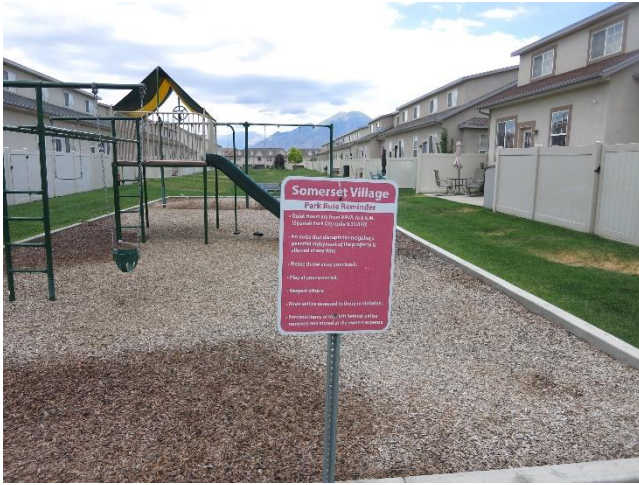
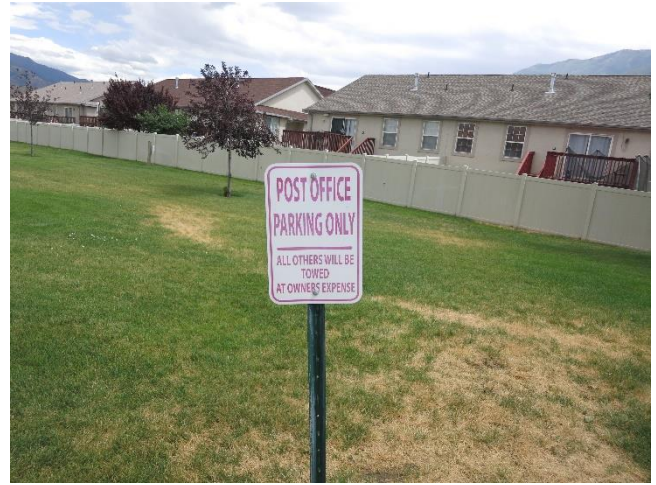
Component Name: Sign Replacement  
 Component Number: Common Development 2002

Multiple private signs were observed throughout the community. Signs that are faded and hard to read should be replaced when necessary. An allowance has been provided to repair faded or damaged signs.

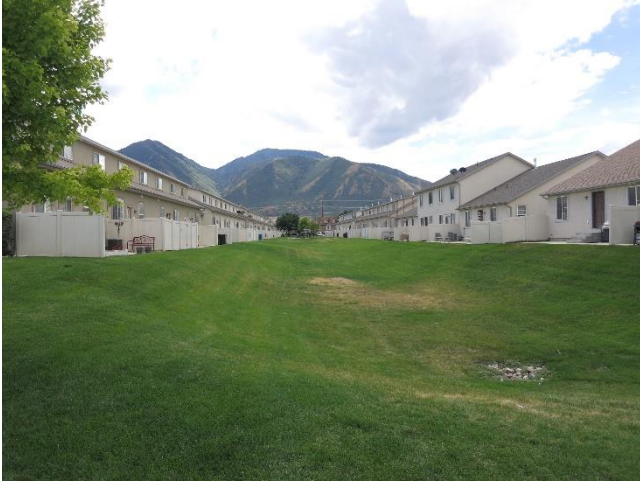
Component Name: Vinyl Fencing  
 Component Number: Common Development 2003

Adjacent property owners should be contacted prior to fence replacement to determine if shared costs is applicable. This report assumes the vinyl fencing partitions are the sole responsibility of the homeowner to replace.

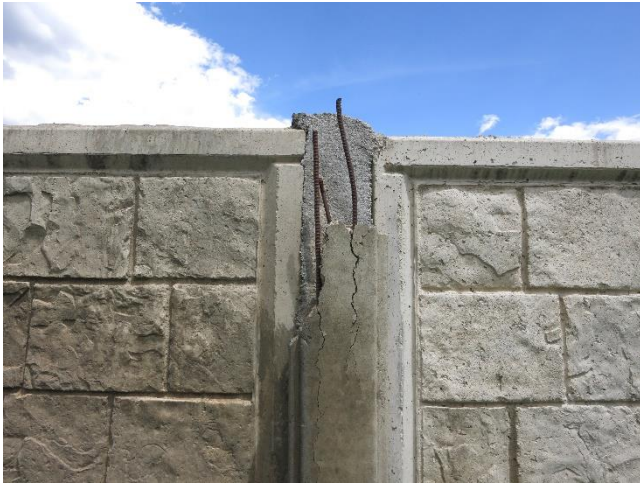
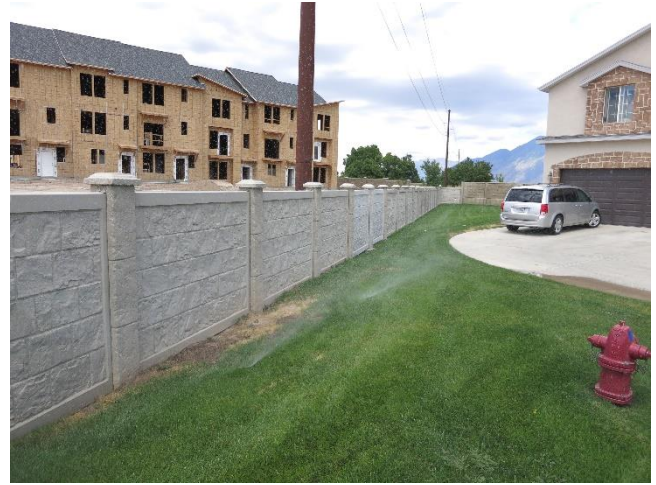
Component Name: Concrete Post & Panel Fencing  
 Component Number: Common Development 2004

Component Life Expectancy: 75 years  
 Average Age of Component: 25 years  
 Remaining Component Life: 50 years

Concrete post and panel fencing is considered to be of a durable material and has a useful life extending beyond the range of this report. Damaged fencing should be repaired from the annual maintenance budget. An allowance has been allotted every 10 years for spot repairs of deteriorated panels and columns. This is usually due to unusual water and salt exposure.

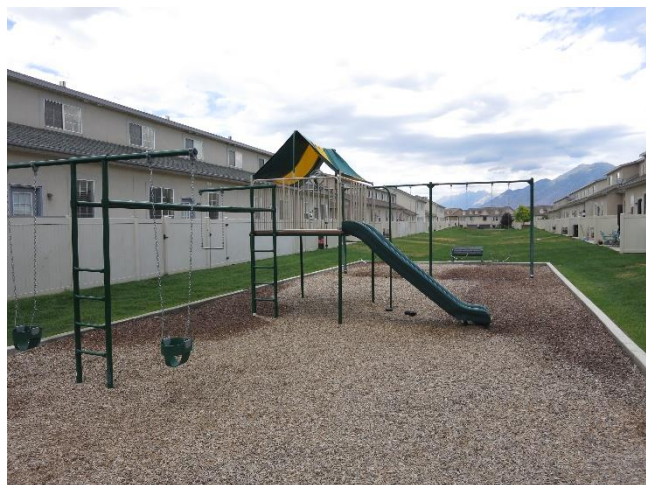
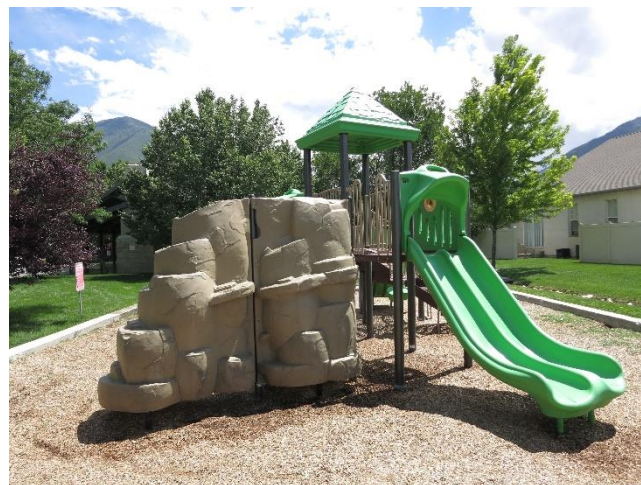
Component Name: Playground Equipment  
 Component Number: Common Development 2005

Component Life Expectancy: 20 years  
 Average Age of Component: 10 years  
 Remaining Component Life: 10 years

Playground structures should be routinely inspected by the HOA to identify any safety hazards. Damaged playground equipment should immediately be replaced or removed.

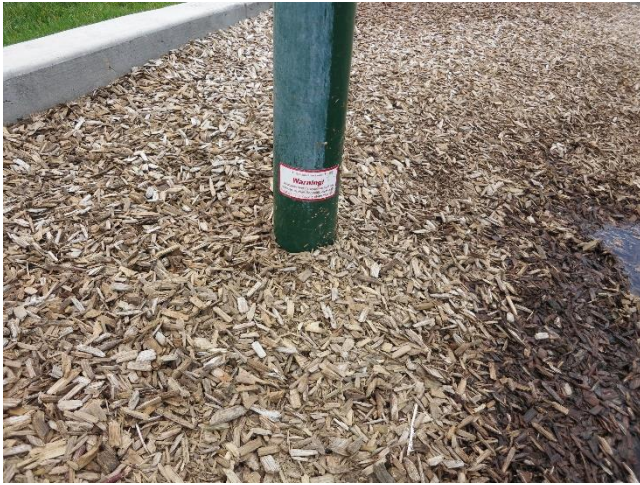
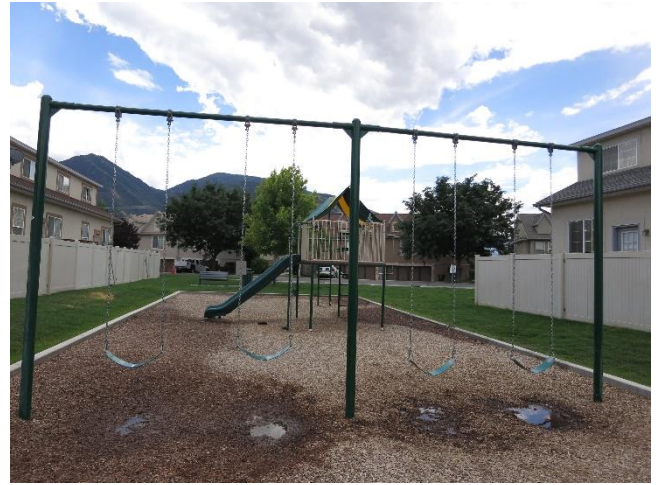
Component Name: Playground Ground Cover  
 Component Number: Common Development 2006

Component Life Expectancy: 5 years  
 Average Age of Component: 5 years  
 Remaining Component Life: 0 years

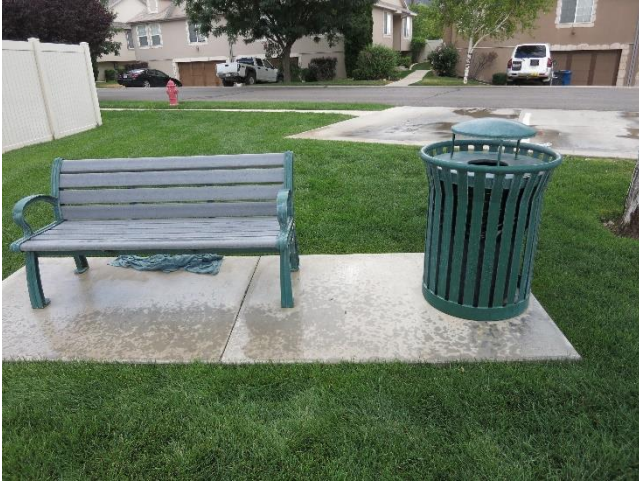
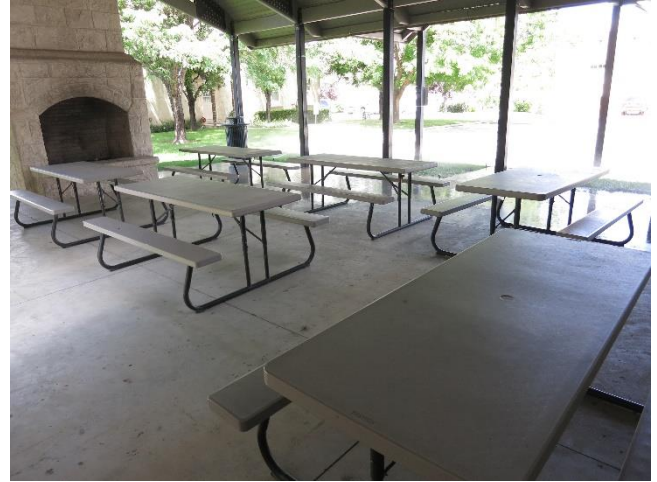
Component Name: Outdoor Furniture  
 Component Number: Common Development 2007

Component Life Expectancy: 20 years  
 Average Age of Component: 10 years  
 Remaining Component Life: 10 years

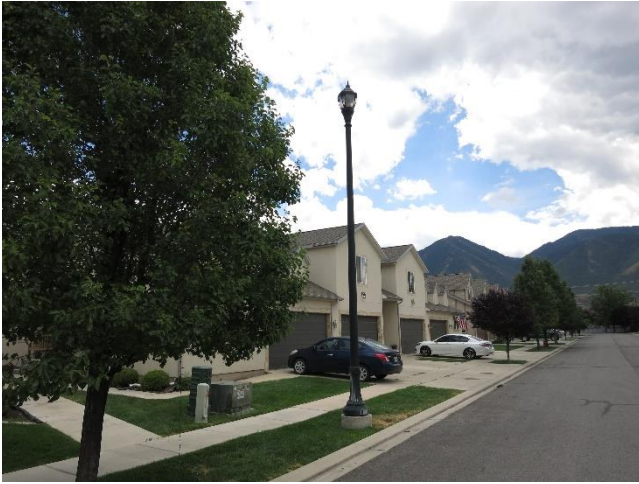
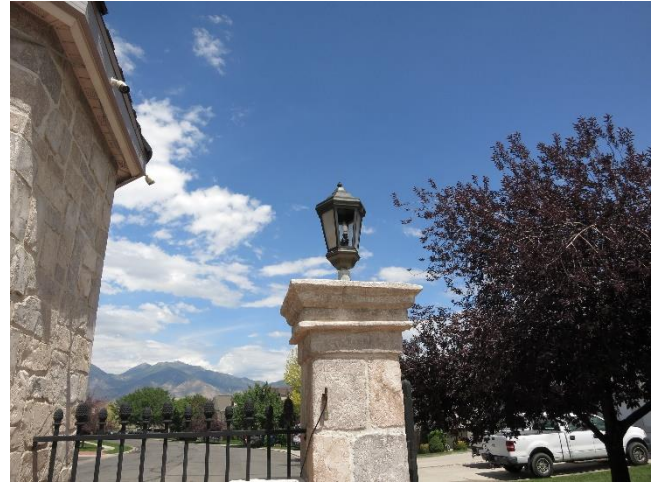
Component Name: Streetlights  
 Component Number: Common Development 2008

Component Life Expectancy: 20 years  
 Average Age of Component: 17 years  
 Remaining Component Life: 3 years

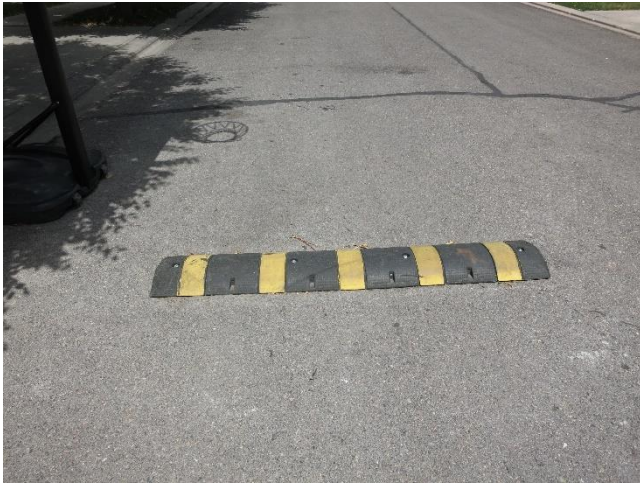
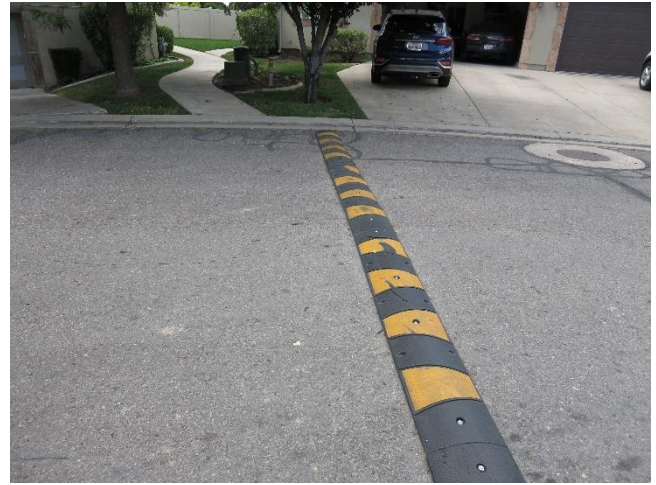
Component Name: Speed Bumps  
 Component Number: Common Development 2009

Component Life Expectancy: 10 years  
 Average Age of Component: 6 years  
 Remaining Component Life: 4 years

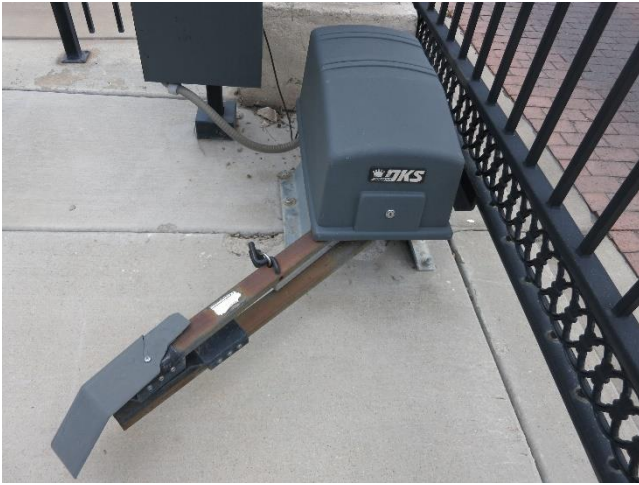
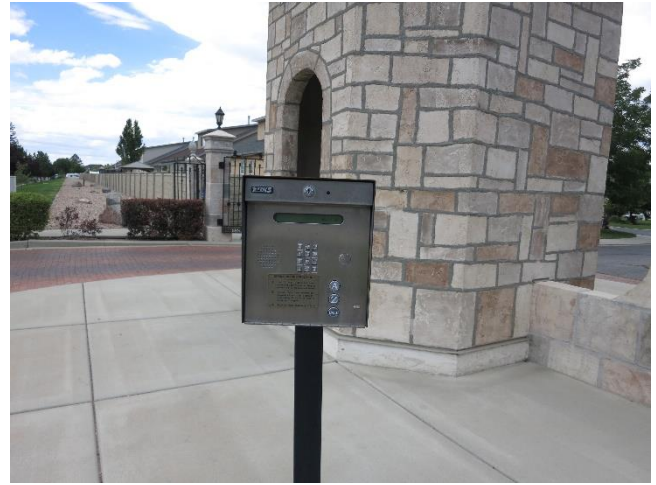
Component Name: Automated Gates  
 Component Number: Common Development 2010

Component Life Expectancy: 15 years  
 Average Age of Component: 10 years  
 Remaining Component Life: 5 years

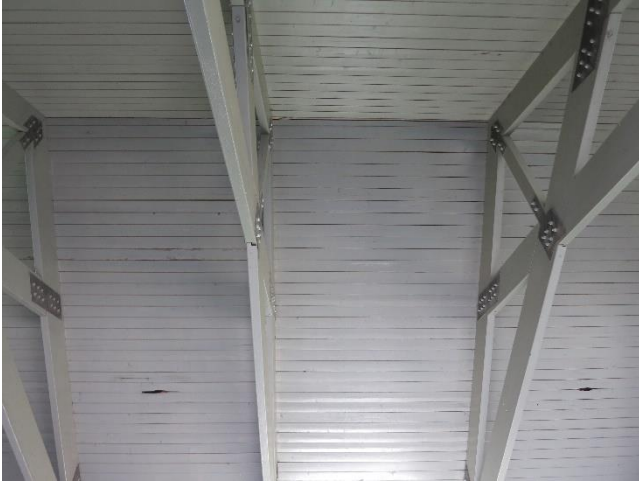
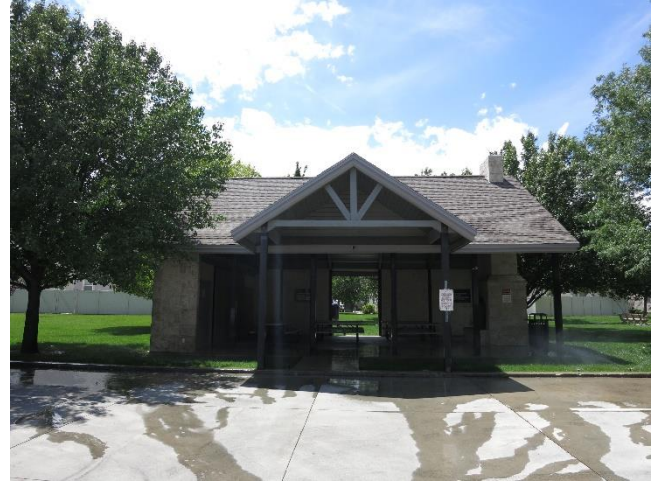
Component Name: Exterior Paint  
 Component Number: Building Exterior 3001

Component Life Expectancy: 10 years  
 Average Age of Component: 5 years  
 Remaining Component Life: 5 years

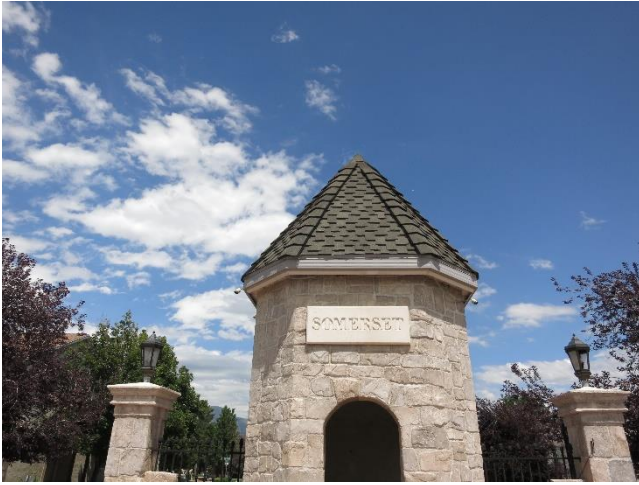
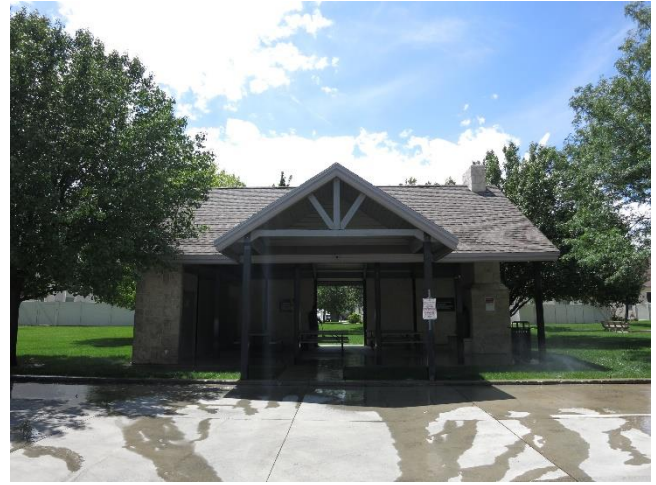
Component Name: Asphalt Shingles  
 Component Number: Building Exterior 3003

Component Life Expectancy: 30 years  
 Average Age of Component: 20 years  
 Remaining Component Life: 10 years
