# Cedars Townhomes HOA

## CAPITAL RESERVE STUDY

Report Number: 23-09  
Site Inspection Date: May 12<sup>th</sup>, 2023  
Report Submittal Date: May 24<sup>th</sup>, 2023

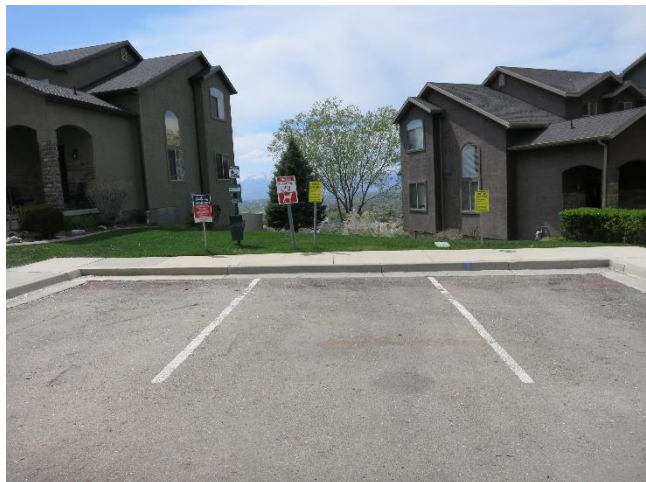
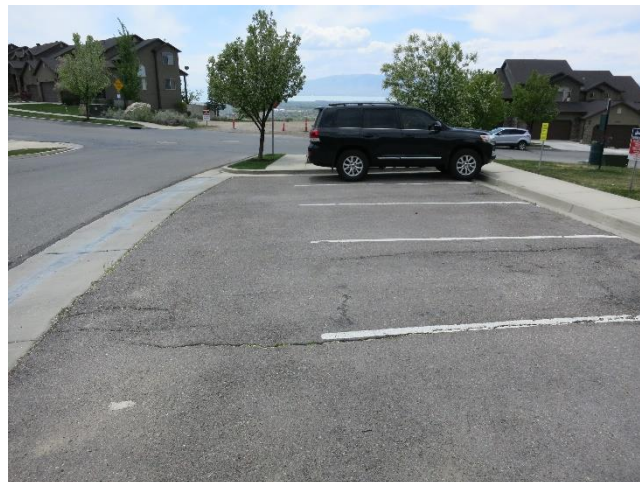
Component Name: 2" Asphalt Mill & Overlay  
 Component Number: Drive Materials 1001

Component Life Expectancy: 30 years  
 Average Age of Component: 17 years  
 Remaining Component Life: 13 years

The AASHTO Pavement Design Guide recommends asphalt paving receive immediate rehabilitation when signs of alligator cracking or longitudinal cracks wider than ¼ inch are present. An asphalt overlay is recommended every 15 to 20 years. With low use, the design life of these has been extended to 30 years. Without an overlay, the road base beneath the paving could deteriorate leading to a complete asphalt replacement.

Areas that show signs of sinking can often be attributed to base course failure. These areas should be repaired prior to a new overlay.

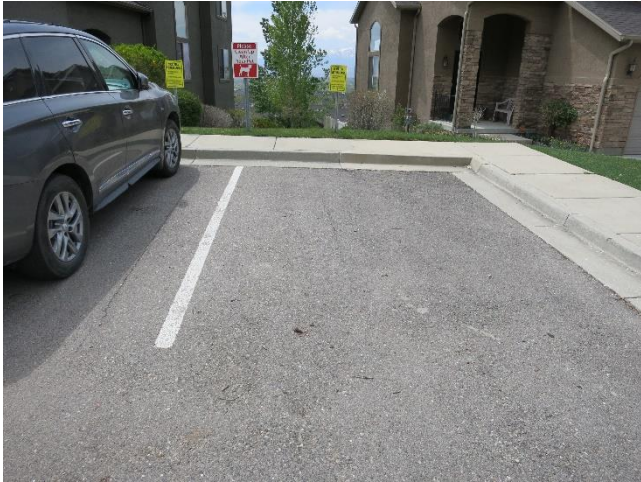
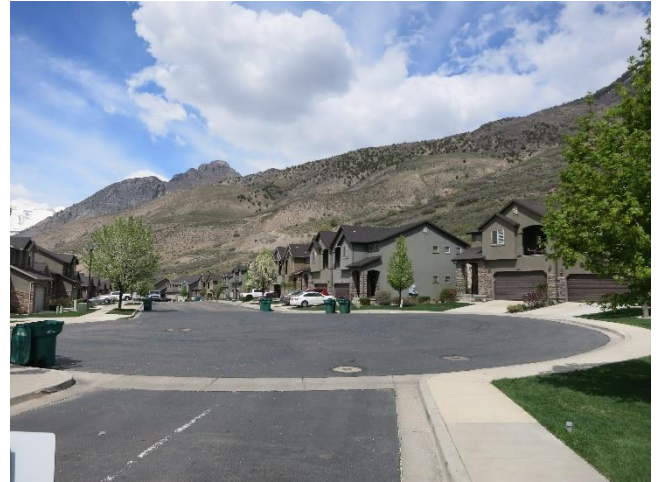
Component Name: Asphalt Slurry Seal  
 Component Number: Drive Materials 1002

Component Life Expectancy: 5 years  
 Average Age of Component: 5 years  
 Remaining Component Life: 0 years

A crack and slurry seal are recommended every 5 years. Slurry seal will help protect the asphalt from degradation by sealing cracks, preventing water seepage and damage. It also rejuvenates the surface and renews the oils, keeping the asphalt from becoming overly brittle.

There are 3 types of slurry seal. For parking lot applications or areas of low vehicular volumes a Type 1 or Type 2 slurry is recommended. A Type 1 slurry utilizes the smallest aggregate size and is good to fill in crack and voids. Type 2 uses a larger aggregate. The larger aggregate could possibly be loosened by vehicles making turns at lower speeds. Type 3 slurry should not be used in this development as it is intended for roadways with high volumes moving in a straight line.

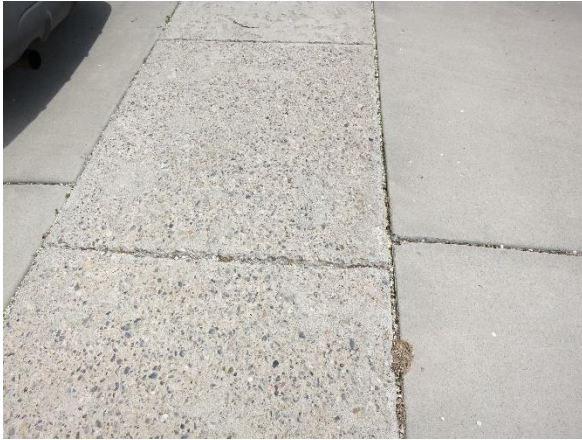
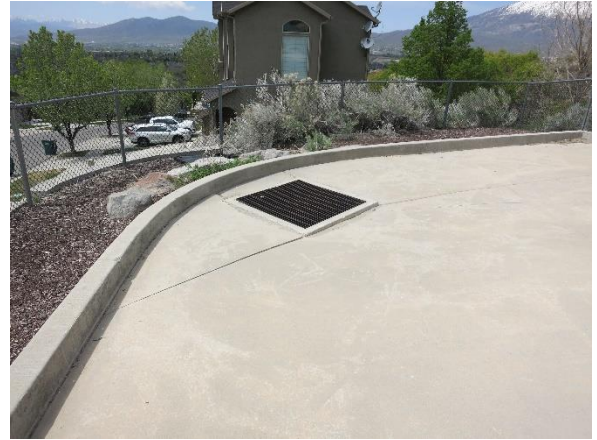
Component Name: Concrete Repair/Replace  
 Component Number: Drive Materials 1003

Reoccurring Allowance: 3 years  
 Beginning Year 2024

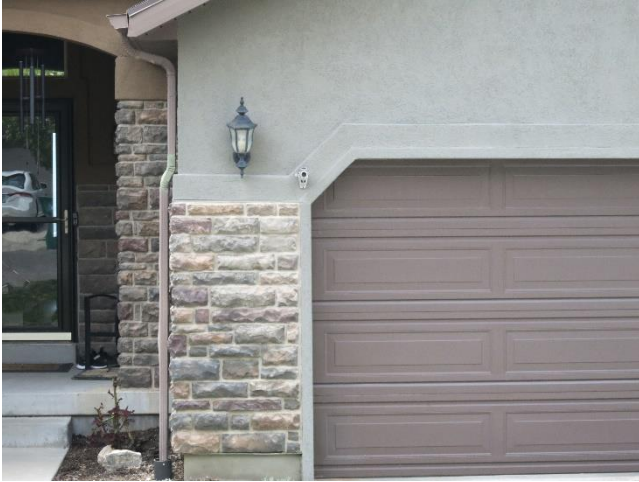
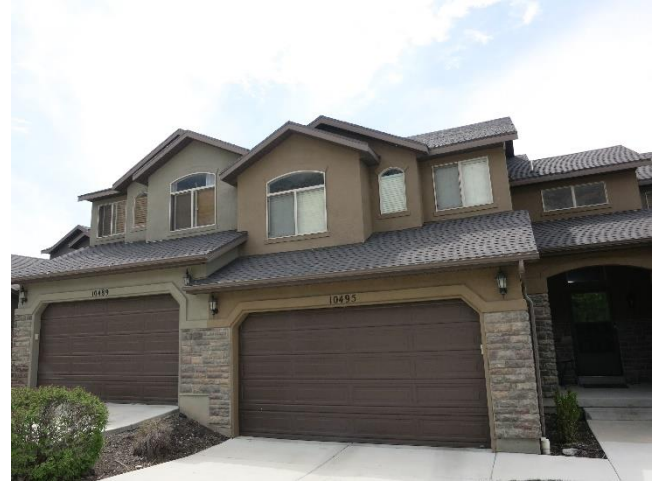
Component Name: Exterior Stone Repair  
 Component Number: Building Exterior 2001

Reoccurring Allowance: 5 years  
 Beginning Year 2025

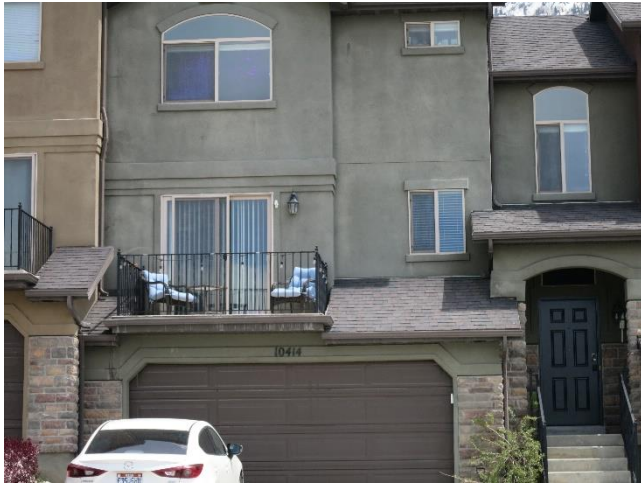
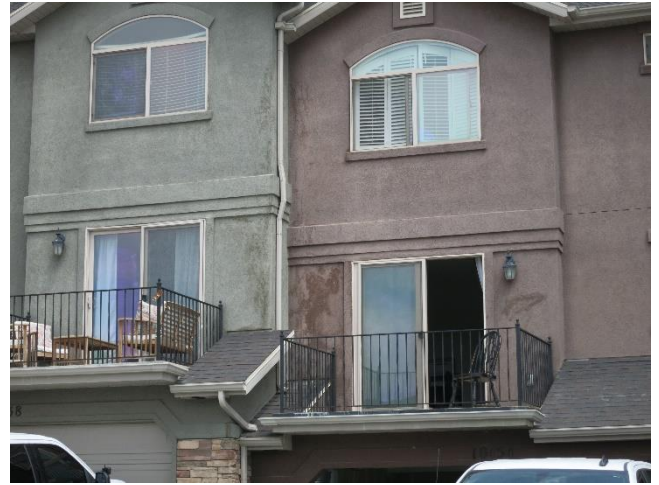
Component Name: Exterior Paint  
 Component Number: Building Exterior 2002

Component Life Expectancy: 12 years  
 Average Age of Component: 3 years  
 Remaining Component Life: 9 years

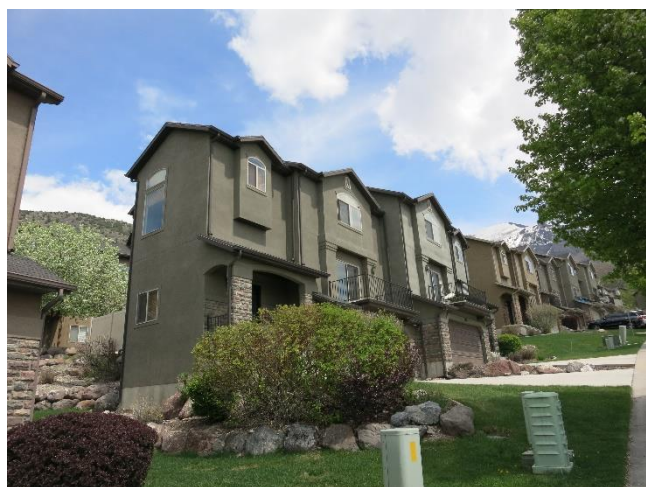
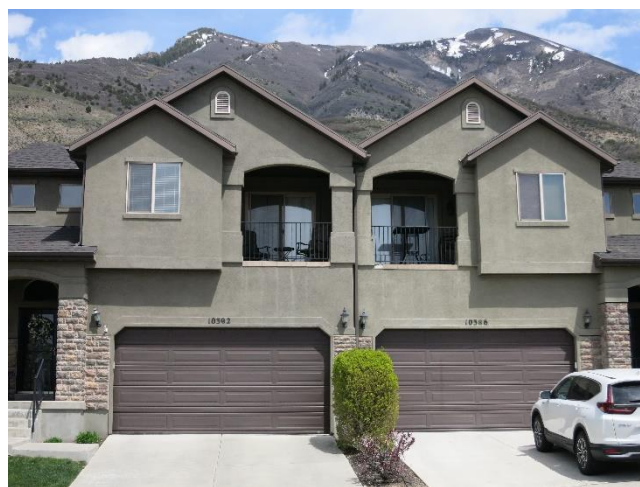
Component Name: Exterior Stucco  
 Component Number: Building Exterior 2003

Reoccurring Repair Allowance: 5 years  
 Beginning Year: 2025

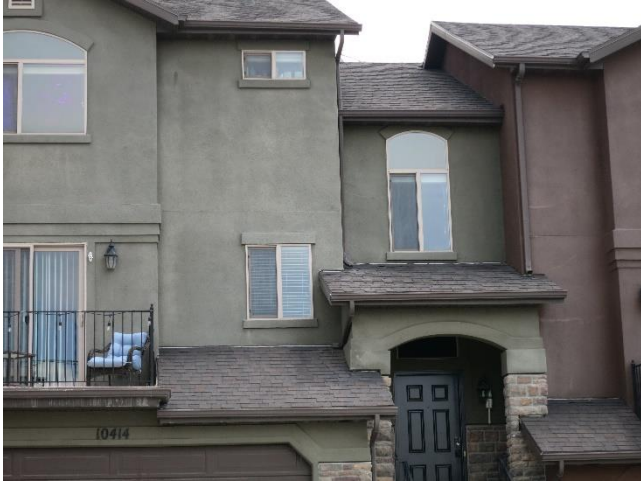
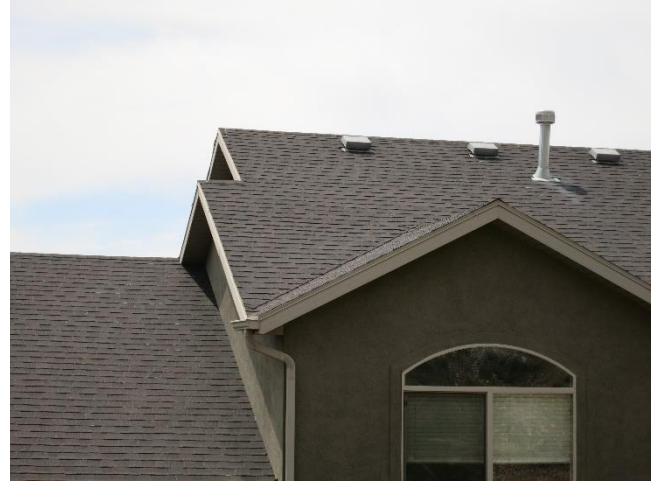
Component Name: Shingle Roofing Replacement  
 Component Number: Building Exterior 2004

Component Life Expectancy: 30 years  
 Average Age of Component: 17 years  
 Remaining Component Life: 13 years

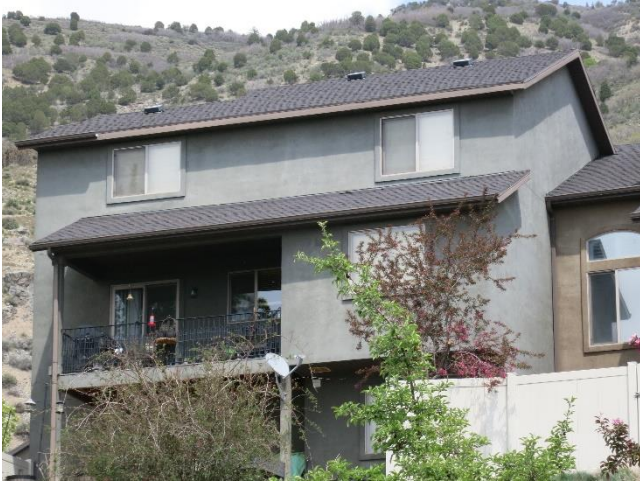
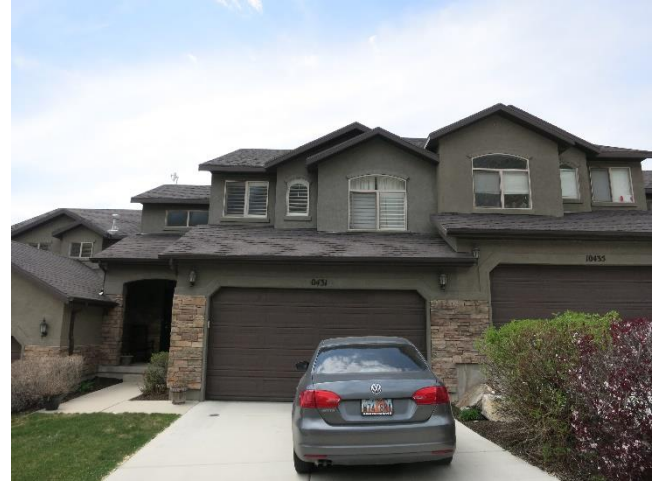
Component Name: Gutter & Downspouts  
 Component Number: Building Exterior 2005

Component Life Expectancy: 30 years  
 Average Age of Component: 17 years  
 Remaining Component Life: 13 years

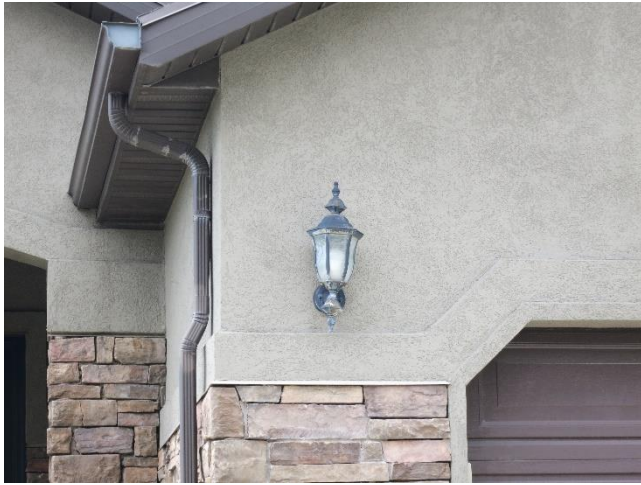
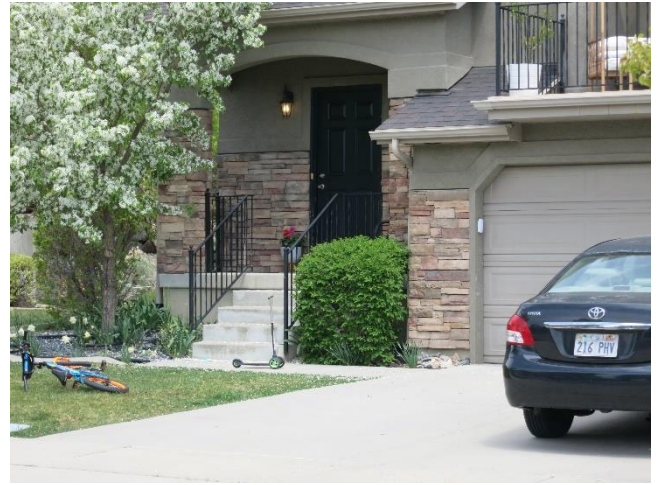
Component Name: Exterior Light Fixtures  
 Component Number: Building Exterior 2006

Component Life Expectancy: 25 years  
 Average Age of Component: 17 years  
 Remaining Component Life: 8 years

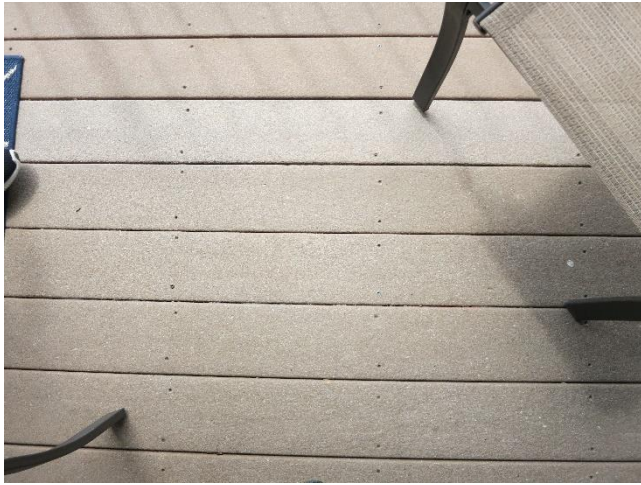
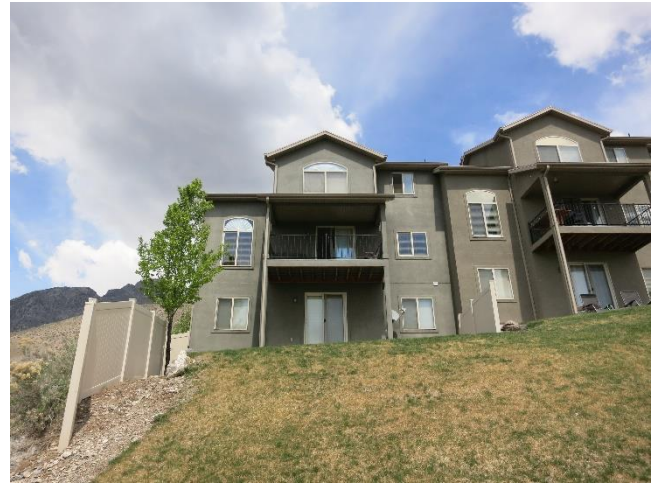
Component Name: Decking Replacement  
 Component Number: Building Exterior 2007

Component Life Expectancy: 30 years  
 Average Age of Component: 17 years  
 Remaining Component Life: 13 years

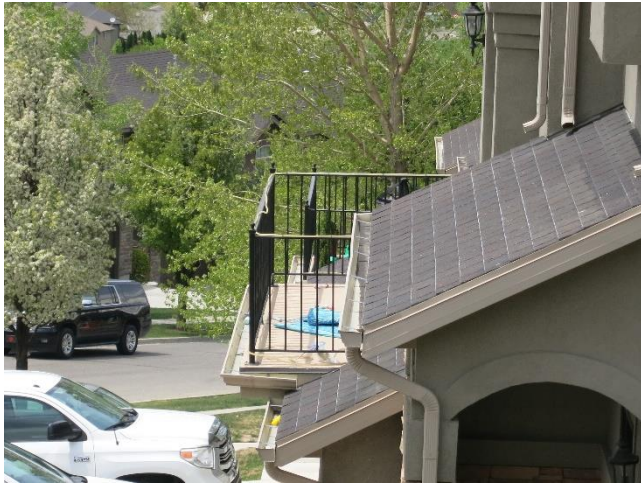
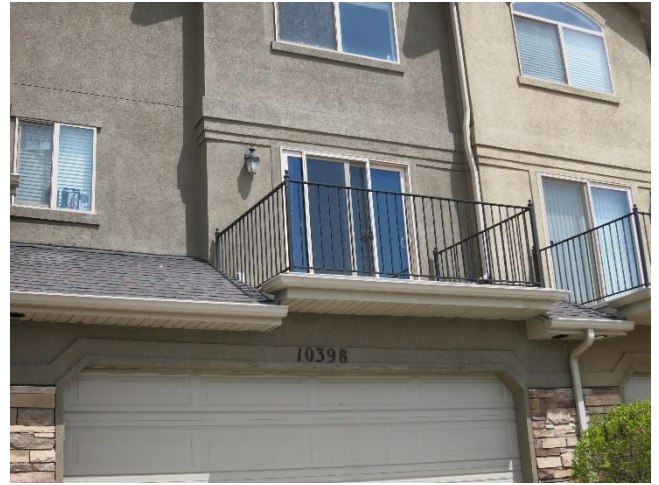
Component Name: Porch Surfacing  
 Component Number: Building Exterior 2008

Component Life Expectancy: 20 years  
 Average Age of Component: 17 years  
 Remaining Component Life: 3 years

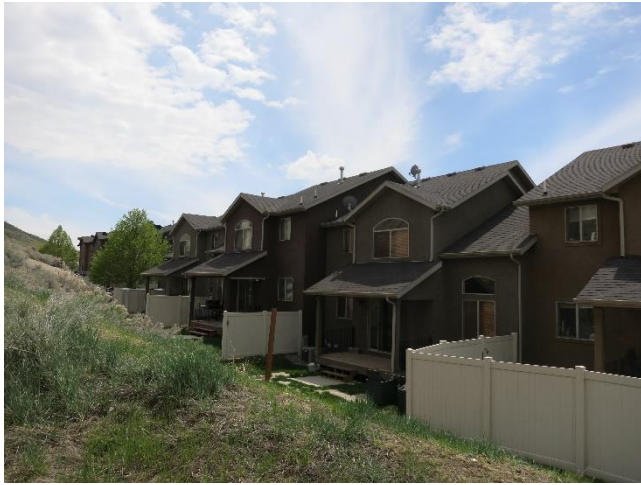
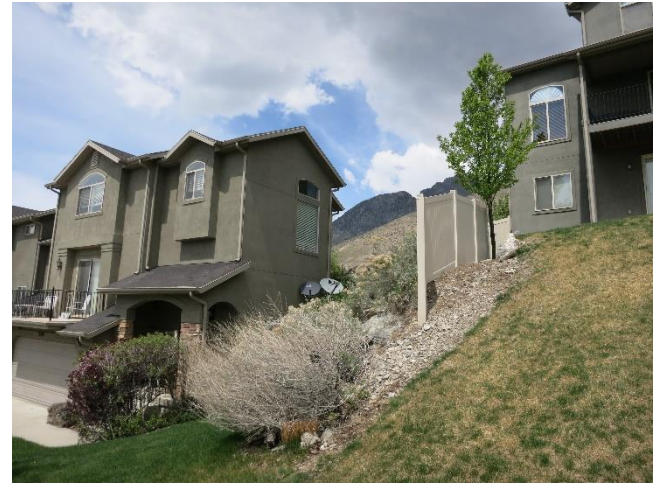
Component Name: Vinyl Party Fencing  
 Component Number: Building Exterior 2009

Component Life Expectancy: 35 years  
 Average Age of Component: 17 years  
 Remaining Component Life: 18 years

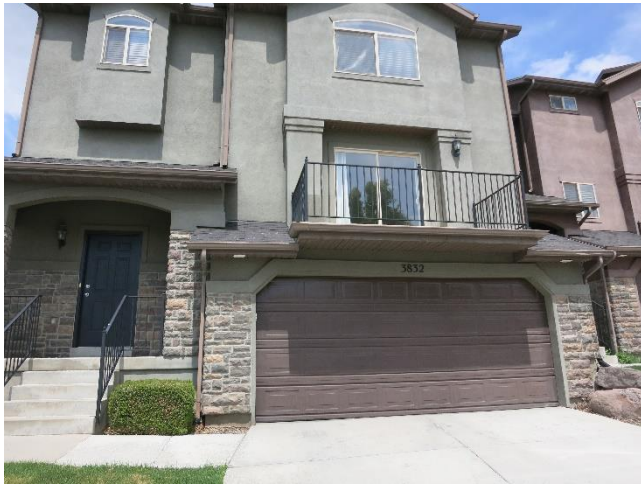
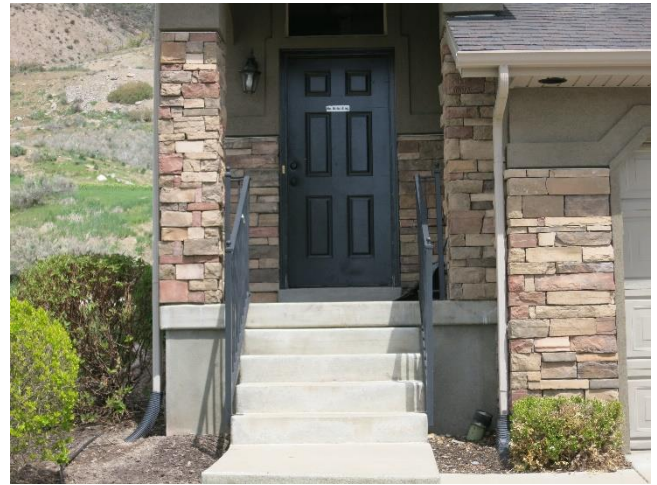
Component Name: Metal Railing Maintenance  
 Component Number: Building Exterior 2010

Component Life Expectancy: 10 years  
 Average Age of Component: 4 years  
 Remaining Component Life: 6 years

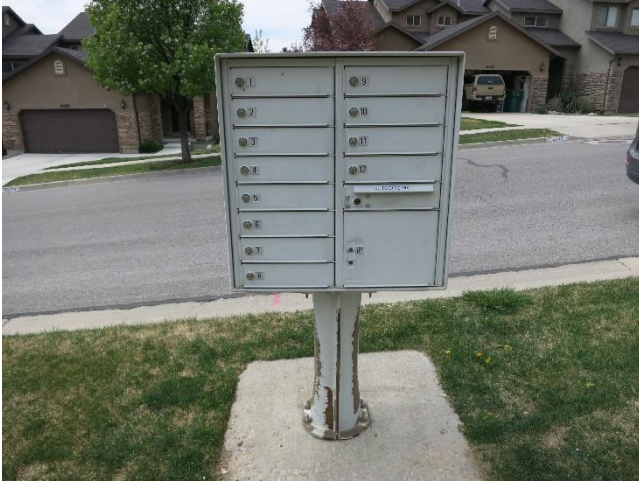
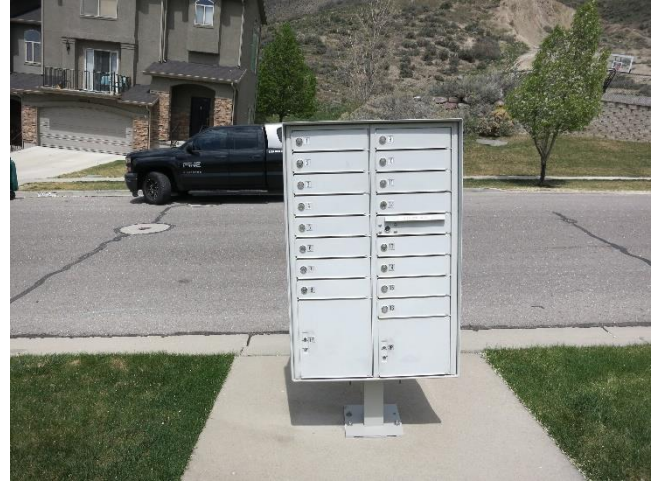
Component Name: Mailboxes  
 Component Number: Common Development 3001

Component Life Expectancy: 25 years  
 Age of Component: 17 years  
 Remaining Component Life: 8 years

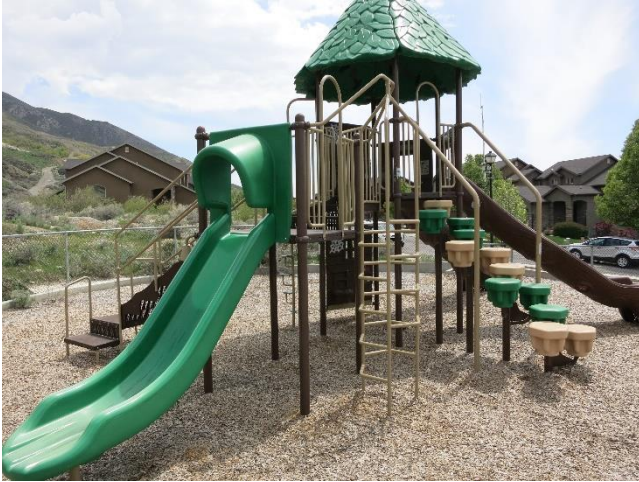
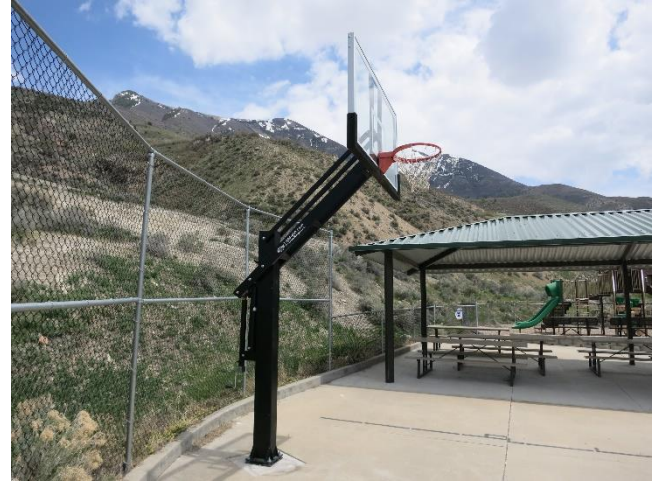
Component Name: Playground Equipment  
 Component Number: Common Development 3005

Component Life Expectancy: 18 years  
 Average Age of Component: 10 years  
 Remaining Component Life: 8 years

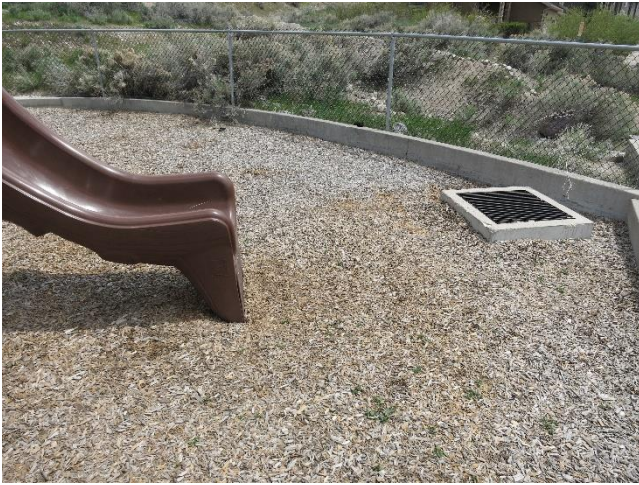
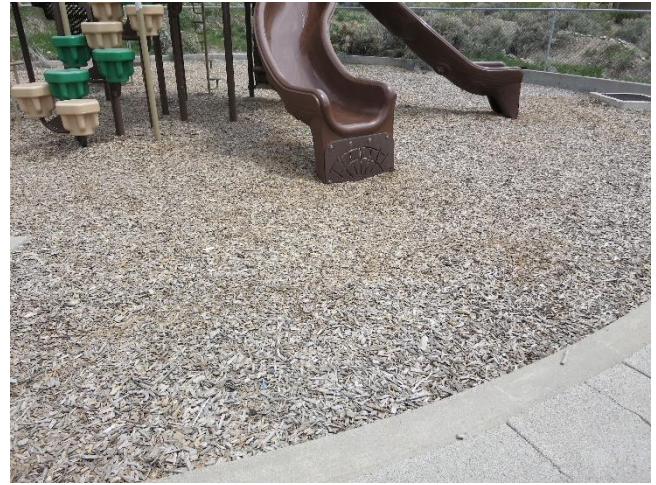
Component Name: Playground Ground Cover  
 Component Number: Common Development 3006

Component Life Expectancy: 3 years  
 Average Age of Component: 3 years  
 Remaining Component Life: 0 years
