# **Park View HOA**

## **CAPITAL RESERVE STUDY**

Report Number: 24-22

Site Inspection Date: November 28<sup>th</sup>, 2020  
Report Submittal Date: December 18<sup>th</sup>, 2020  
Report Updated: January 8<sup>th</sup>, 2025

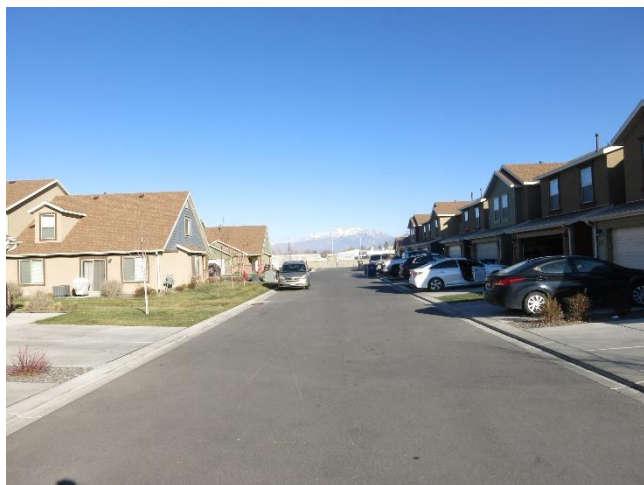
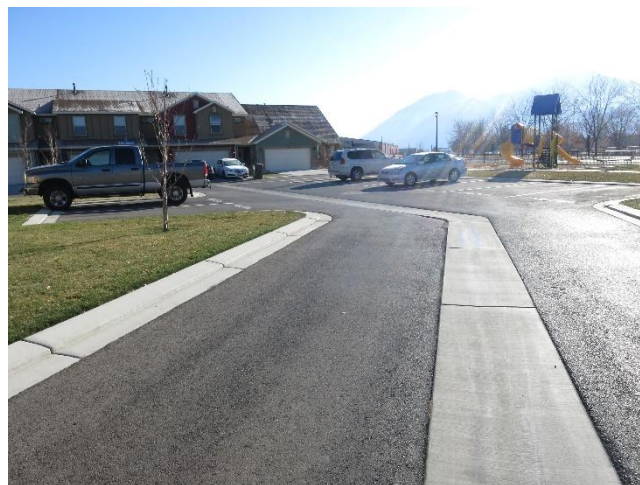
Component Name: 2" Asphalt Mill & Overlay  
 Component Number: Drive Materials 1001

Component Life Expectancy: 20 years  
 Average Age of Component: 9 years  
 Remaining Component Life: 11 years

The AASHTO Pavement Design Guide recommends asphalt paving receive immediate rehabilitation when signs of alligator cracking or longitudinal cracks wider than ¼ inch are present. An asphalt overlay is recommended every 15 to 20 years. The overlay will add new structure to the road and fix any pot holes or structural defects that may develop over time. Without an overlay, the road base beneath the paving could deteriorate leading to a complete asphalt replacement.

Areas that show signs of sinking can often be attributed to base course failure. These areas should be repaired prior to a new overlay.

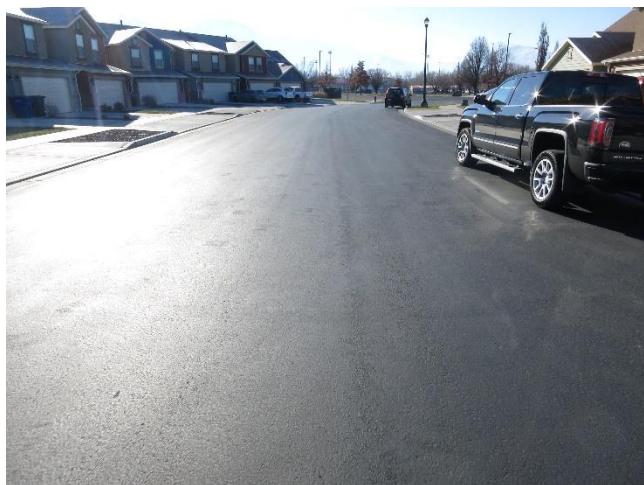
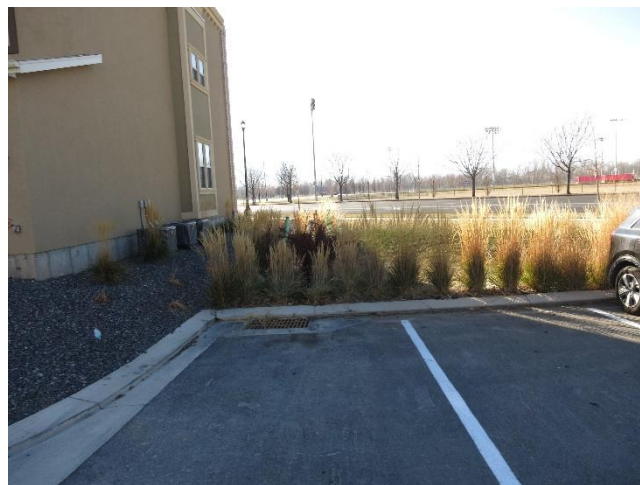
Component Name: Asphalt Slurry Seal  
 Component Number: Drive Materials 1002

Component Life Expectancy: 5 years  
 Average Age of Component: 5 years  
 Remaining Component Life: 0 years

A crack and slurry seal is recommended every 5 years. Slurry seal will help protect the asphalt from degradation by sealing cracks, preventing water seepage and damage. It also rejuvenates the surface and renews the oils, keeping the asphalt from becoming overly brittle.

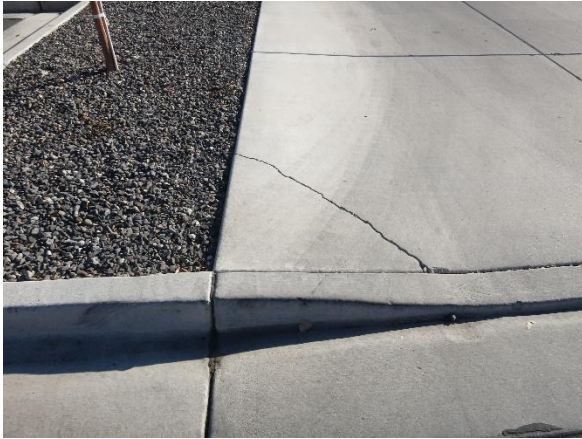
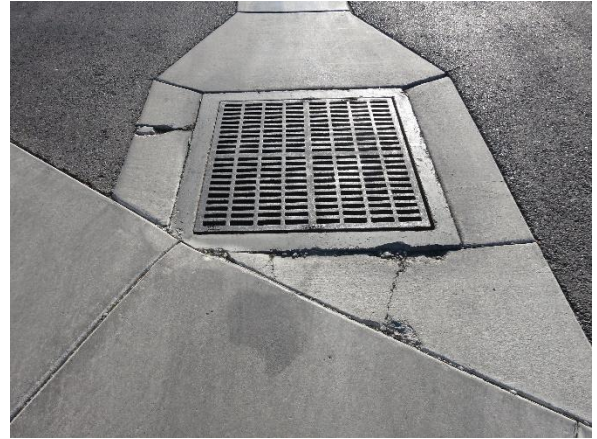
Component Name: Concrete Repair/Replace  
 Component Number: Drive Materials 1003

The American Public Works Association (Utah Chapter) recommends concrete panels to be repaired and or replaced when there are 3 or more cracks that extend the full depth of the slab or if there is spalling that covers more than 25% of the panel. Protruding edges should be ground down to prevent further damage and to prevent any safety hazards.

It is recommended that a hazardous concrete replacement program be started, with specific areas of concrete and pavers replaced on a five-year cycle. A minimal cost of \$10,000 and recommended cost of \$15,000 is budgeted in 2025 for this item, then every five years going forward. This allowance will allow spot replacement of cracked, spalling, or displaced concrete as needed. It includes any common area concrete, which could include sidewalk, curb and gutter, waterways, or stairs.

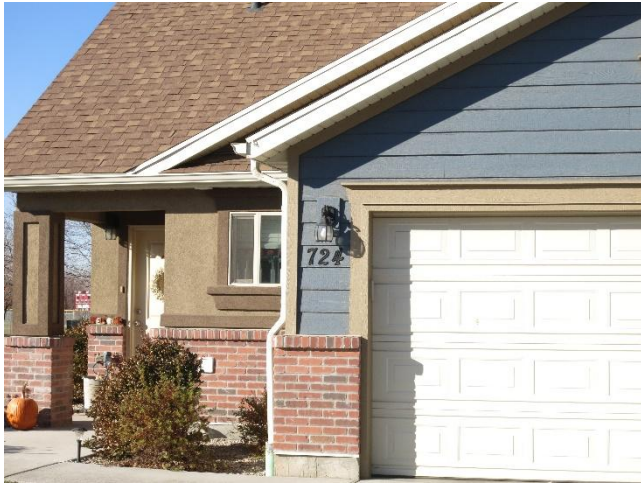
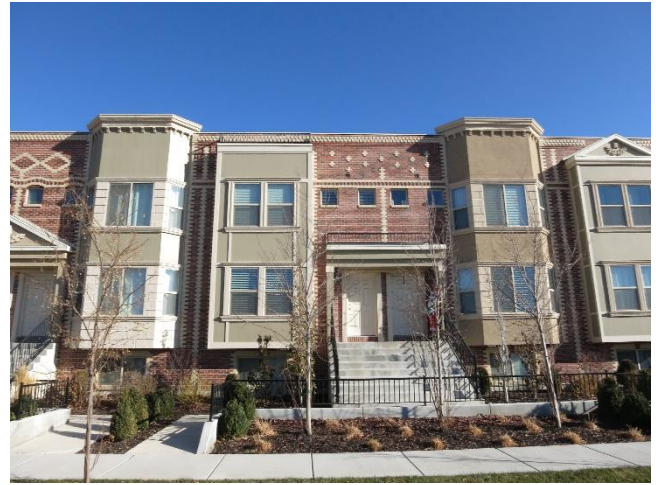
Component Name: Brick / Stone  
 Component Number: Building Exterior 2001

Brick, stone, and concrete are durable building materials that can last a very long time. Because of the long lifespan of this component, it is plausible that it will last the lifetime of the building. Therefore, no money has been allocated to replace or maintain this item.

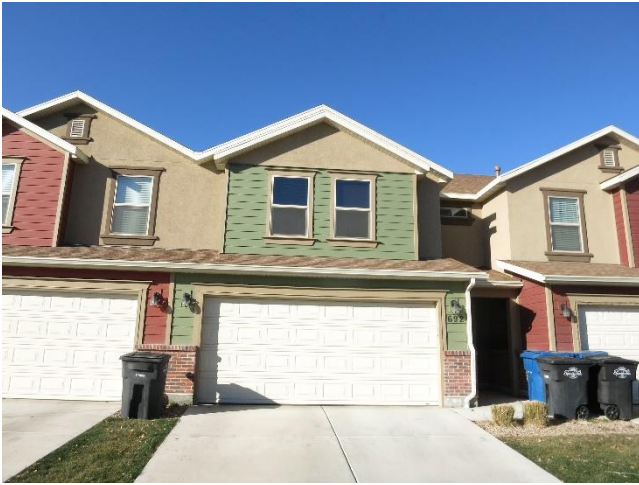
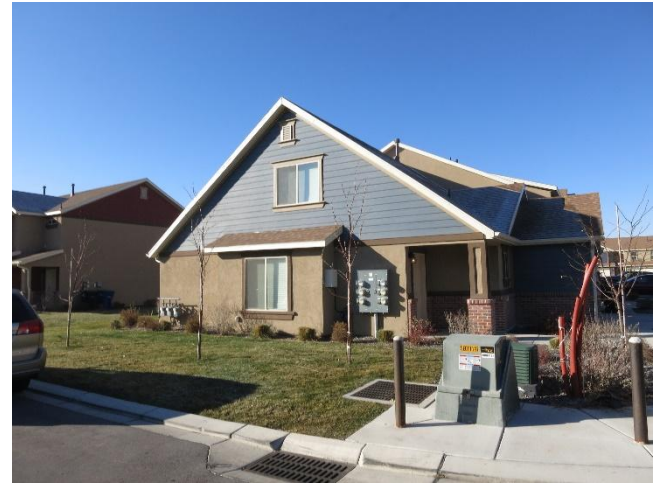
Component Name: Exterior Paint  
 Component Number: Building Exterior 2002

Component Life Expectancy: 12 years  
 Average Age of Component: 9 years  
 Remaining Component Life: 3 years

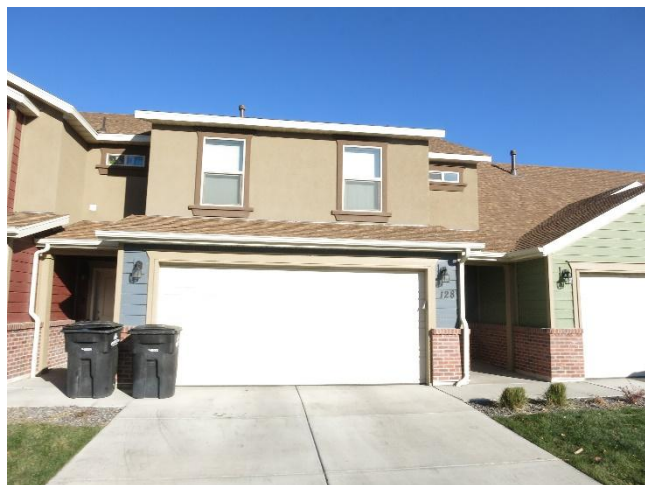
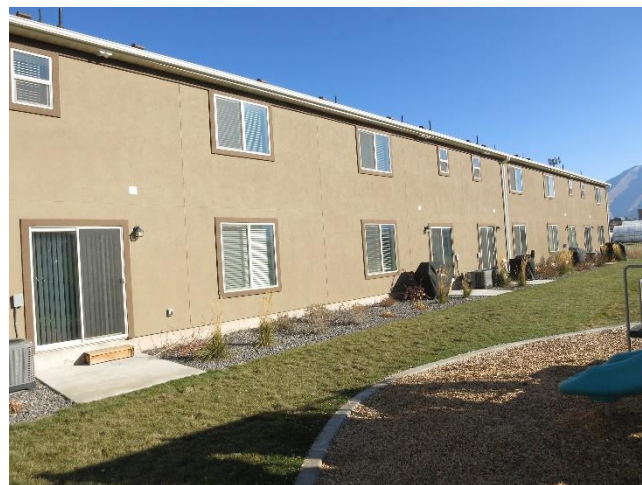
Component Name: Stucco  
 Component Number: Building Exterior 2003

Reoccurring Repair Allowance: 5 years  
 Beginning Year: 2025

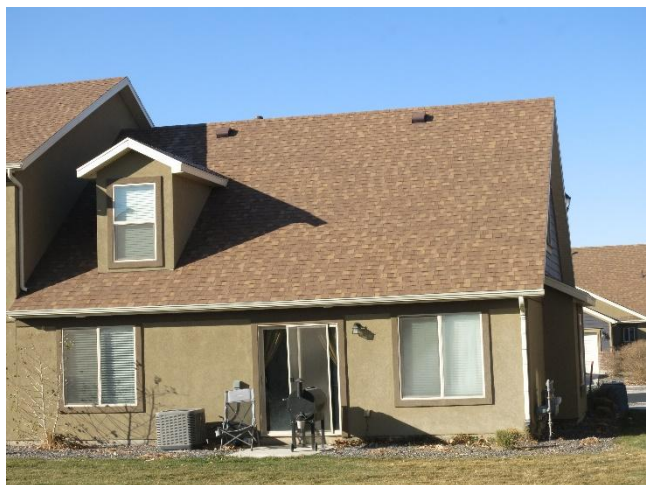
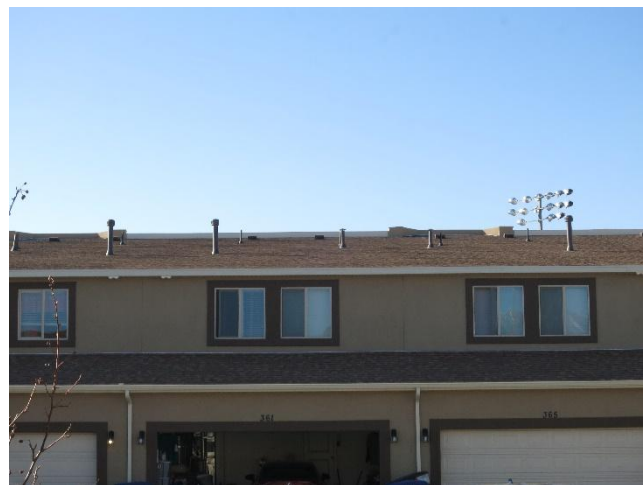
Component Name: Roofing Replacement  
 Component Number: Building Exterior 2004

Component Life Expectancy: 30 years  
 Average Age of Component: 9 years  
 Remaining Component Life: 21 years

The roofs for each unit were observed to be asphalt shingle roofing.

Replacement roofing is the highest expense for the reserve account. It is anticipated that in 2046 new roofing will be needed. This cost is currently estimated to be over \$700,000 in 2025 dollars, about \$5,500 per unit. By 2046, inflation will require over \$1.2 million in the reserve account to cover this expense. This is the single most significant component in the community, and drives the financial model and recommendations of this report.

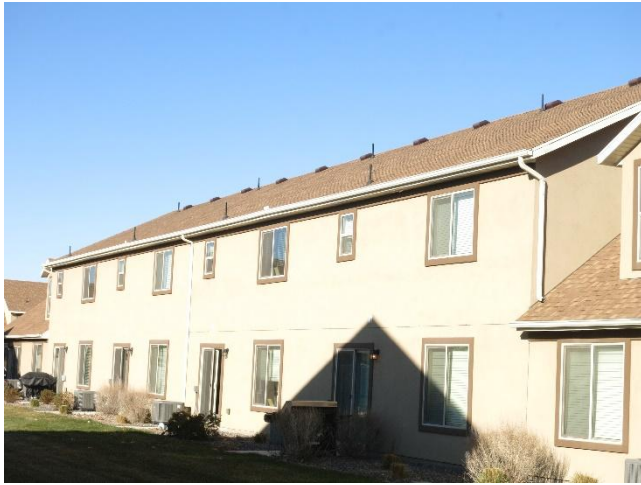
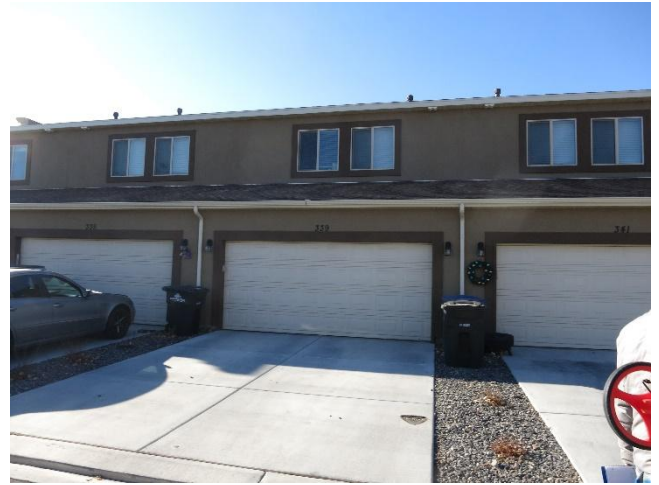
Component Name: Gutter & Downspouts  
 Component Number: Building Exterior 2005

Component Life Expectancy: 30 years  
 Average Age of Component: 9 years  
 Remaining Component Life: 21 years

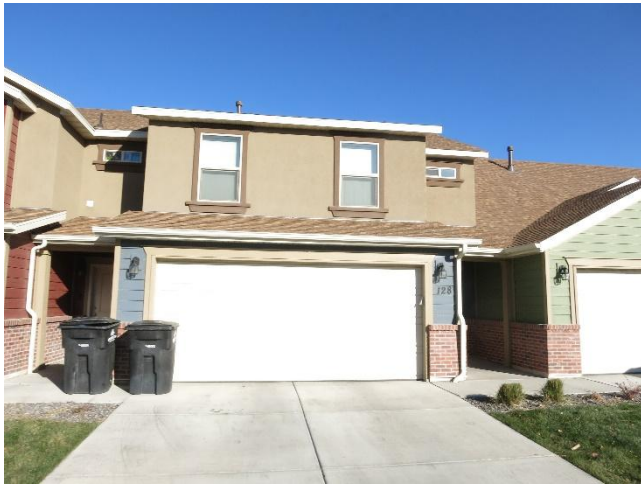
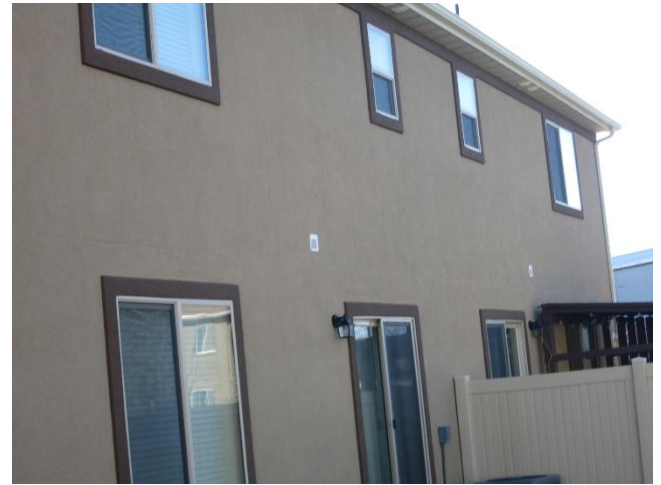
Component Name: Exterior Light Fixtures  
 Component Number: Building Exterior 2006

Component Life Expectancy: 20 years  
 Average Age of Component: 9 years  
 Remaining Component Life: 11 years

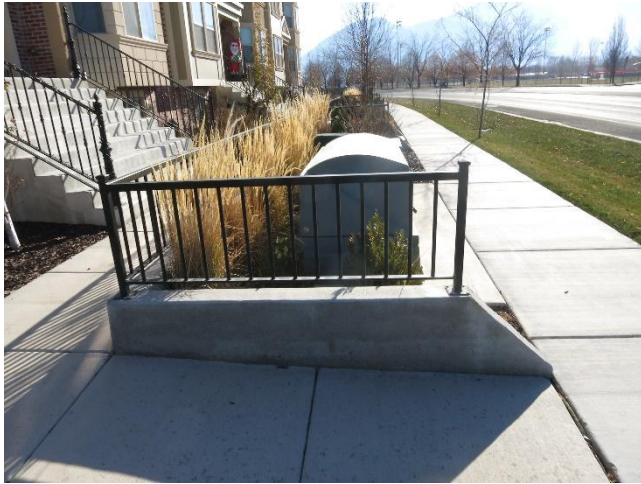
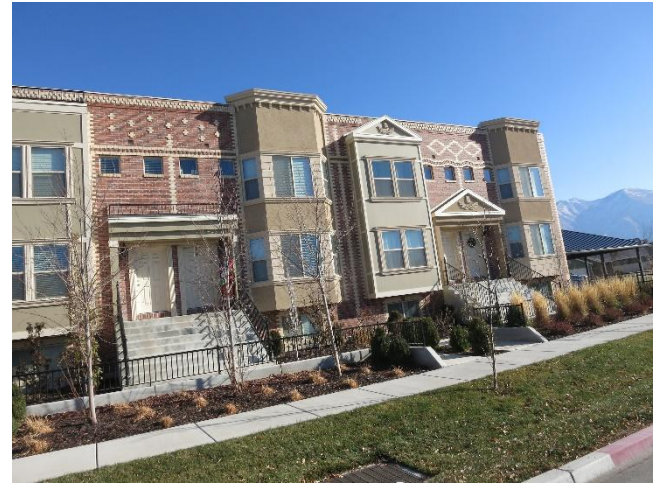
Component Name: Metal Deck Railing Maintenance  
 Component Number: Building Exterior 2008

Component Life Expectancy: 15 years  
 Average Age of Component: 9 years  
 Remaining Component Life: 6 years

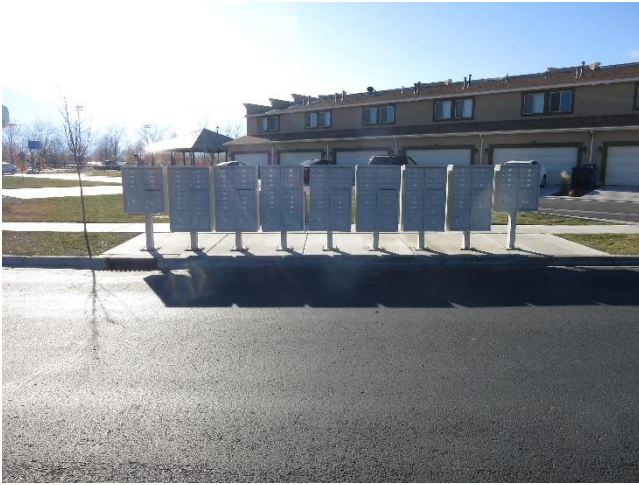
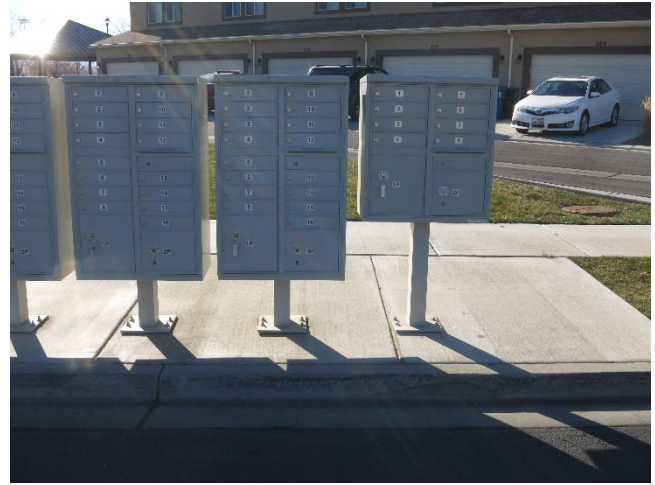
Component Name: Mailboxes  
 Component Number: Common Development 3001

Component Life Expectancy: 20 years  
 Age of Component: 9 years  
 Remaining Component Life: 11 years

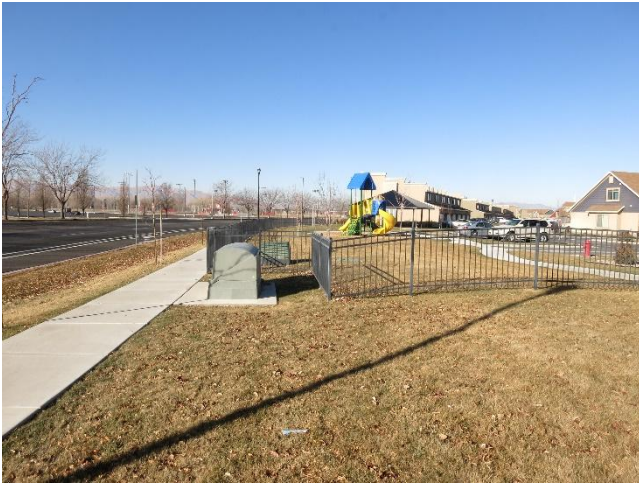
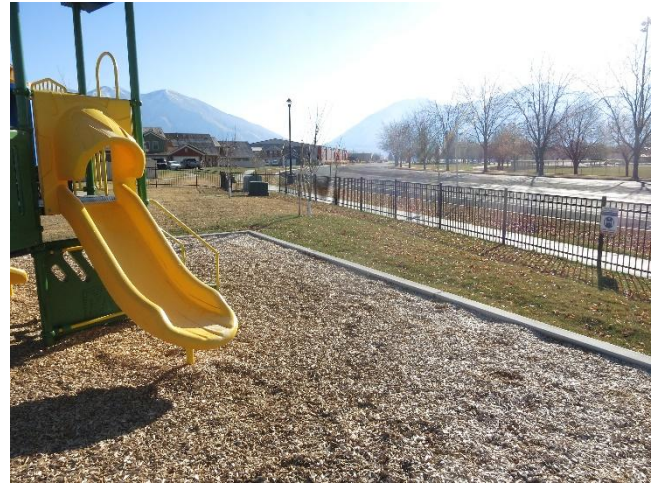
Component Name: Metal Fencing Maintenance  
 Component Number: Common Development 3003

Component Life Expectancy: 15 years  
 Average Age of Component: 9 years  
 Remaining Component Life: 6 years

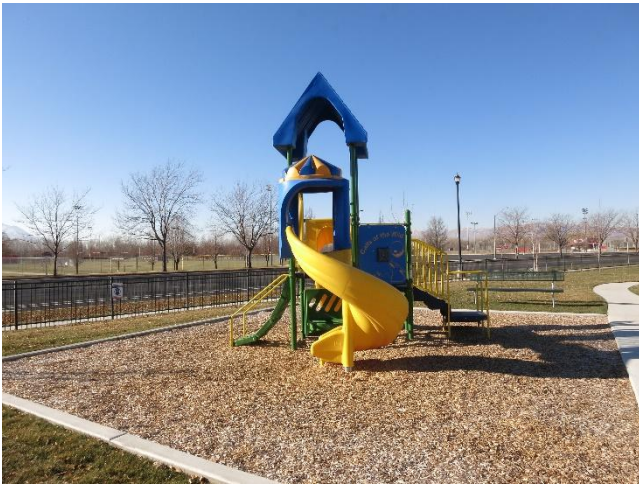
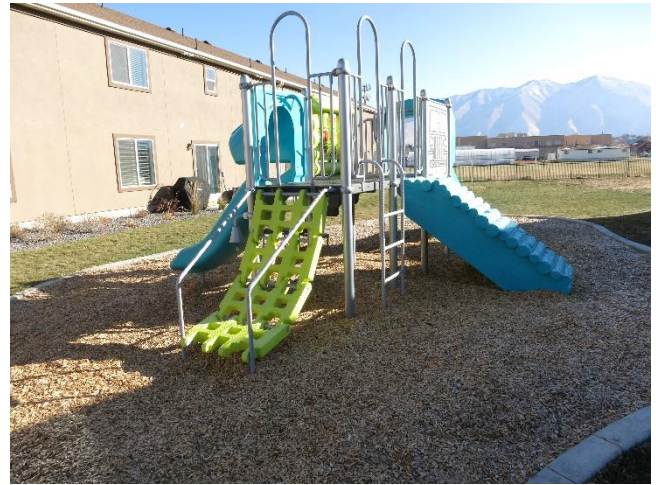
Component Name: Playground Equipment  
 Component Number: Common Development 3005

Component Life Expectancy: 15 years  
 Average Age of Component: 9 years  
 Remaining Component Life: 6 years

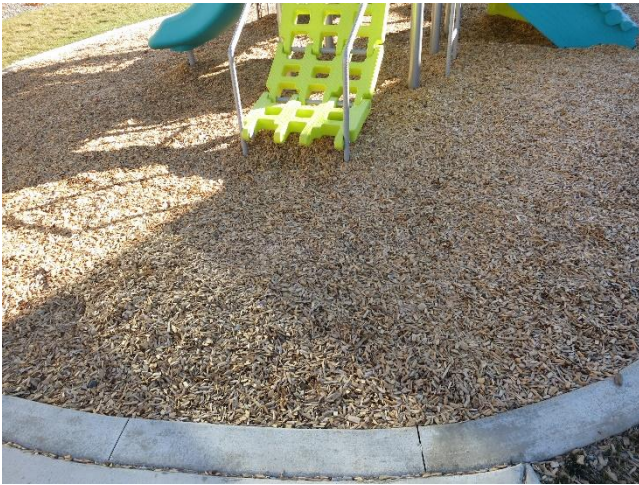
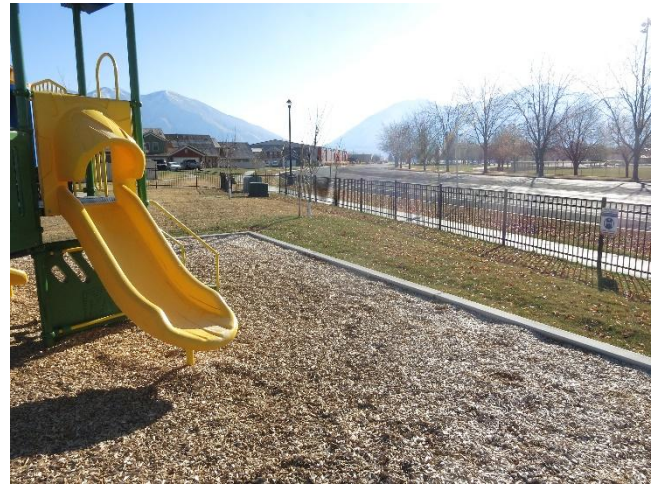
Component Name: Playground Ground Cover  
 Component Number: Common Development 3006

Component Life Expectancy: 3 years  
 Average Age of Component: 3 years  
 Remaining Component Life: 0 years
