# Canyonbrook Condominiums

## Level 2 Reserve Study

**Report Period – 01/01/2020 – 12/31/2020**

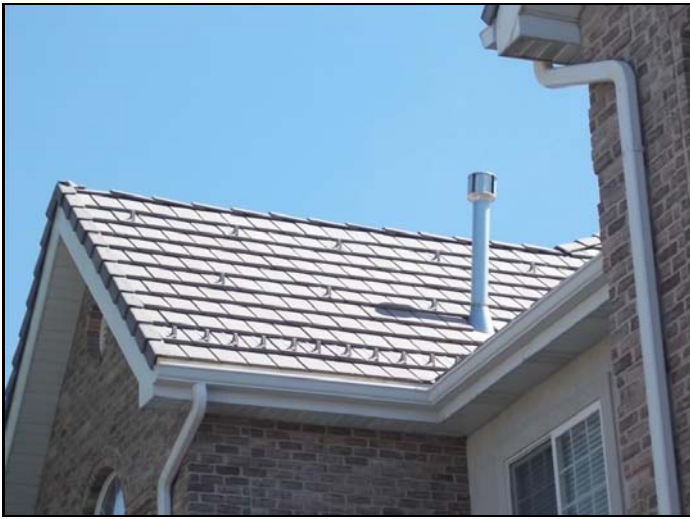
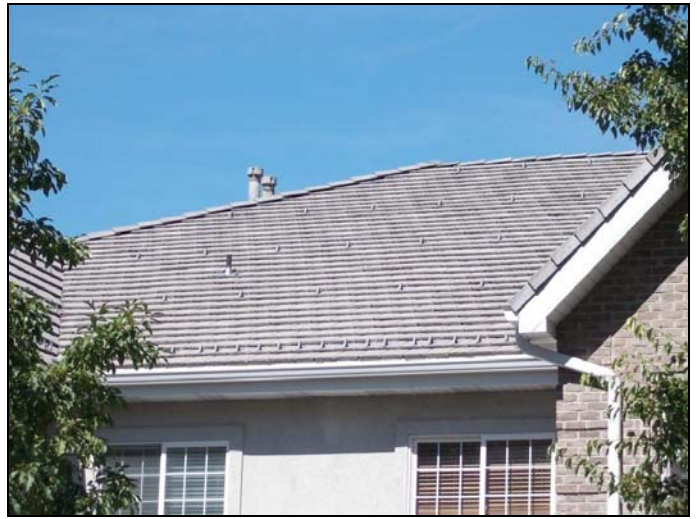
Comp #: 106 Tile Roofs - 2021 - Underlayment Replace

The tile roof is in good condition. Research with the client reveals leaking issues. Although the tile portion of this roofing system has an extended useful life of 50 - 100 years or more, we recommend funding to replace the underlayment approximately every 25 - 30 years. Remaining life based on current age.

**\$4.50/Sq.ft.; Estimate to replace underlayment**

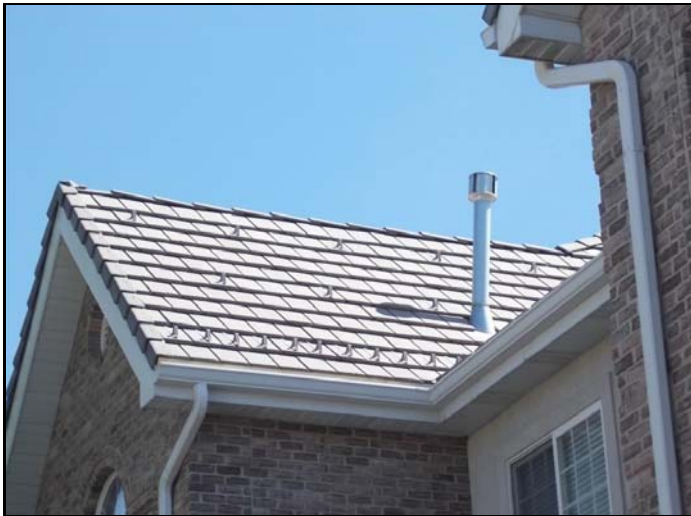
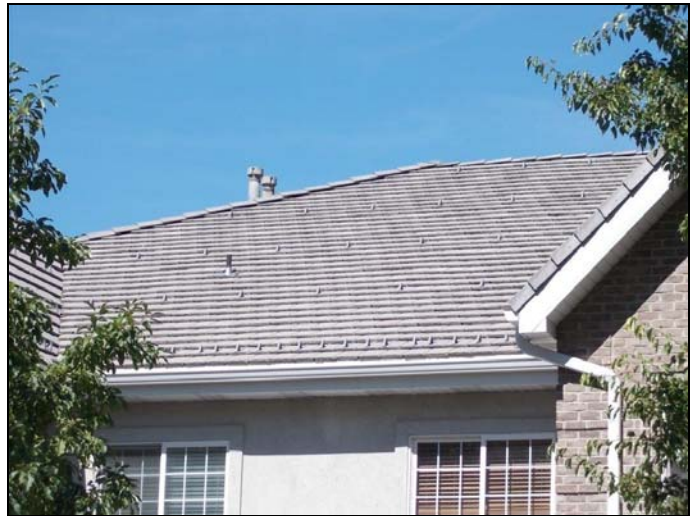
## Comp #: 106 Tile Roofs - 2023 - Underlayment Replace

The tile roof is in good condition. Research with the client reveals leaking issues. Although the tile portion of this roofing system has an extended useful life of 50 - 100 years or more, we recommend funding to replace the underlayment approximately every 25 - 30 years. Remaining life based on current age.

\$4.50/Sq.ft.; Estimate to replace underlayment

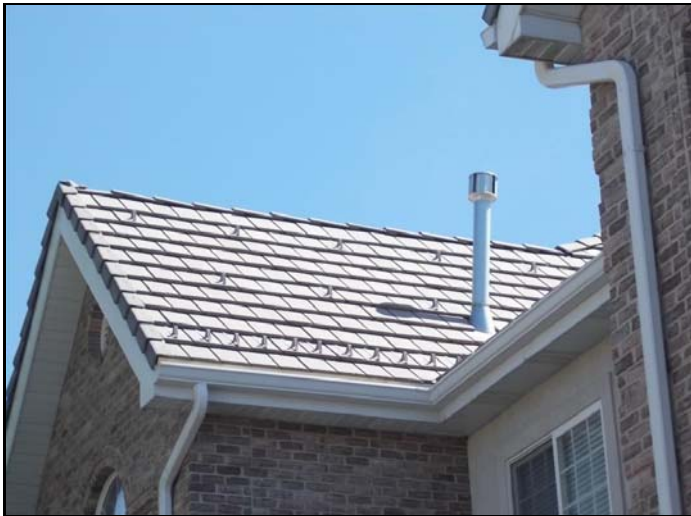
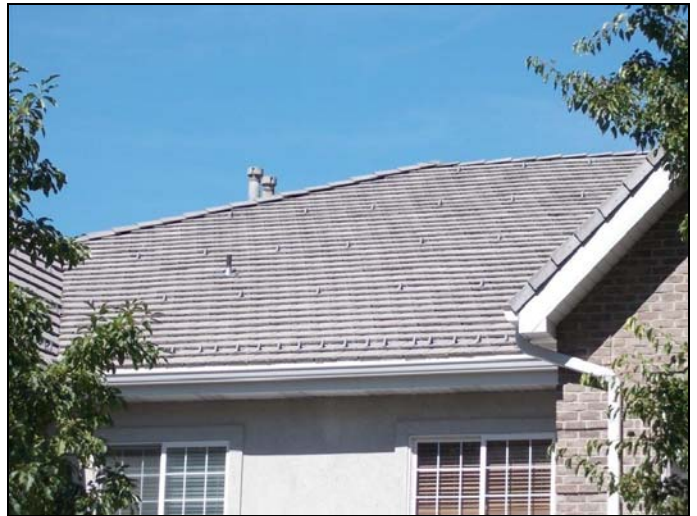
## Comp #: 106 Tile Roofs - 2025 - Underlayment Replace

The tile roof is in good condition. Research with the client reveals leaking issues. Although the tile portion of this roofing system has an extended useful life of 50 - 100 years or more, we recommend funding to replace the underlayment approximately every 25 - 30 years. Remaining life based on current age.

\$4.50/Sq.ft.; Estimate to replace underlayment

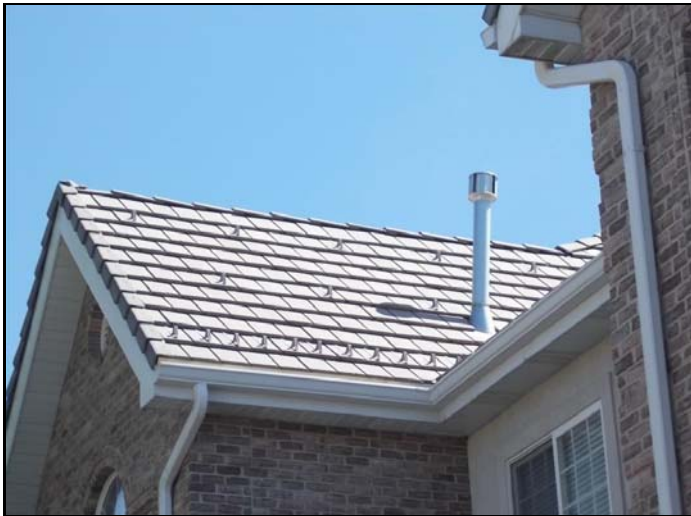
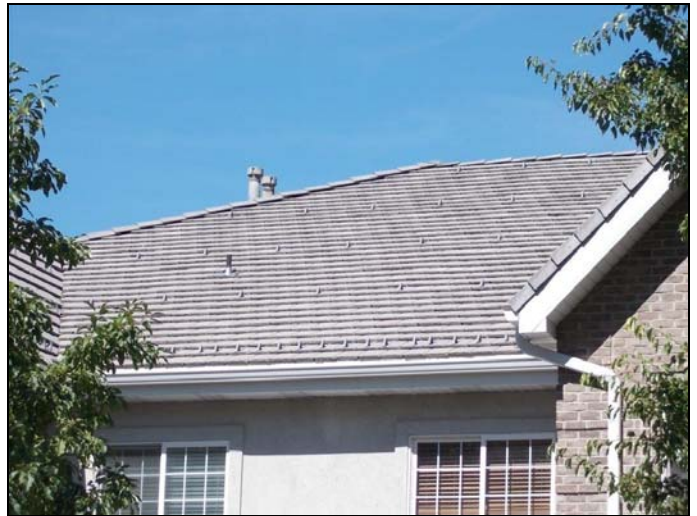
## Comp #: 106 Tile Roofs - 2027 - Underlayment Replace

The tile roof is in good condition. Research with the client reveals leaking issues. Although the tile portion of this roofing system has an extended useful life of 50 - 100 years or more, we recommend funding to replace the underlayment approximately every 25 - 30 years. Remaining life based on current age.

\$4.50/Sq.ft.; Estimate to replace underlayment

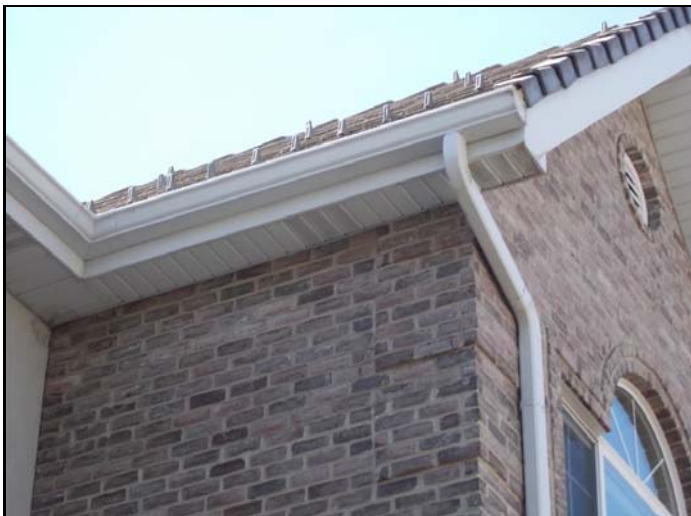
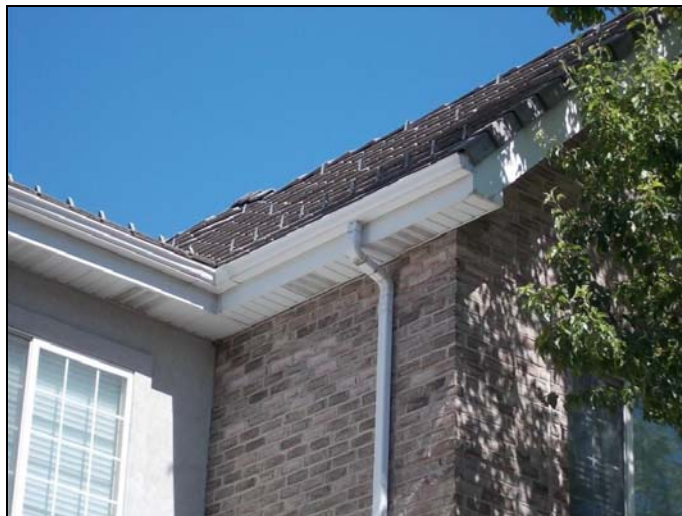
Comp #: 120 Rain Gutters/Downspouts - Replace

The rain gutters and downspouts are in fair condition. We recommend funding to replace this component approximately every 25 - 30 years. Remaining life based on current age.

\$5.50/Linear ft.; Estimate to replace

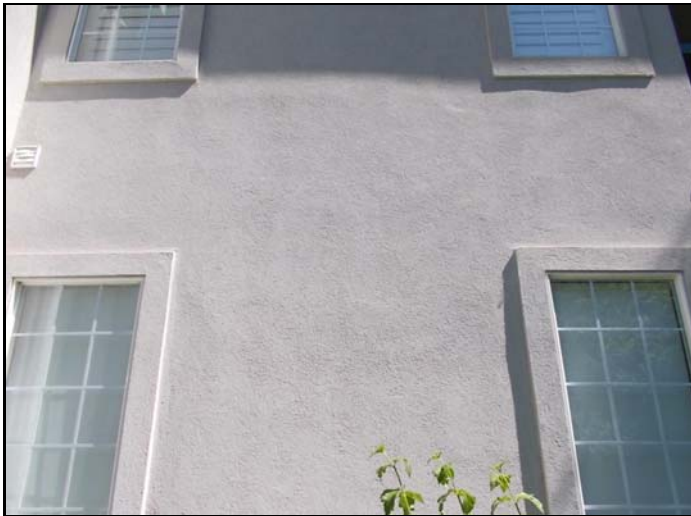
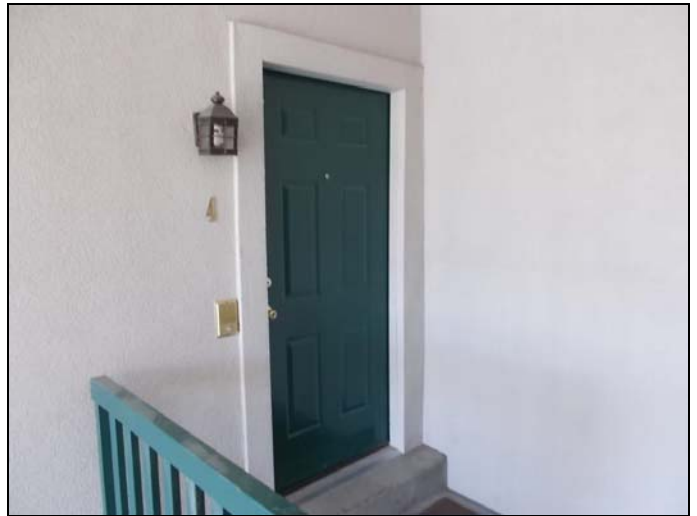
Comp #: 201 Stucco Surfaces - Repair/Repaint

The stucco surfaces are in good to fair condition. We recommend funding to repair/repaint this component approximately every 12 - 15 years. Remaining life based on current age.

\$1.00/Sq.ft.; Estimate to repair/repaint

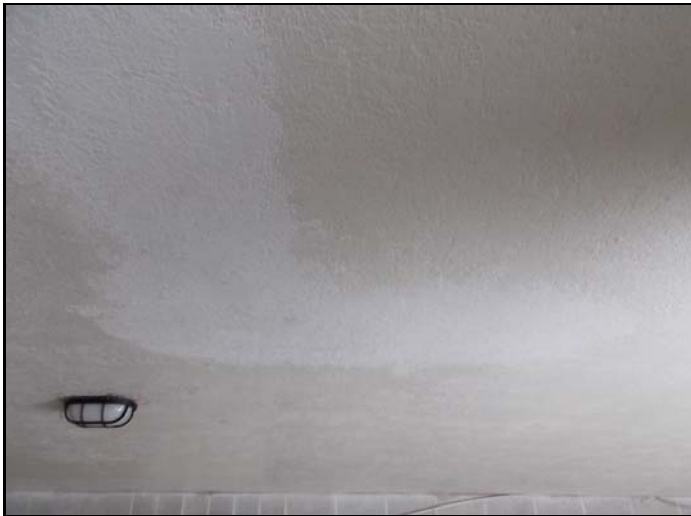
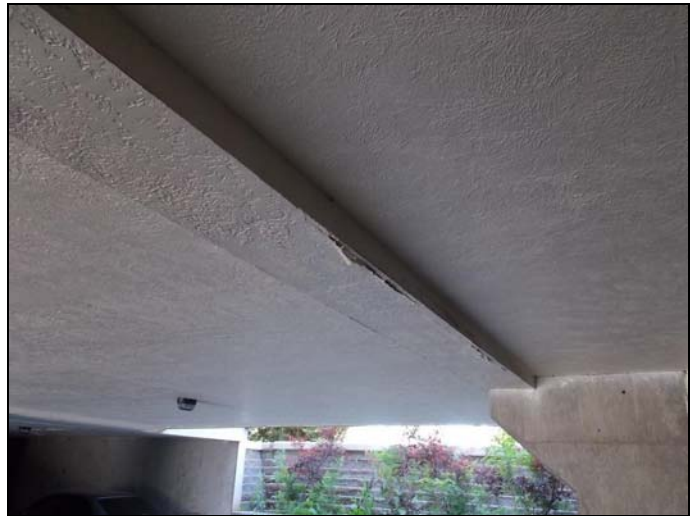
Comp #: 203 Garage Ceilings - Repair/Repaint

The painted garage ceilings are in fair to poor condition. We recommend funding to repair/repaint this component approximately every 10 - 12 years. Remaining life based on current condition.

\$1.25/Sq.ft.; Estimate to repair/repaint

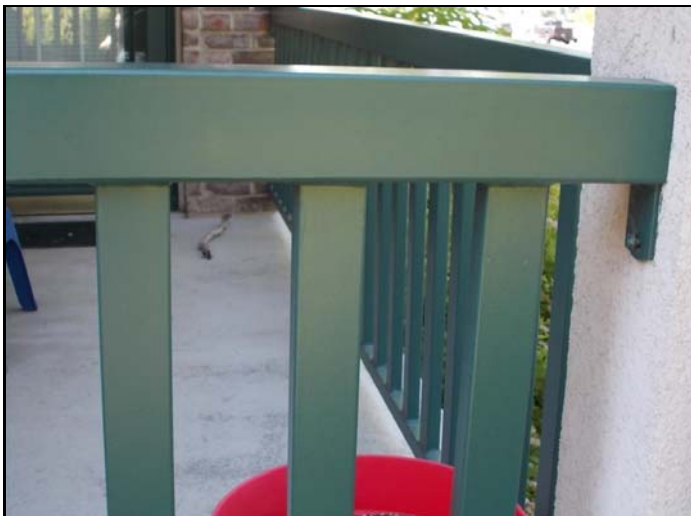
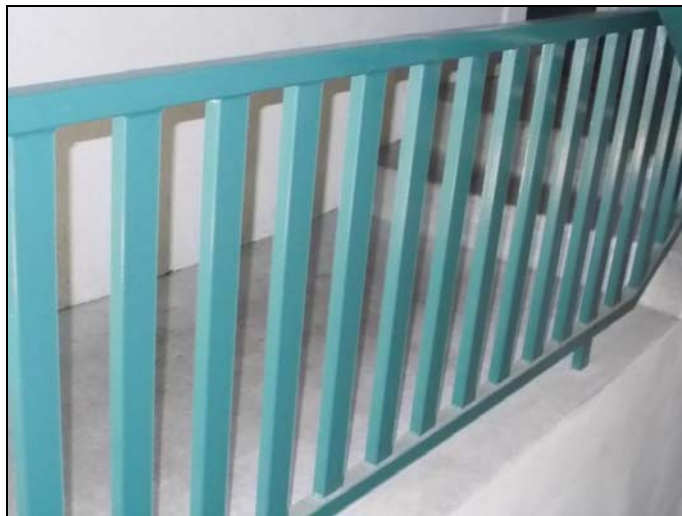
Comp #: 212 Balcony & Common Area Railing - Repaint

The painted metal railing surfaces are in fair condition. We recommend funding to paint this component approximately every 8 - 10 years. Remaining life based on current condition.

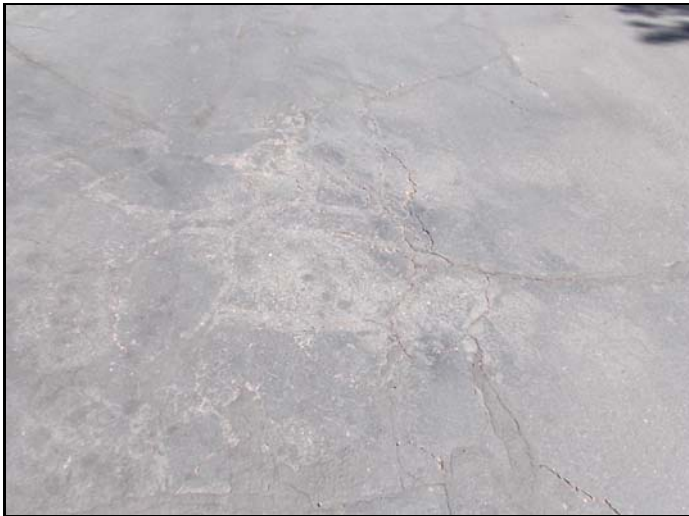
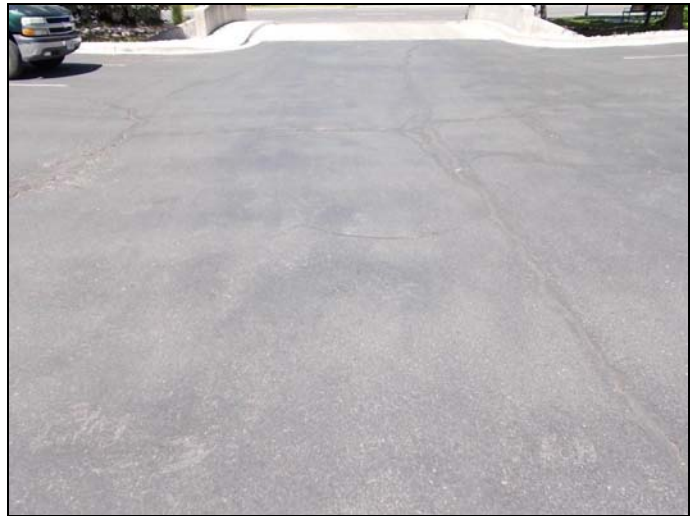
Comp #: 401 Asphalt - Major Rehab

The asphalt surfaces are in fair condition. We recommend funding for a major rehab of this component approximately every 25 - 30 years. Remaining life based on current condition.

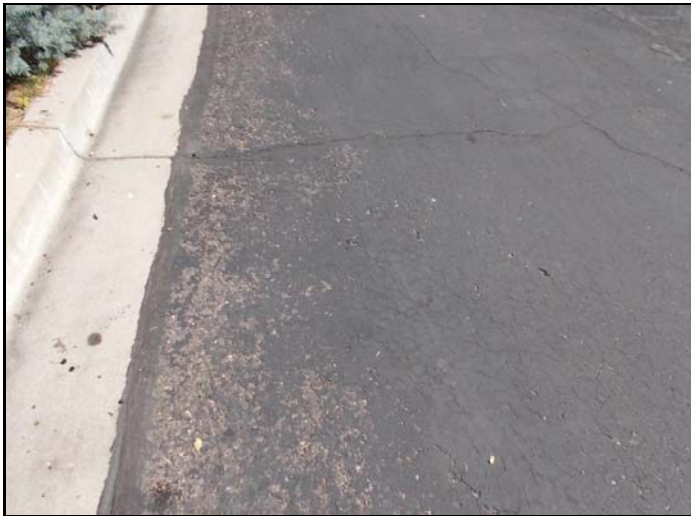
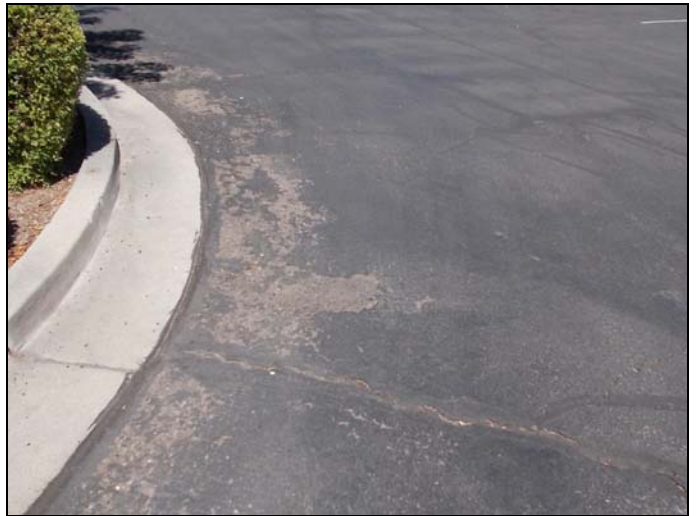
Comp #: 402 Asphalt - Seal Coat

The asphalt seal coat is in fair condition. Typically we recommend asphalt surfaces should be sealed every 3 - 5 years, but due to the use of the new HA5 product from Holbrook Asphalt, we are setting the useful life at 7 years. Remaining life based on current age.

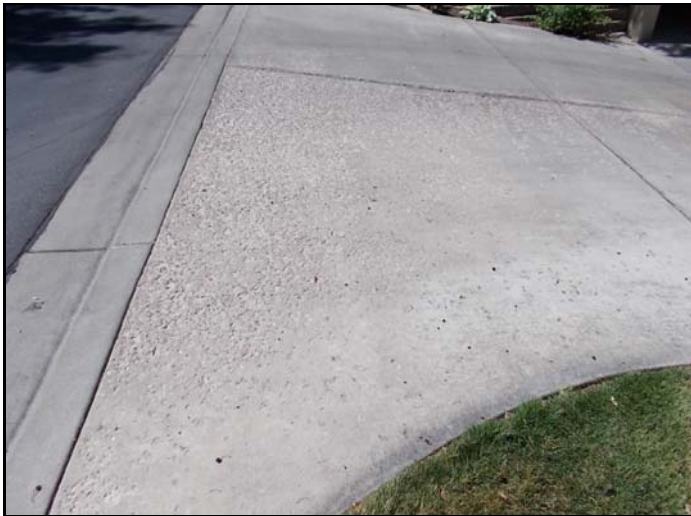
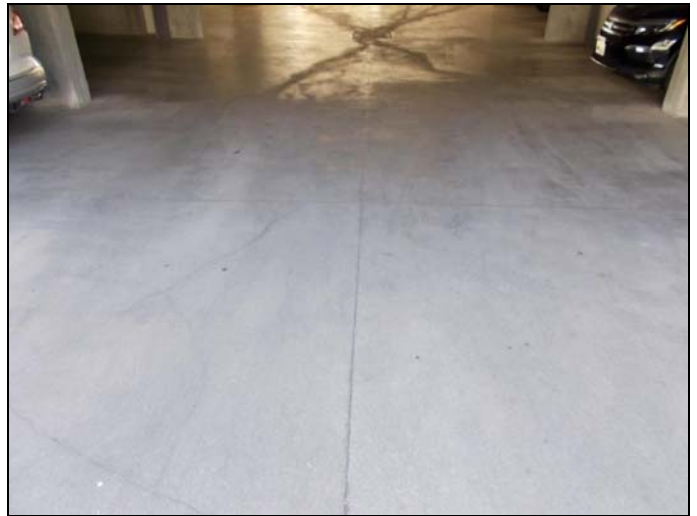
Comp #: 403 Concrete - Repair/Replace

The concrete is generally in good condition. This component has an extended useful life under normal conditions. We recommend funding to make repairs and partially replace this component approximately every 10 years. Remaining life based on current age.

Allowance to repair/replace

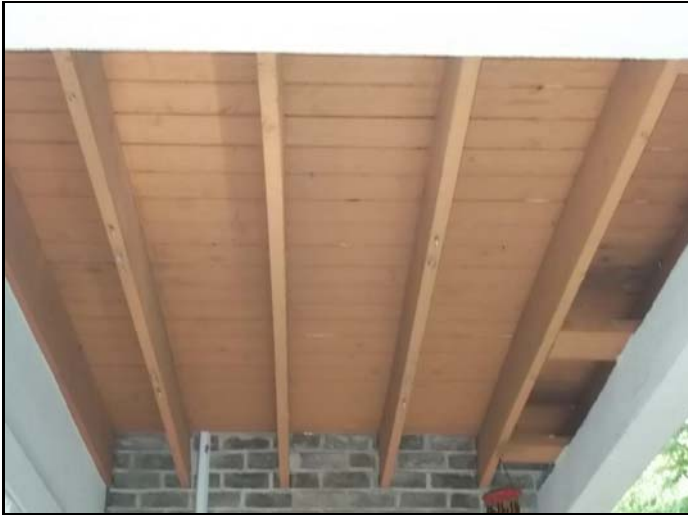
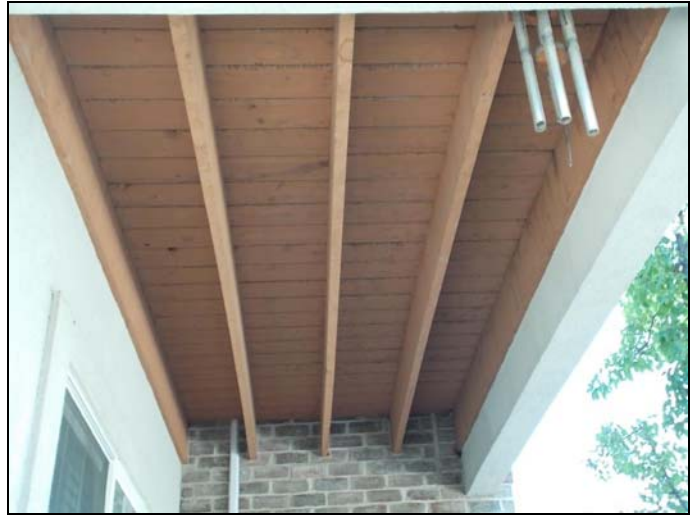
Comp #: 606 Wood Balcony Surfaces - Repaint

Unable to inspect the top of this component at the time of the inspection. We recommend this component be painted approximately every 8 - 10 years. Remaining life based on current age.

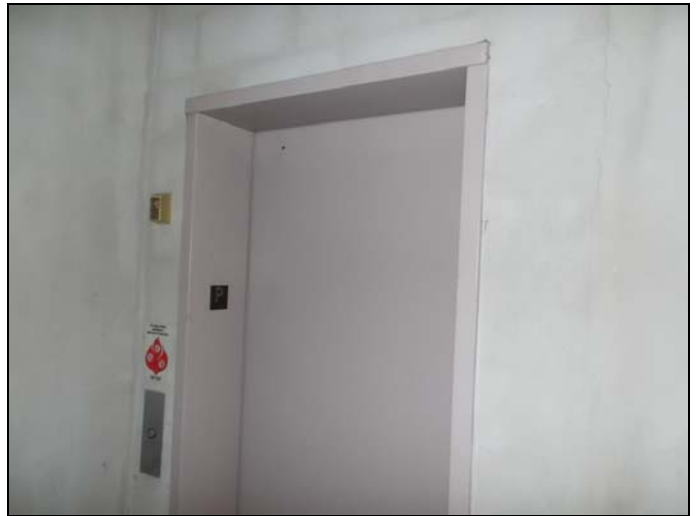
Comp #: 707 Elevator - Modernize

The elevator is in working condition. We recommend funding to modernize this component approximately every 25 - 30 years. Modernization consists of controller replacement, door package upgrade, and control panel replacement. Remaining life based on current age.

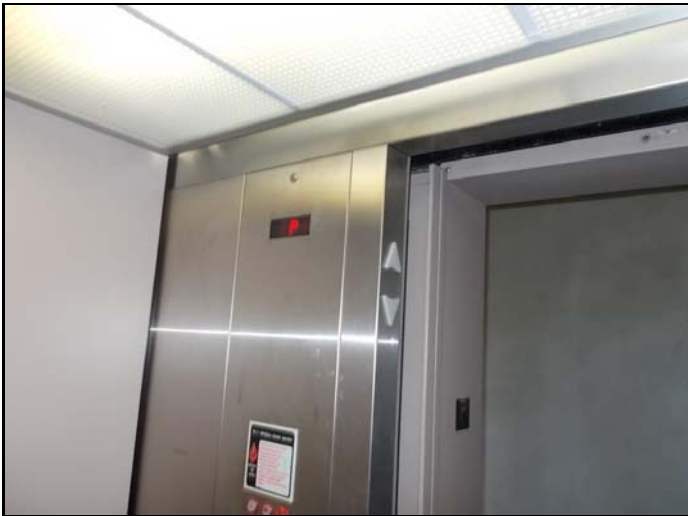
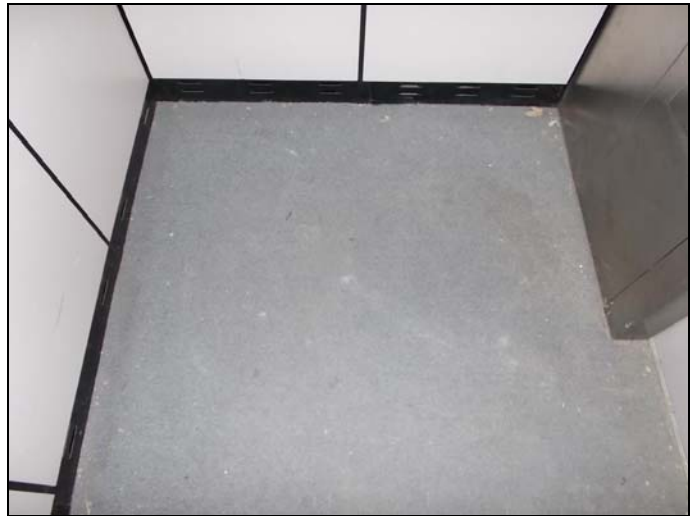
Comp #: 709 Elevator Cab - Remodel

The elevator cab is in fair condition. We recommend funding to remodel this component approximately every 15 - 20 years. Remaining life based on current condition.

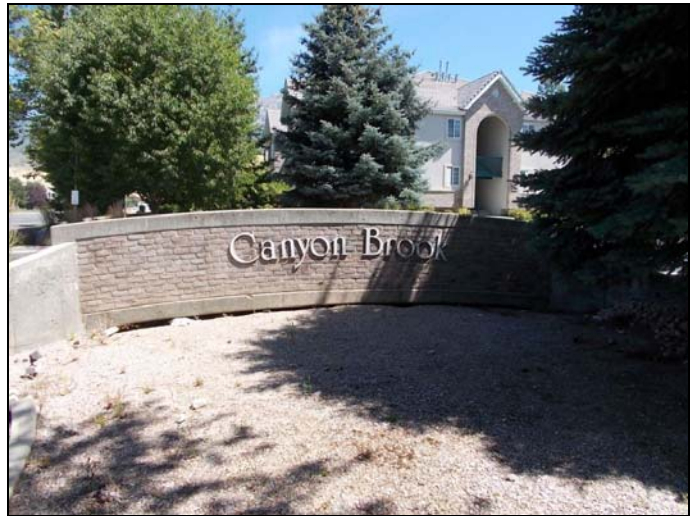
Comp #: 801 Monument Signs - Replace

Due to the minimal cost associated with replacing these letters, reserve funding is not appropriate. Replace as necessary as an operating expense. No reserve funding necessary.

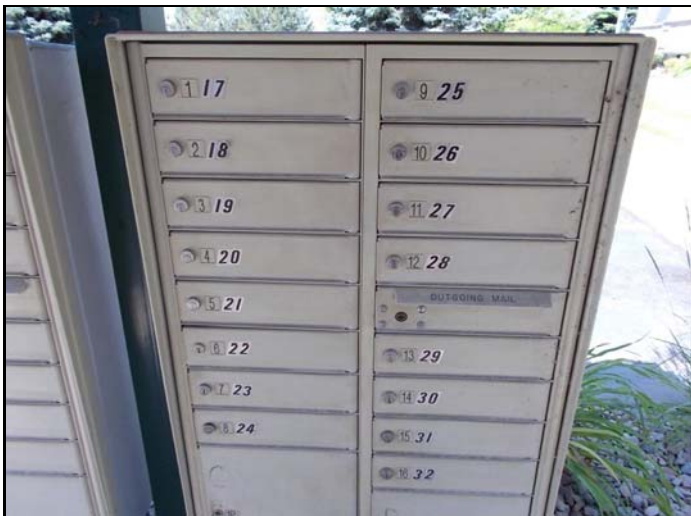
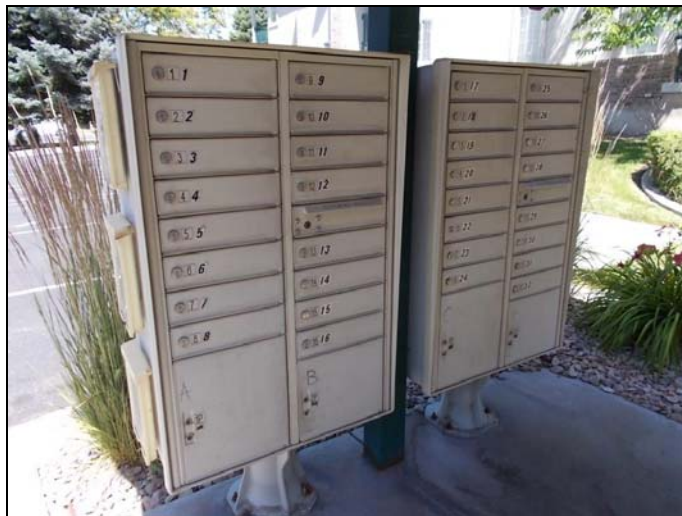
Comp #: 803 Mailboxes - Replace

The mailboxes are in good condition. Typically these mailboxes are owned and maintained by the postal service. No reserve funding necessary.

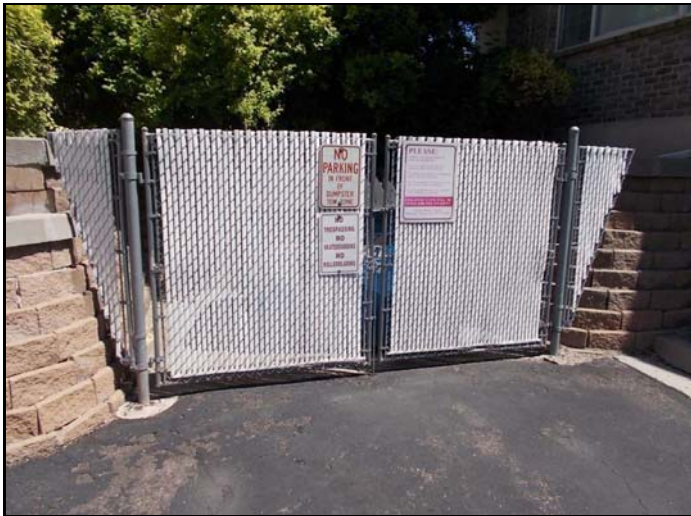
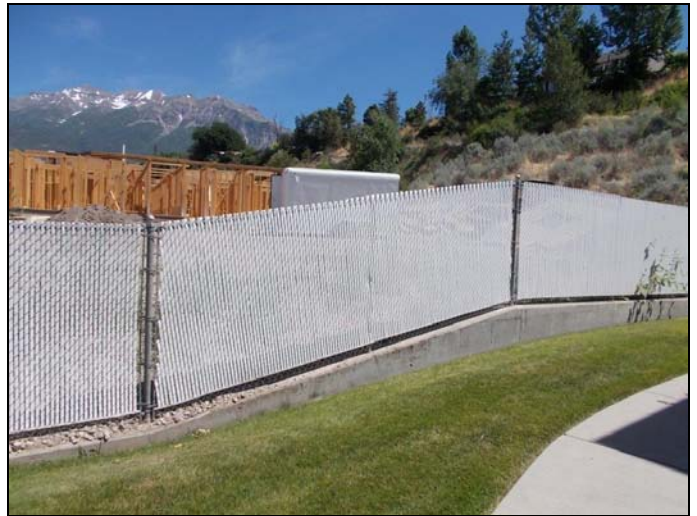
## Comp #: 1003 Chain Link Fencing - Replace

The chain link fencing is in good condition. We recommend funding to replace this component approximately every 30 - 40 years. Remaining life based on current age.

Estimate to replace

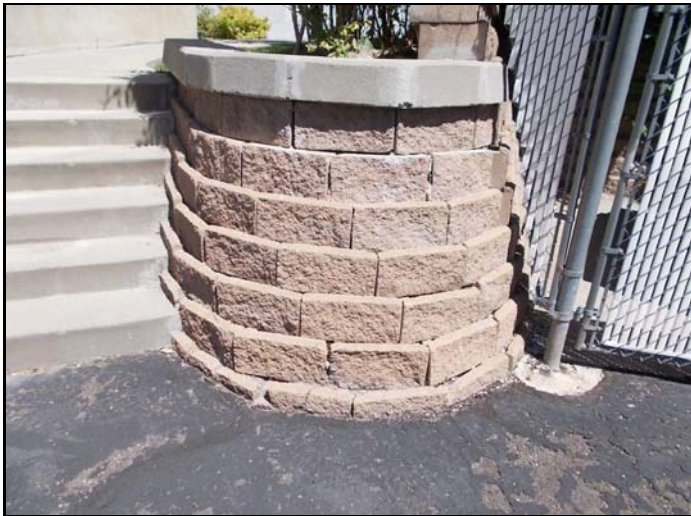
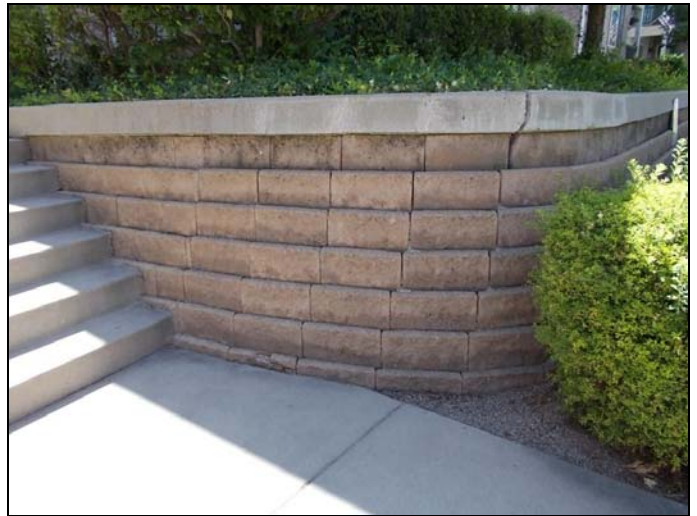
Comp #: 1011 Retaining Wall - Repair/Replace

The retaining wall appears to be in good condition. This component has an extended useful life. Make repairs as necessary as an operating expense. No reserve funding necessary.

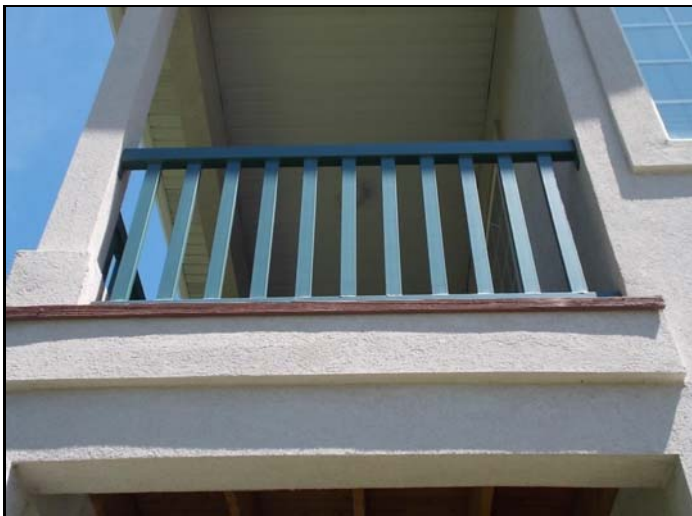
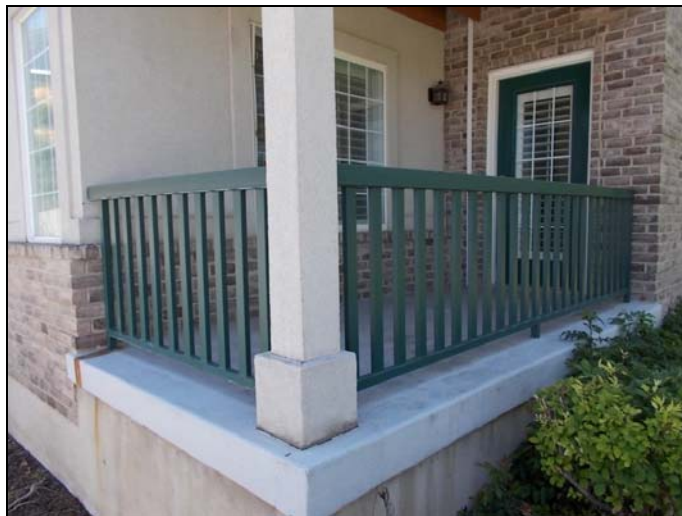
Comp #: 1090 Metal Railing - Replace

The metal railing is in good condition. We recommend funding to replace this component approximately every 40 - 50 years. Remaining life based on current age.

Estimate to replace

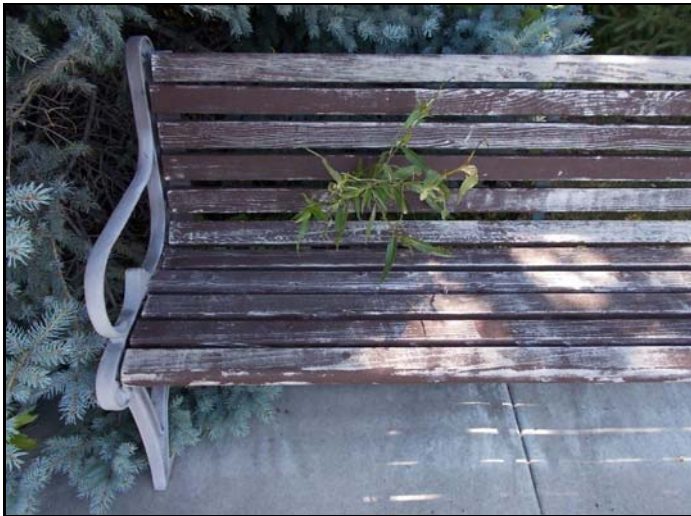
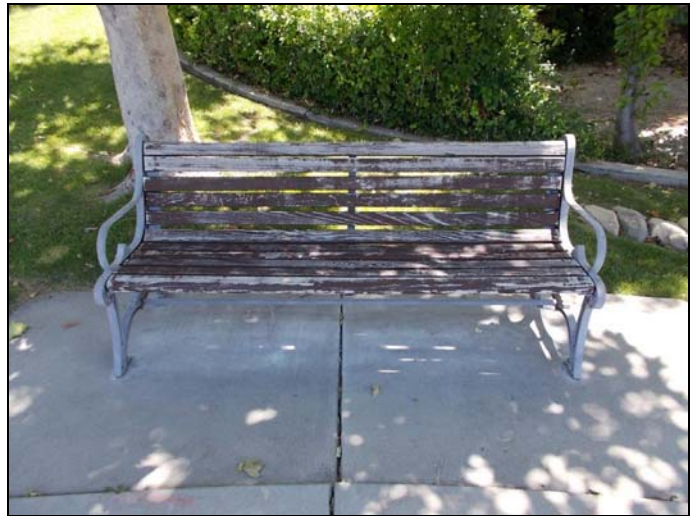
Comp #: 1307 Benches - Replace

The benches are in poor condition. We recommend funding to replace this component approximately every 10 - 15 years. Remaining life based on current age.

*Best Cost:* **\$1,200**  
\$600/Bench; Estimate to replace

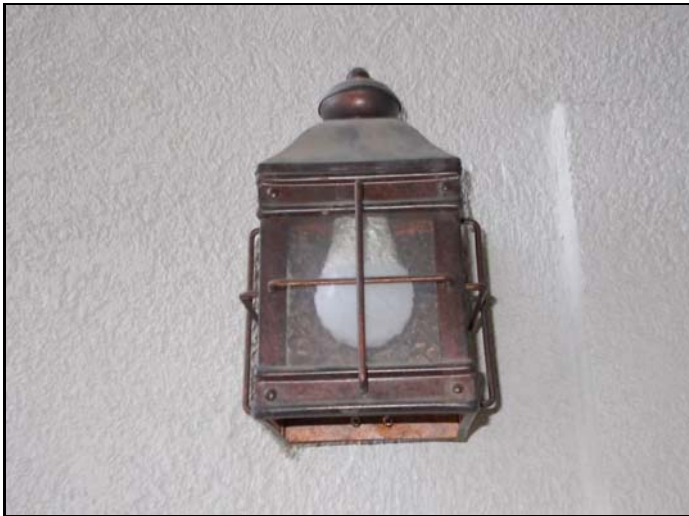
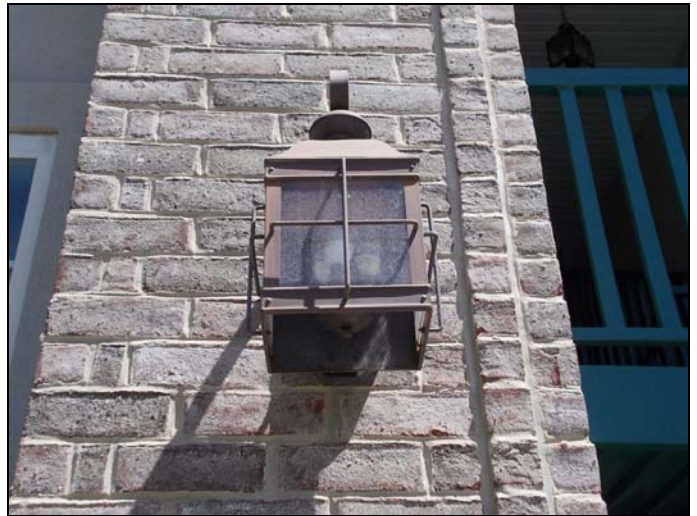
Comp #: 1602 Exterior Light Fixtures - Replace

The exterior light fixtures are in good to fair condition. We recommend funding to replace this component approximately every 16 years to maintain appearance and function. Remaining life based on current age.

*Best Cost:* **\$16,800**  
\$100/Fixture; Estimate to replace

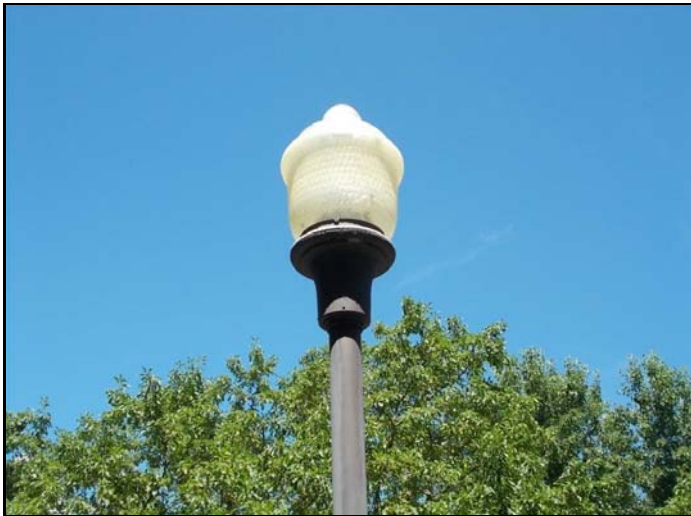
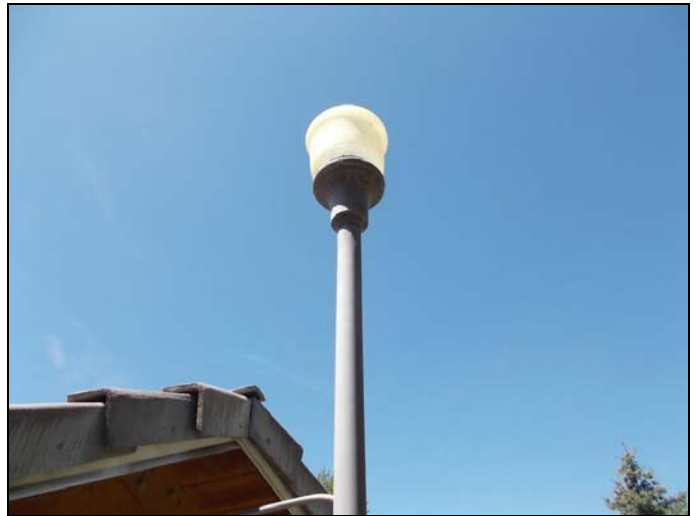
Comp #: 1609 Street Light Fixtures - Replace

The street light fixtures are in fair condition. No expectation to replace the light poles. Paint poles as necessary as an operating expense. We recommend funding to replace this component approximately every 20 years. Remaining life based on current age.

*Best Cost:* **\$5,250**  
\$750/Fixture; Estimate to replace

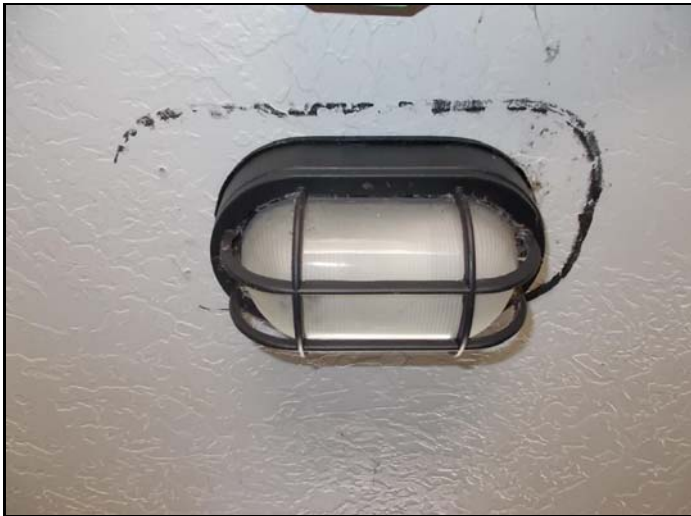
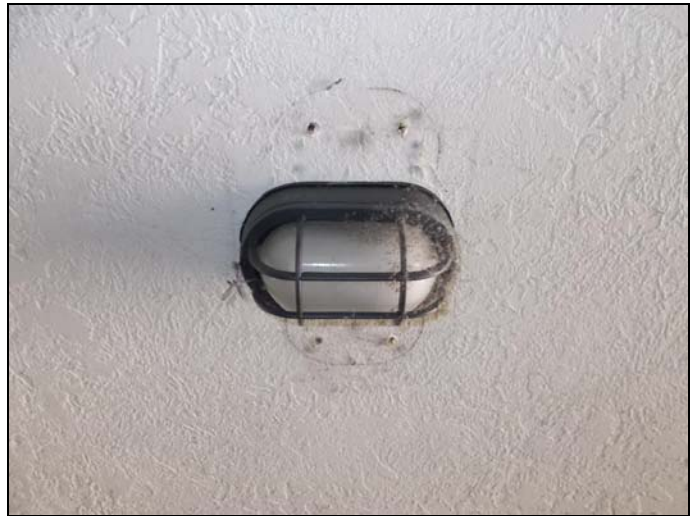
Comp #: 1690 Garage Lights - Replace

Research with the client reveals this component is replaced as necessary as an operating expense.

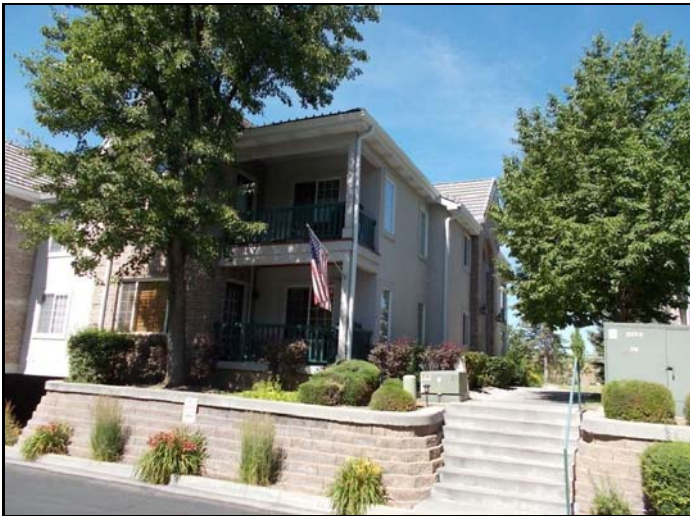
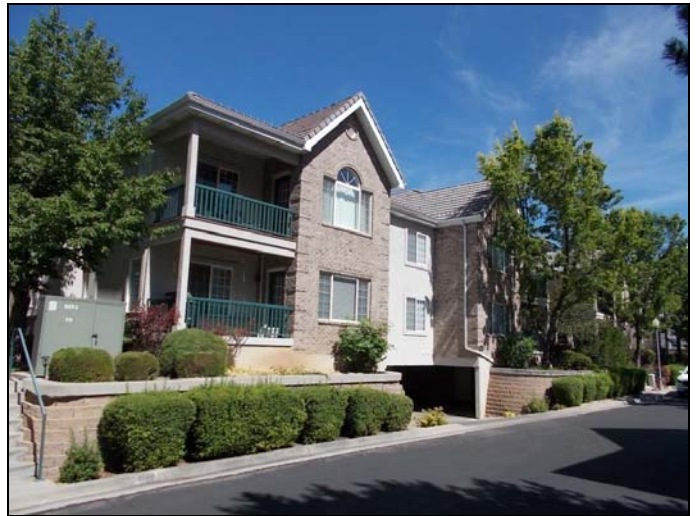
Comp #: 1812 Landscaping & Irrigation System - Renovate

The landscaping and irrigation system are in good condition. We recommend funding for an allowance to renovate the landscaping and irrigation system approximately every 20 years. Remaining life based on current age.
