# **Steeple Chase**

## **Level 1 Reserve Study**

**Report Period – 01/01/2014 – 12/31/2014**

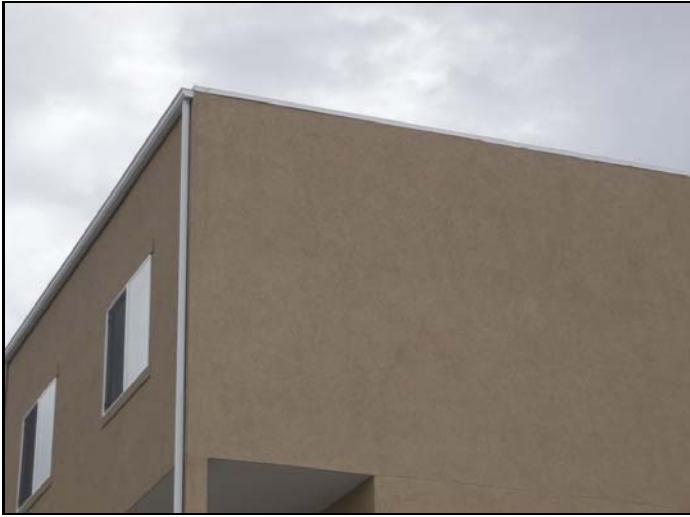
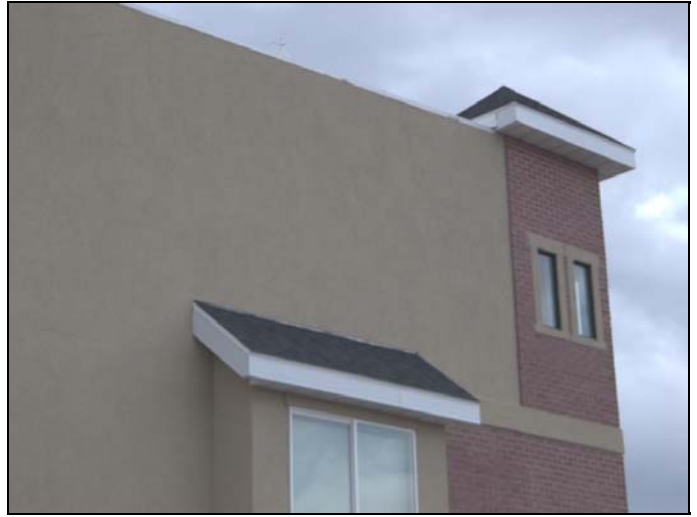
Comp #: 104 Flat Roof - Replace

*Location:* **Three Story Building Roofs**

Unable to inspect this component at the time of the inspection. Research with the client reveals this component is in good condition. The roofs should be inspected and cleaned yearly to prevent damage and to ensure a full life from this component. This component has a useful life of approximately 20 - 25 years. Remaining life based on current age.

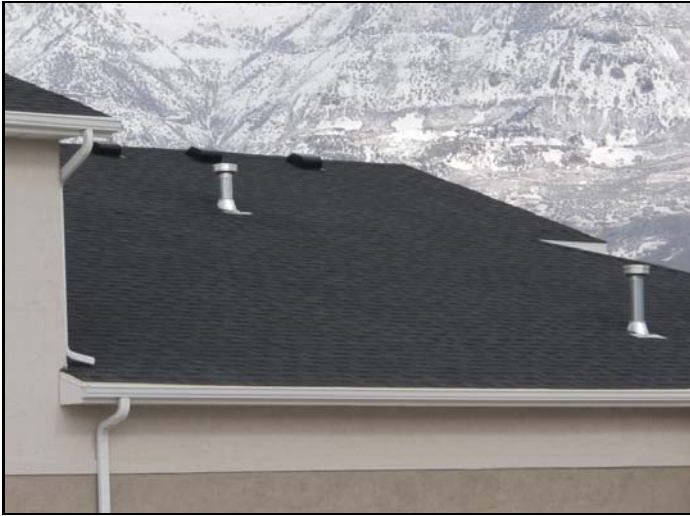
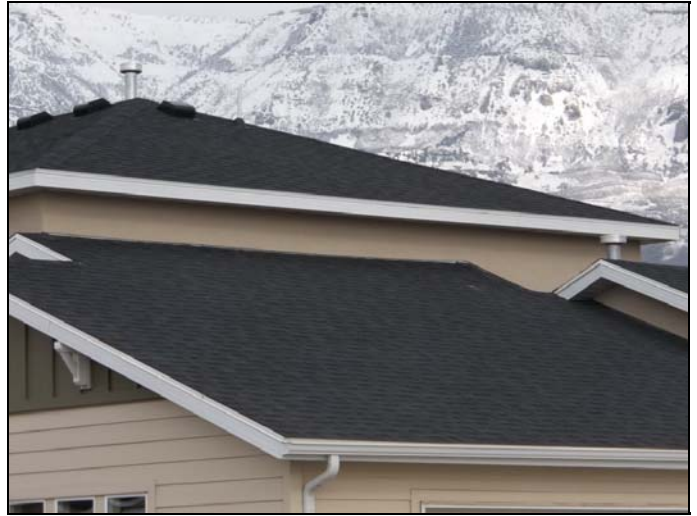
Comp #: 105 Pitched Roof - Comp Shingle - Replace

*Location:* **Building Roofs**

The roofs are in good condition. No problems were noted at the time of the inspection. Typically this type of roofing material has a useful life of approximately 25 years. Inspect this component regularly and make local repairs as necessary as an operating expense to ensure full life from this component. Remaining life based on current age.

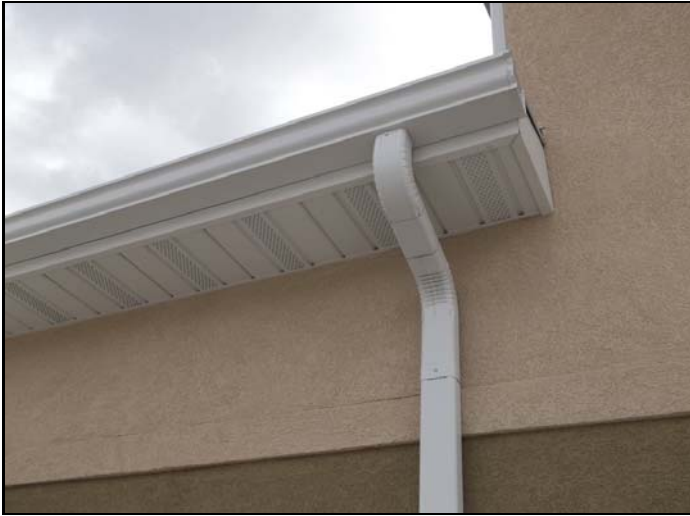
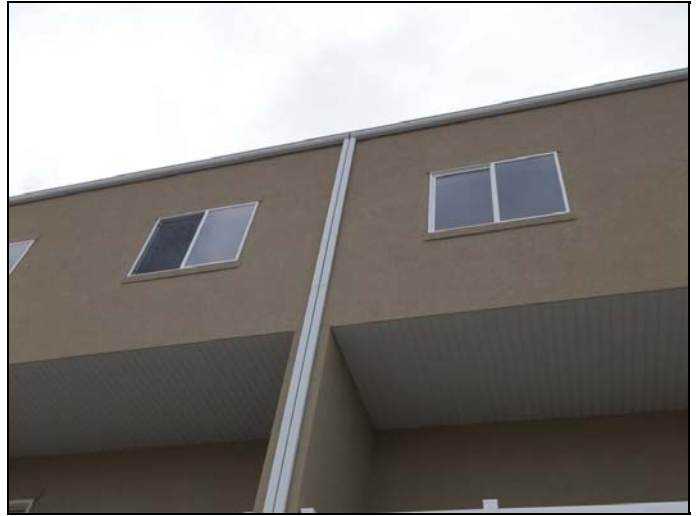
Comp #: 120 Rain Gutters/Downspouts - Replace

*Location:* **Building Roofs**

The rain gutters and downspouts are in good condition. No problems were noted at the time of the inspection. We recommend replacing the rain gutters and downspouts at the same time as the roof replacement (see Comp# 105 Pitched Roof - Comp Shingle - Replace) to ensure proper function and to take advantage of the cost savings benefits. We recommend funding to replace these gutters and downspouts every 25 years. Remaining life based on current age.

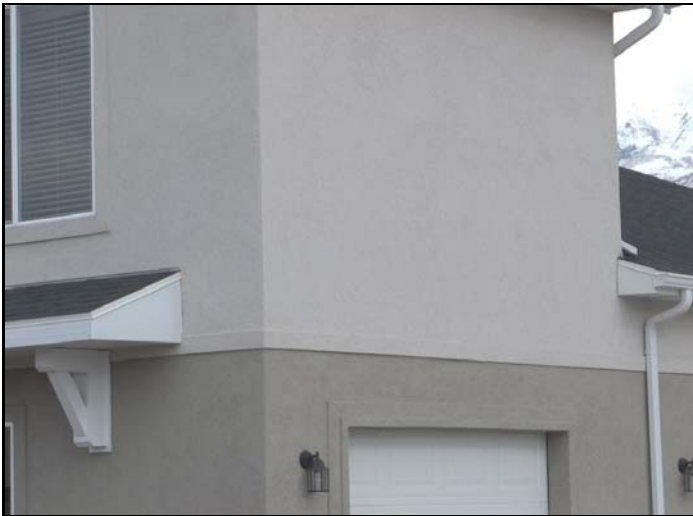
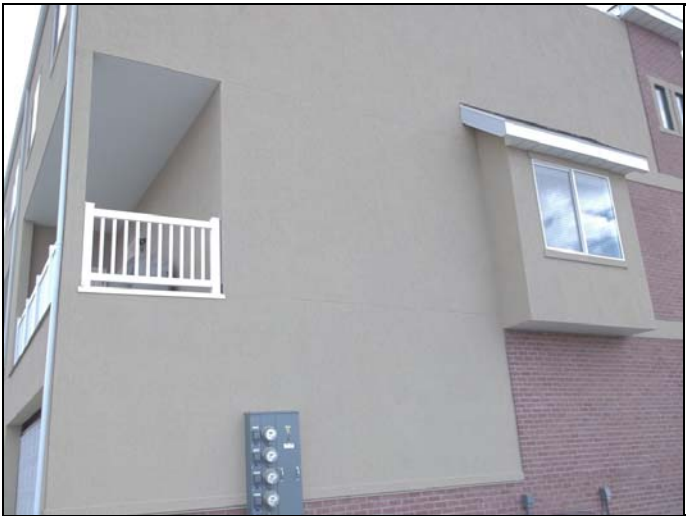
Comp #: 201 Stucco Surfaces - Repair/Repaint

*Location:* **Building Exteriors**

The stucco surfaces are in good condition. No problems were noted at the time of the inspection. We recommend funding to repair/repaint this component approximately every 10 - 12 years to protect the stucco surface and maintain appearance. Remaining life based on current age.

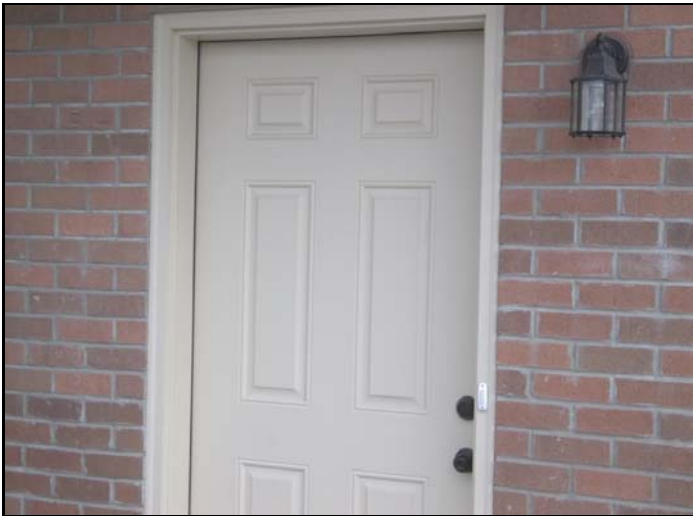
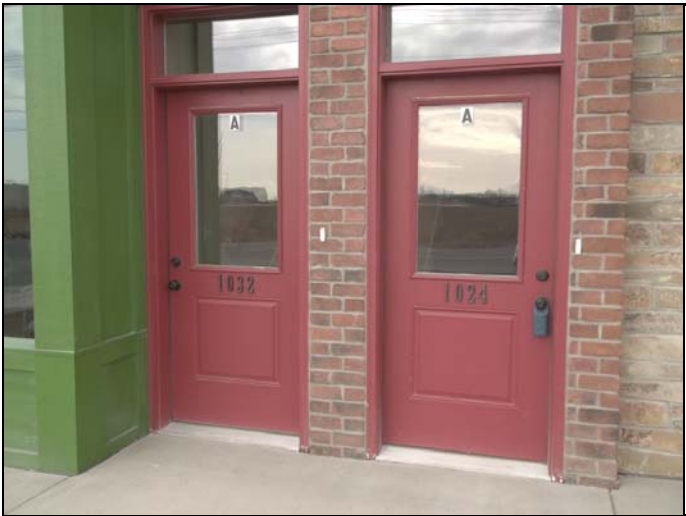
Comp #: 204 Front Doors - Repaint

Location: Unit Front Entrances

The painted front door surfaces are generally in good condition. No problems were noted at the time of the inspection. Repaint doors approximately every 6 years to maintain appearance and protect surfaces. Remaining life based on current age.

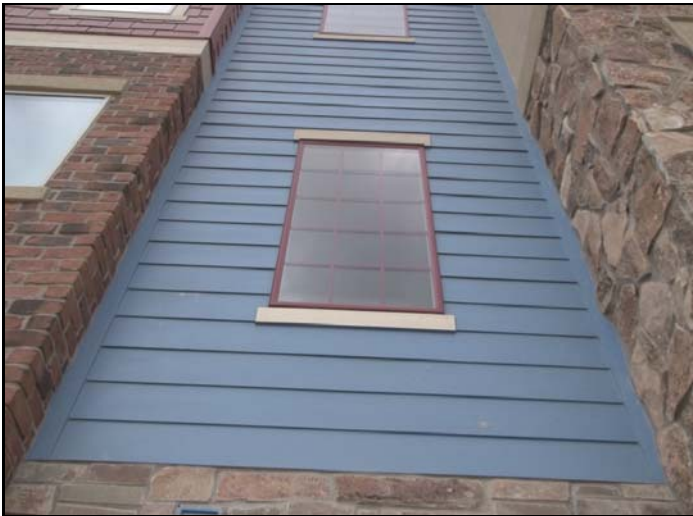
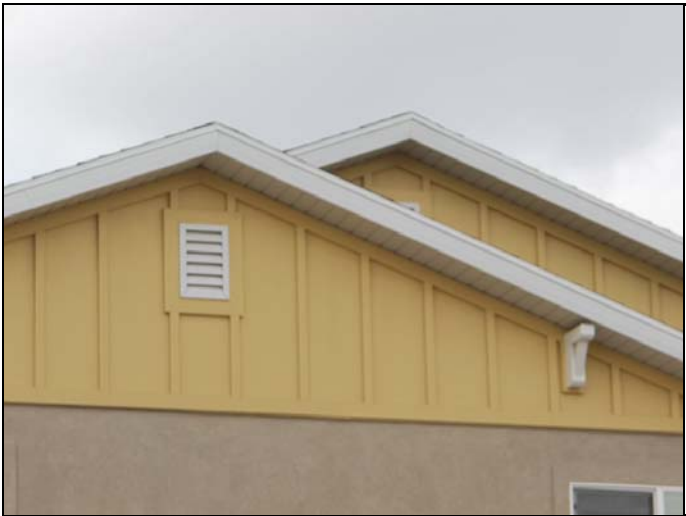
Comp #: 215    Siding - Repair/Repaint

*Location:*                **Building Exteriors**

The siding painted surfaces are in good condition. No problems were noted at the time of the inspection. Expect to repair/repaint this component approximately every 6 - 8 years to maintain appearance and to protect the siding surfaces. Remaining life is based on current age.

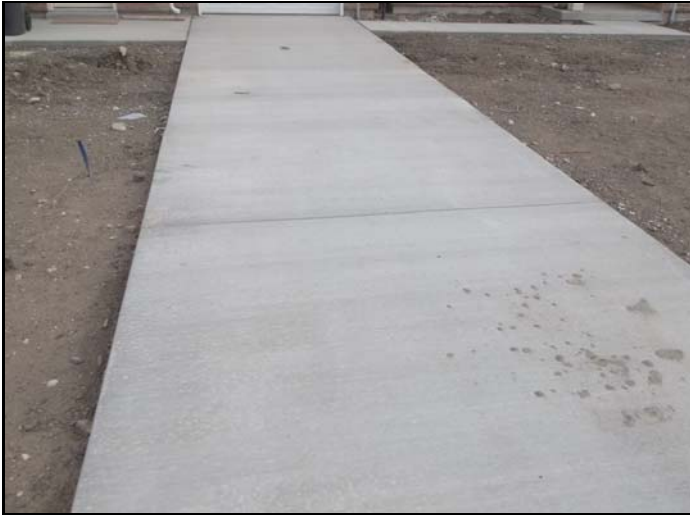
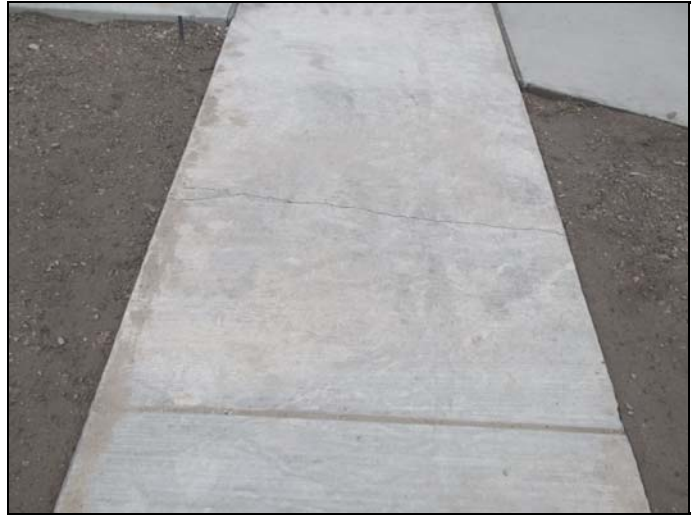
Comp #: 403 Concrete - Repair/Replace

*Location:* **Driveways & Sidewalks**

The concrete is in good condition. Minor cracking was noted at the time of the inspection. No expectation to completely replace the concrete surfaces. We recommend making local repairs as necessary as an operating expense and funding to make more significant repairs approximately every 10 years. Remaining life based on current age.

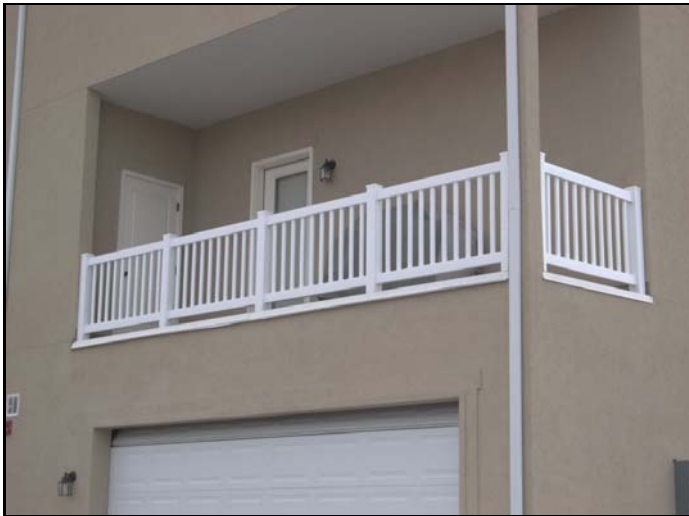
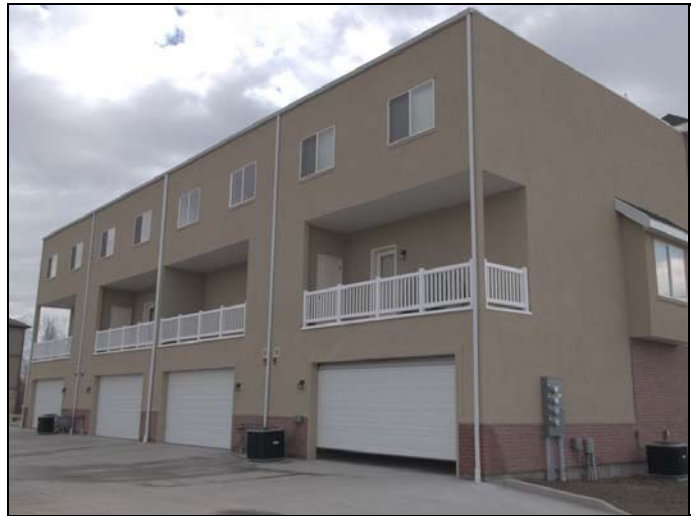
Comp #: 604 Decks - Resurface

*Location:* **Three Story Buildings**

Unable to inspect this component at the time of the inspection. Research with the client reveals the decks are in good condition. No problems were noted at the time of the inspection. We recommend funding to resurface this component approximately every 15 - 20 years. Remaining life based on current age.

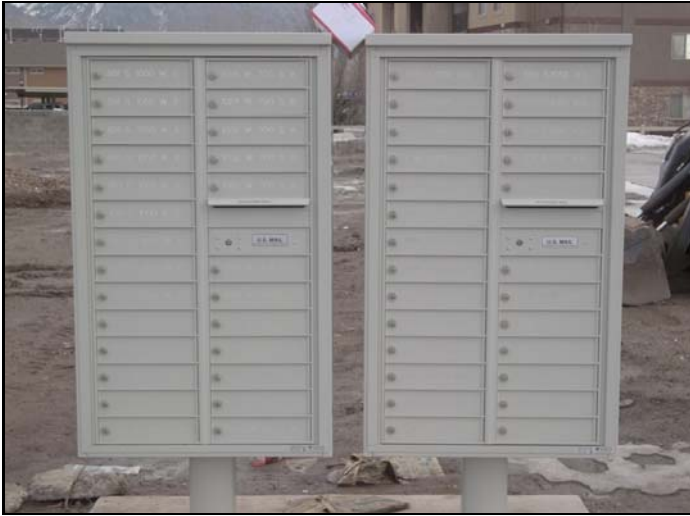
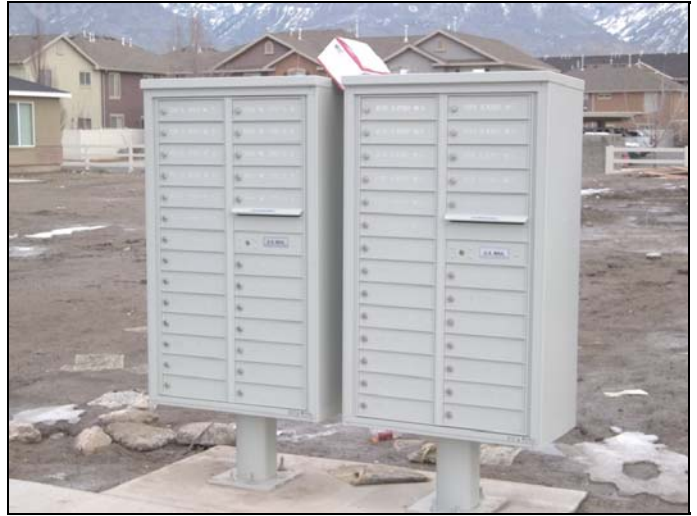
Comp #: 803 Mailboxes - Replace

*Location:* **Common Area**

The mailboxes are in good condition. No problems were noted at the time of the inspection. Expect to replace this component approximately every 18 - 20 years assuming normal use and wear. Remaining life based on current age.

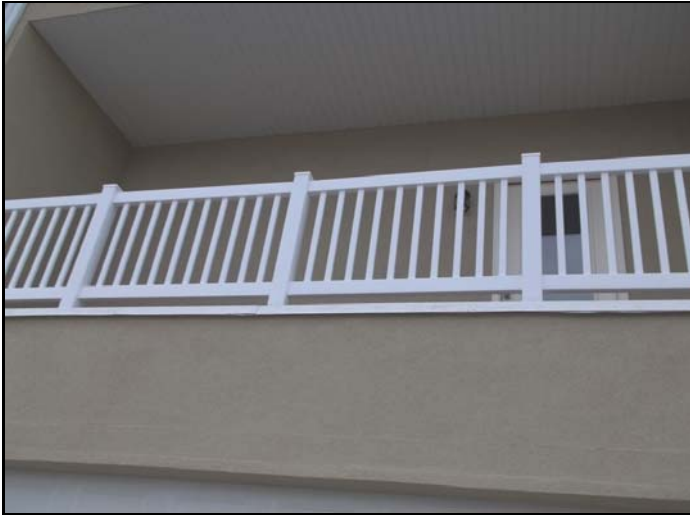
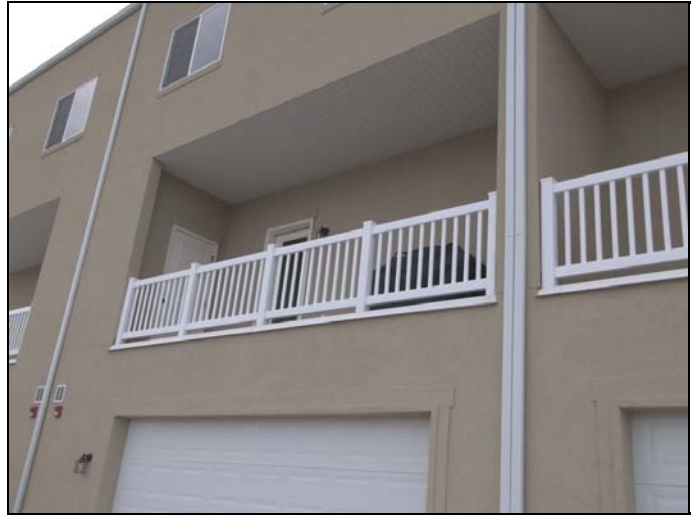
Comp #: 1090 Deck Rail - Replace

*Location:* **Three Story Building Decks**

The deck rail is in good condition. No problems were noted at the time of inspection. We recommend funding to replace this type of railing on an 20 - 25 year schedule. Remaining life based on current age.

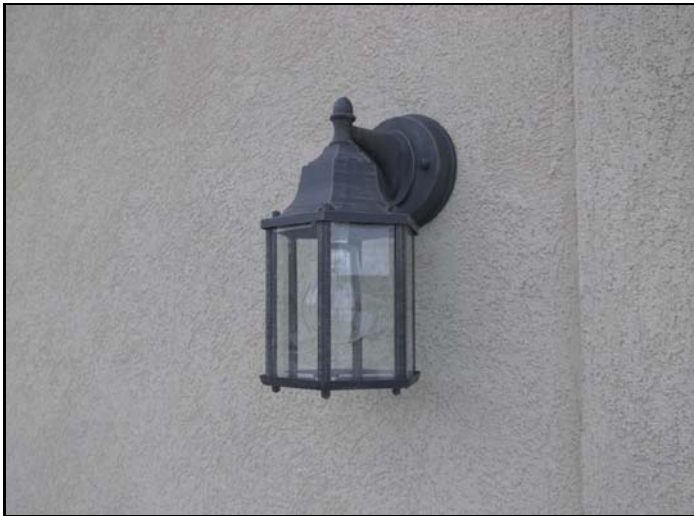
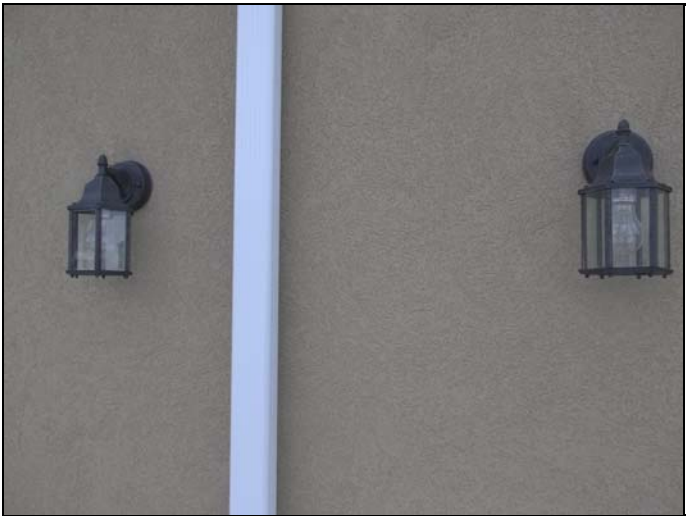
Comp #: 1602 Exterior Light Fixtures - Replace

Location: Building Exteriors

The exterior light fixtures are in good condition. No problems were noted at the time of the inspection. Expect to replace this component approximately every 16 years to maintain appearance and function. Remaining life based on current age.
