# Whispering Willows

## Tier 2 Reserve Study

Reference Number: 1496

Date of Property Inspection: 12/19/22

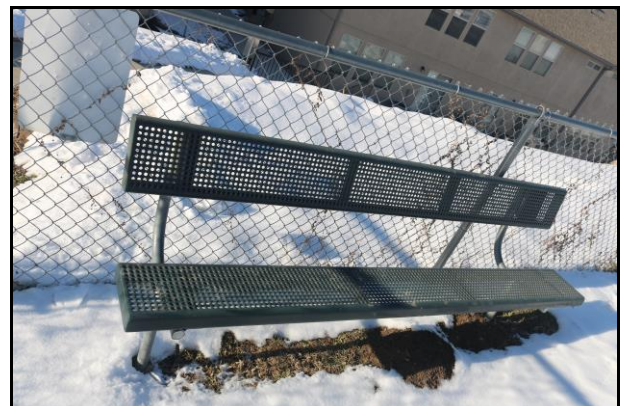
The benches around the property have small bits of tearing where metal is showing through. Board may consider replacing or repairing near the end of life.
