# SOMERSET VILLAGE

## HOA RESERVE STUDY

Beginning Period: January 1, 2023  
Ending: December 31, 2052

Report Number: 22-07  
Site Inspection Date: September 8, 2022  
Report Submittal Date: October 21, 2022

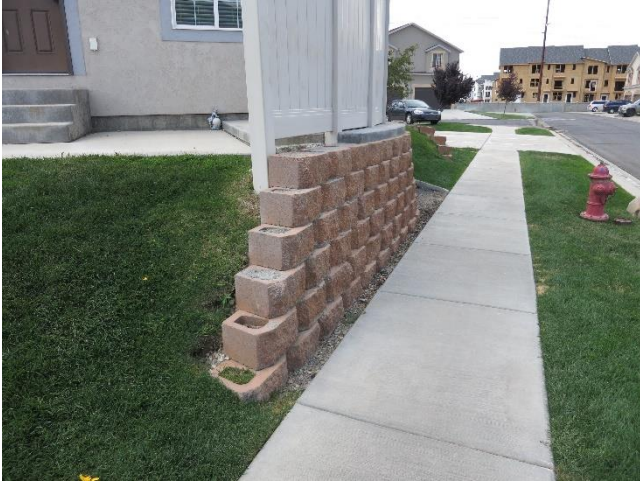
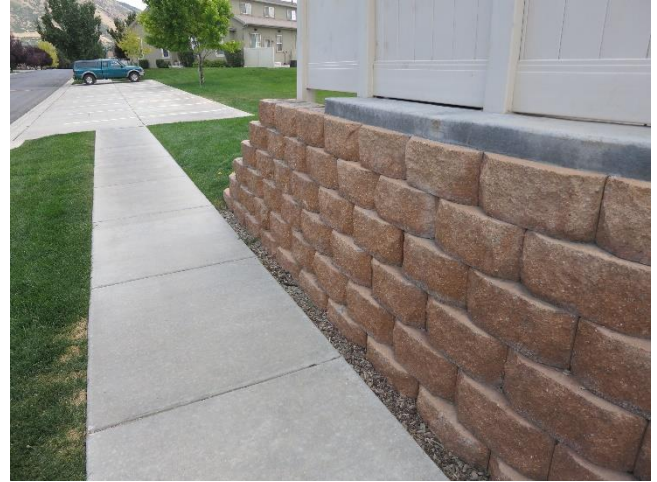
Component Name: Retaining Wall  
 Component Number: Common Development 2011

Component Life Expectancy: N/A years  
 Average Age of Component: N/A years  
 Remaining Component Life: N/A years

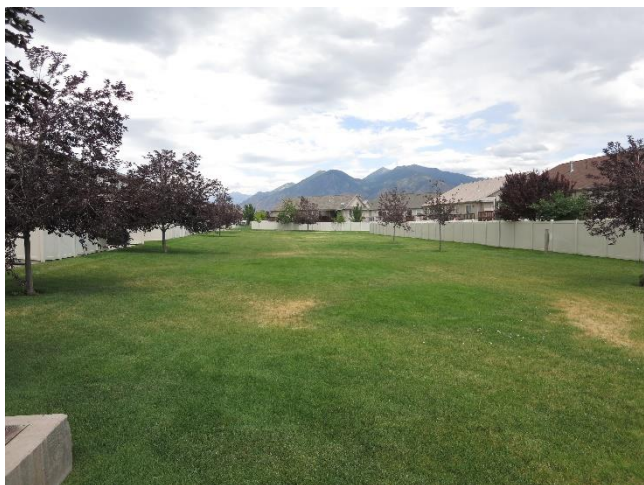
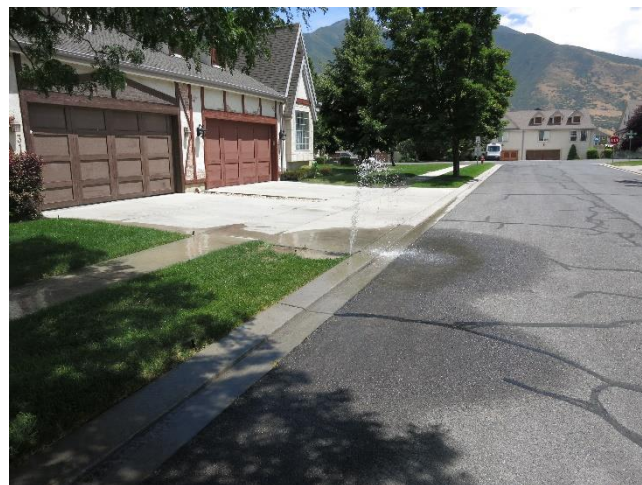
Component Name: Landscape & Irrigation  
 Component Number: Common Development 2012

Reoccurring Allowance: N/A years  
 Beginning Year

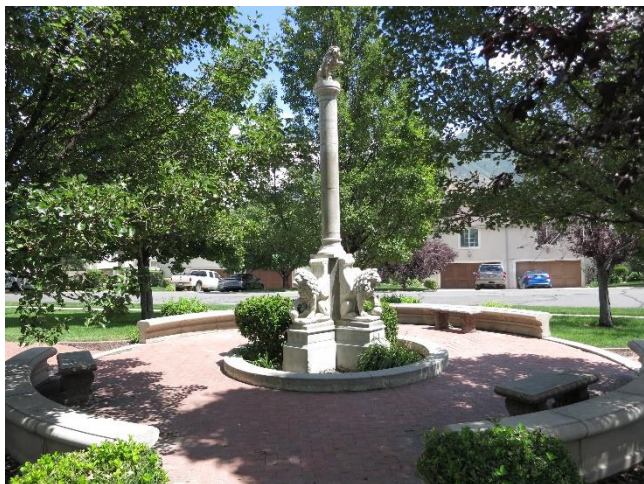
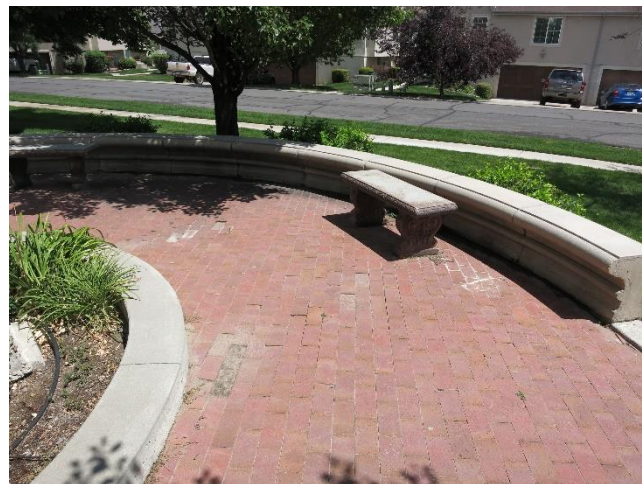
Component Name: Decorative Feature  
 Component Number: Common Development 2013

Component Life Expectancy: N/A years  
 Average Age of Component: N/A years  
 Remaining Component Life: N/A years

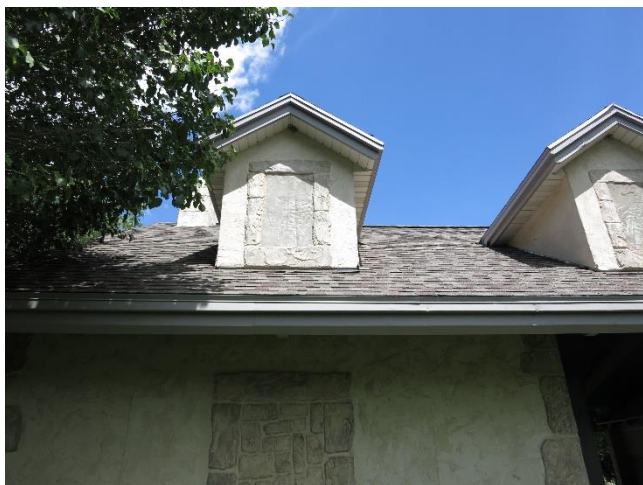
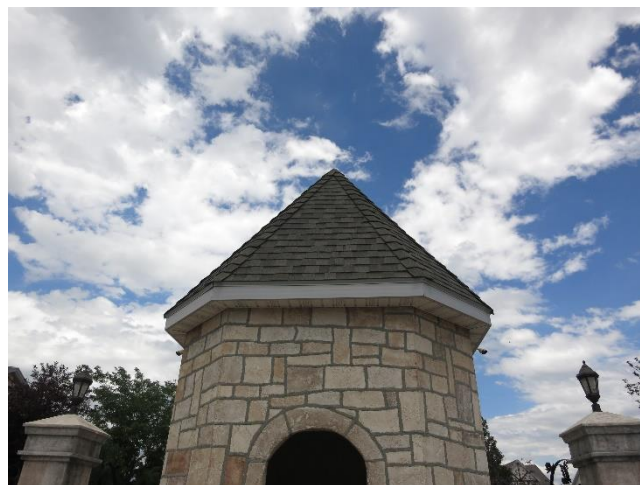
Component Name: Exterior Stucco  
 Component Number: Building Exterior 3002

Component Life Expectancy: N/A years  
 Average Age of Component: N/A years  
 Remaining Component Life: N/A years
