# Cedars Townhomes HOA

## CAPITAL RESERVE STUDY

Report Number: 23-09  
Site Inspection Date: May 12<sup>th</sup>, 2023  
Report Submittal Date: May 24<sup>th</sup>, 2023

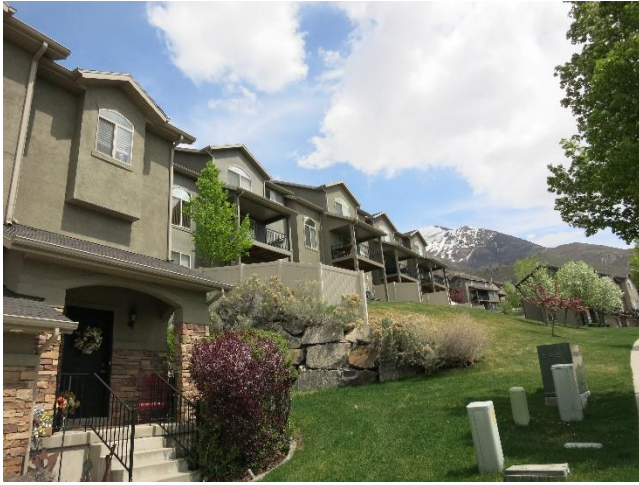
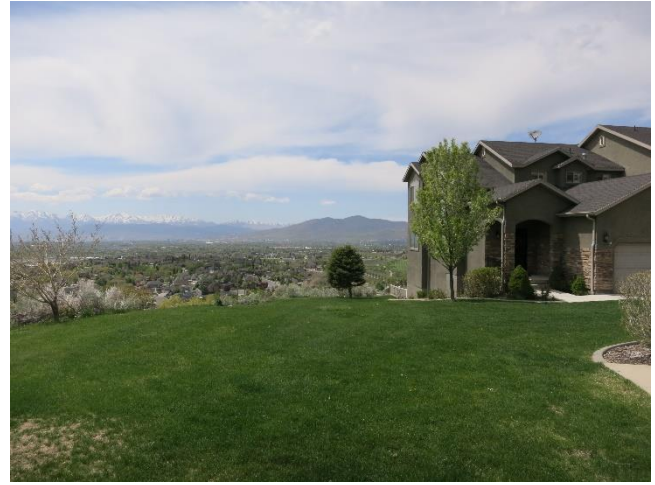
Component Name: Landscape & Irrigation  
 Component Number: Common Development 3010

Typically, landscape irrigation systems are never replaced as a whole system but rather maintained as parts break. This item should be accounted for within the annual operating account. There are too many external factors beyond design life that contribute to sprinkler damage to accurately determine a life expectancy (i.e., driving/aerating over heads, sand infiltration, freeze damage, etc.).
