# **Park View HOA**

## **CAPITAL RESERVE STUDY**

Report Number: 24-22

Site Inspection Date: November 28<sup>th</sup>, 2020  
Report Submittal Date: December 18<sup>th</sup>, 2020  
Report Updated: January 8<sup>th</sup>, 2025

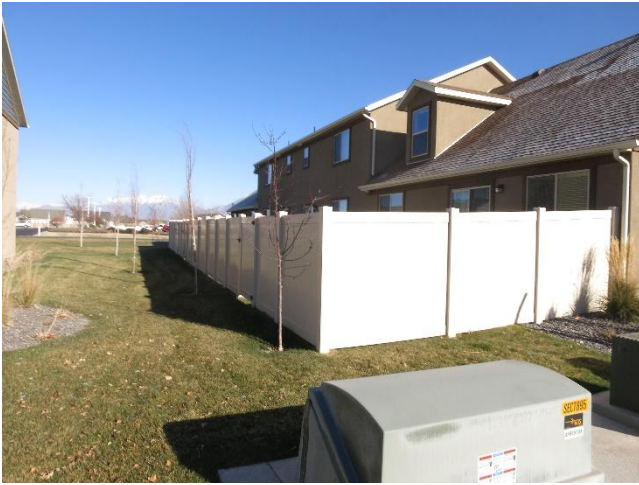
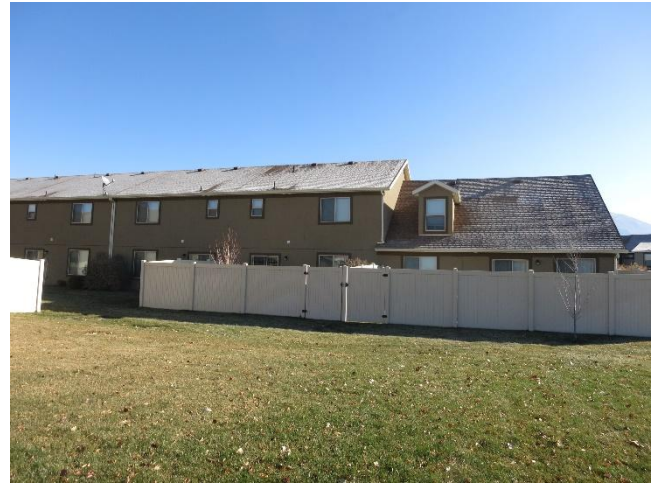
Component Name: Vinyl Fencing  
 Component Number: Building Exterior 2007

Component Life Expectancy: N/A years  
 Average Age of Component: \_\_\_\_\_ years  
 Remaining Component Life: \_\_\_\_\_ years

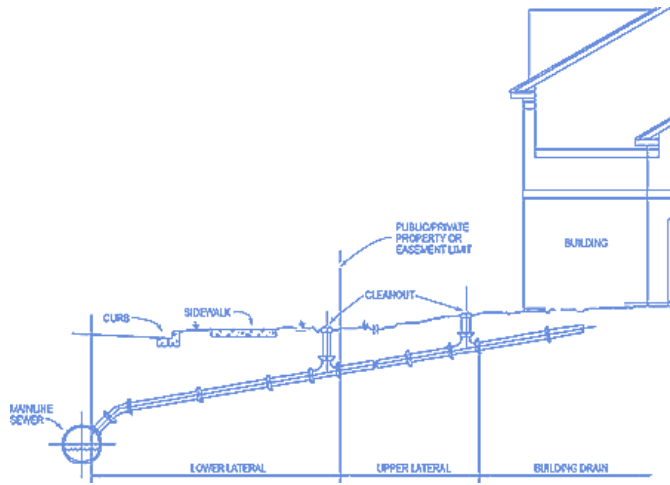
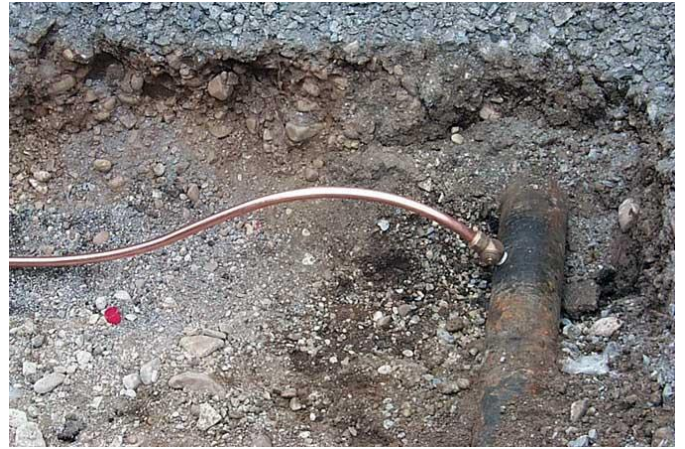
Component Name: Sewer & Water Lines  
 Component Number: Building Exterior 2010

Component Life Expectancy: N/A years  
 Age of Component: \_\_\_\_\_ years  
 Remaining Component Life: \_\_\_\_\_ years

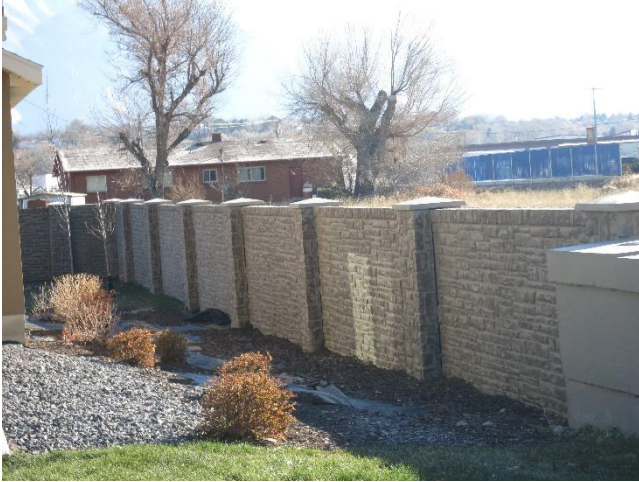
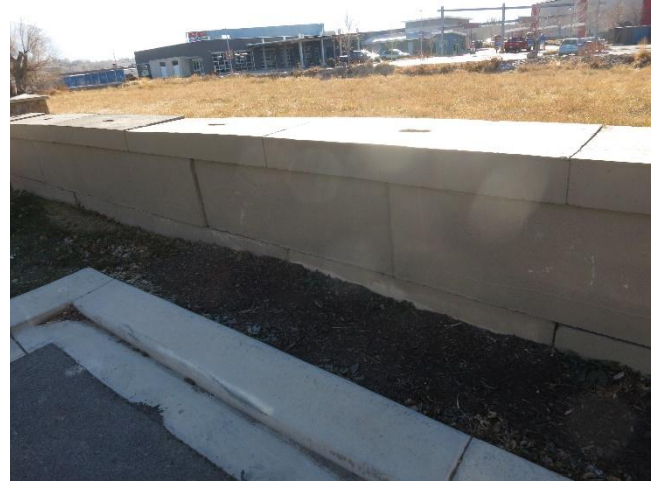
Component Name: Concrete Panel Fencing  
 Component Number: Common Development 3002

Component Life Expectancy: ∞ years  
 Average Age of Component:            years  
 Remaining Component Life:            years

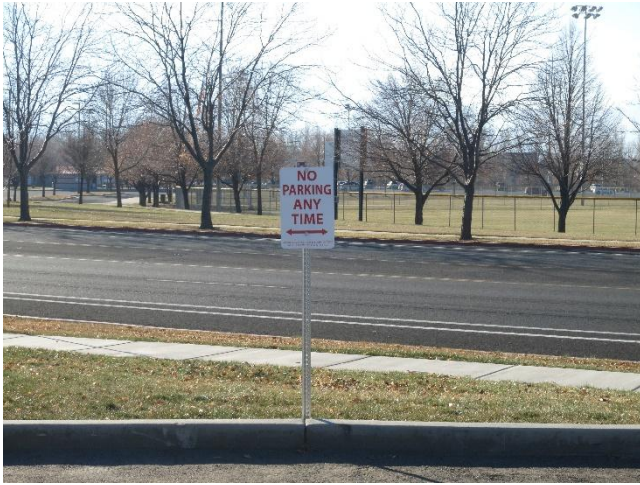
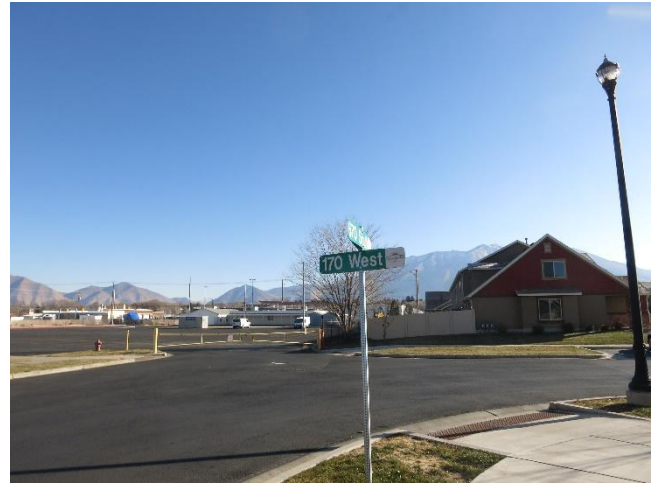
Component Name: Sign Replacement  
 Component Number: Common Development 3004

Sign Allowance N/A years  
 Beginning Year N/A

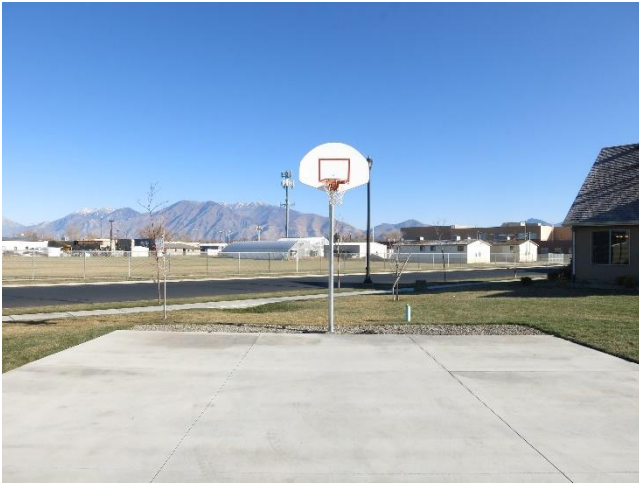
Component Name: Basketball Hoop  
 Component Number: Common Development 3007

Component Life Expectancy: N/A years  
 Average Age of Component:            years  
 Remaining Component Life:            years

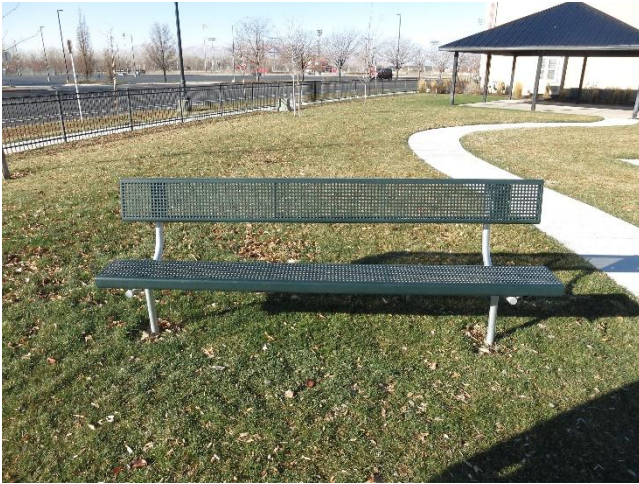
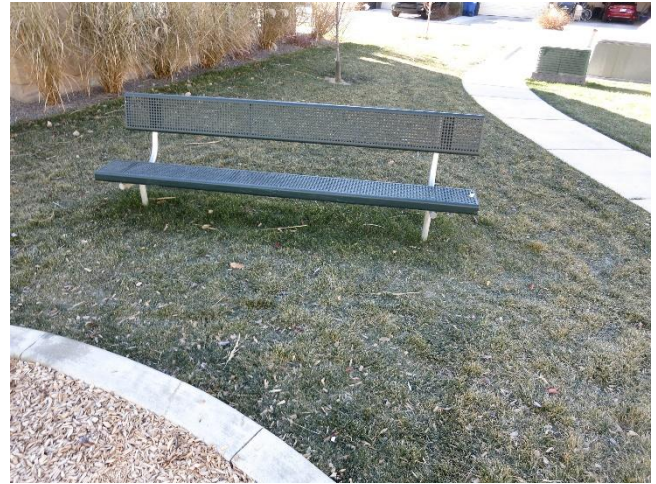
Component Name: Outdoor Furniture  
 Component Number: Common Development 3008

Component Life Expectancy: N/A years  
 Average Age of Component:            years  
 Remaining Component Life:            years

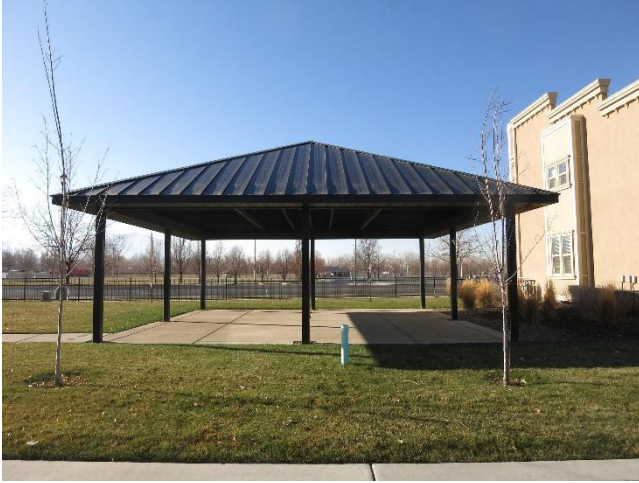
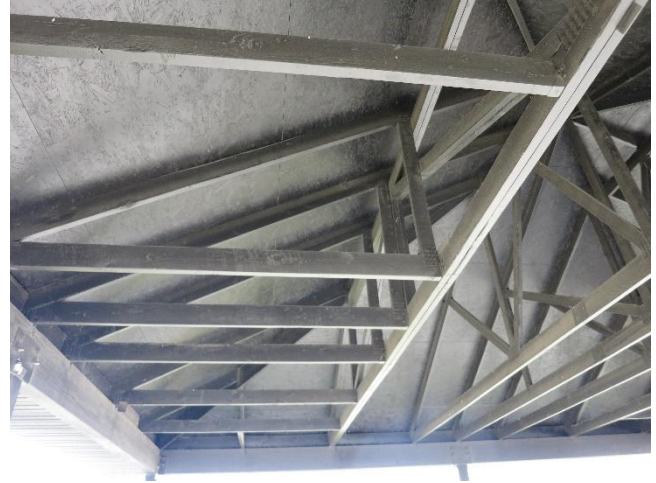
Component Name: Metal Pavilion  
 Component Number: Common Development 3009

Component Life Expectancy: ∞ years  
 Average Age of Component:            years  
 Remaining Component Life:            years

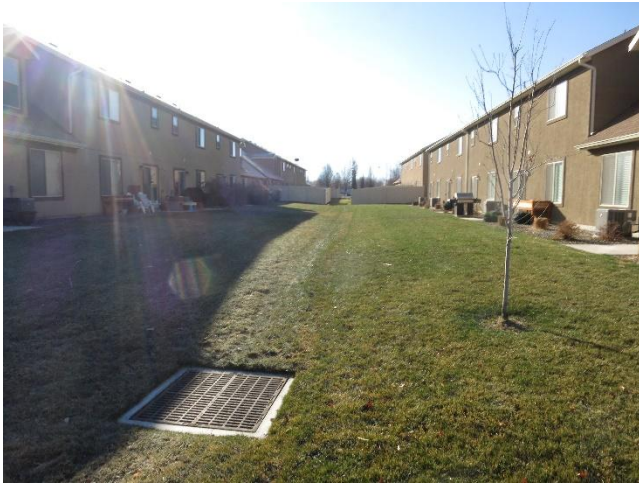
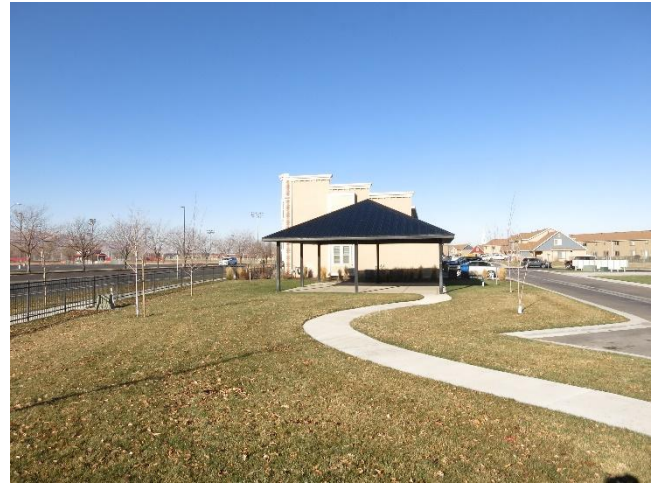
Component Name: Landscape & Irrigation  
 Component Number: Common Development 3010

Component Life Expectancy: N/A years  
 Age of Component: \_\_\_\_\_ years  
 Remaining Component Life: \_\_\_\_\_ years
